**Berkeley Balcony
Investigation Materials**

On June 16, 2015, a fourth floor balcony at the Library Gardens apartment complex in Berkeley, California collapsed, killing six people and seriously injuring seven others.

Re: Unit 305 & 405 Balcony Destructive Testing Protocol
Project: Library Gardens, 2020 Kittridge St., Berkeley, CA

Pursuant to the California Contractor's State License Board's request, I have performed an initial onsite investigation, reviewed various documents noted below and prepared the Construction Summary Report. Additionally, I have performed onsite visual & destructive testing investigations at the subject project located at 2020 Kittredge St., Berkeley, CA as well as the remnants of the balconies at Units 405 & 305. Exhibit "C" attached to this report contains a specific comparison of the design of various balcony components versus the as-built conditions found in the field through visual observation, destructive testing & laboratory analysis. This Construction Summary Report is organized by the following sections.

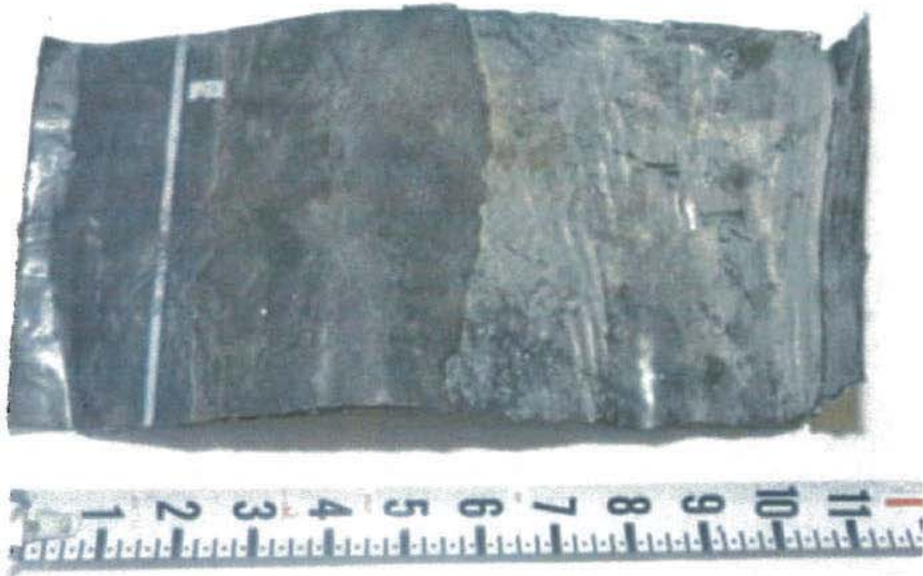
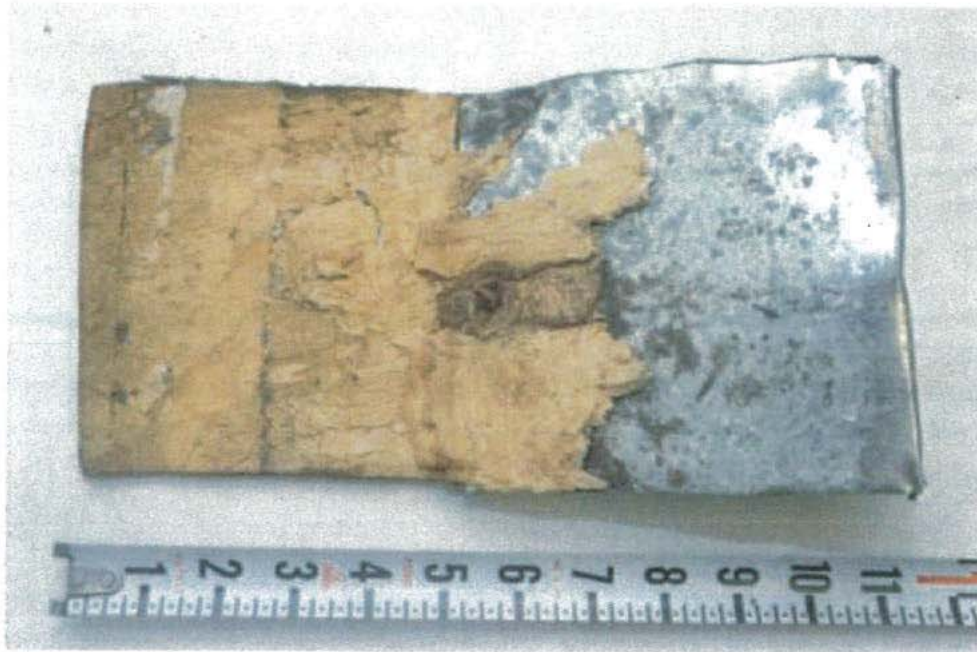
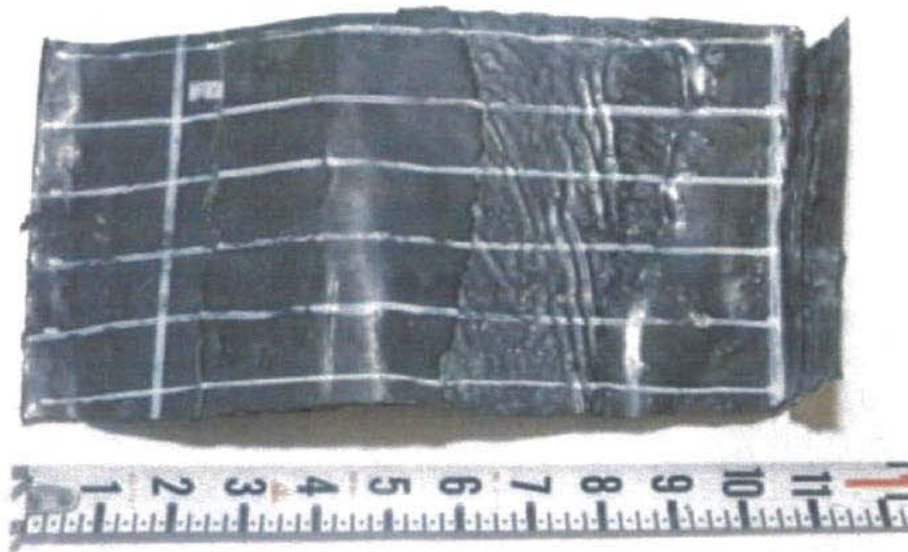
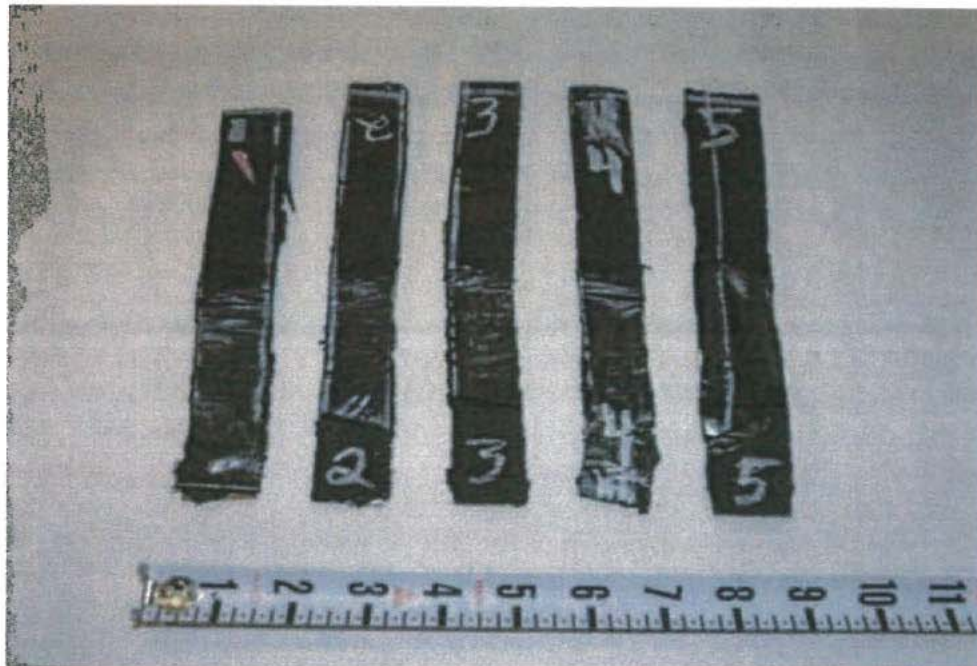
Figure 1- Photos of sample 305A showing a) as received Bituthene layer b) as received layer of substrate metal and OSB c) cutting lines (d) cut specimens.

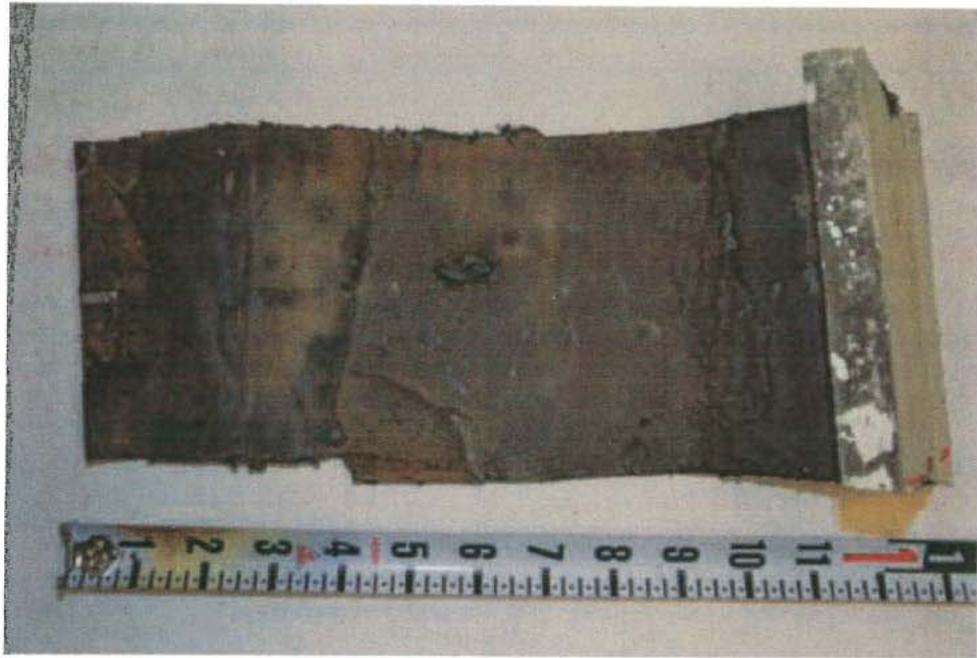
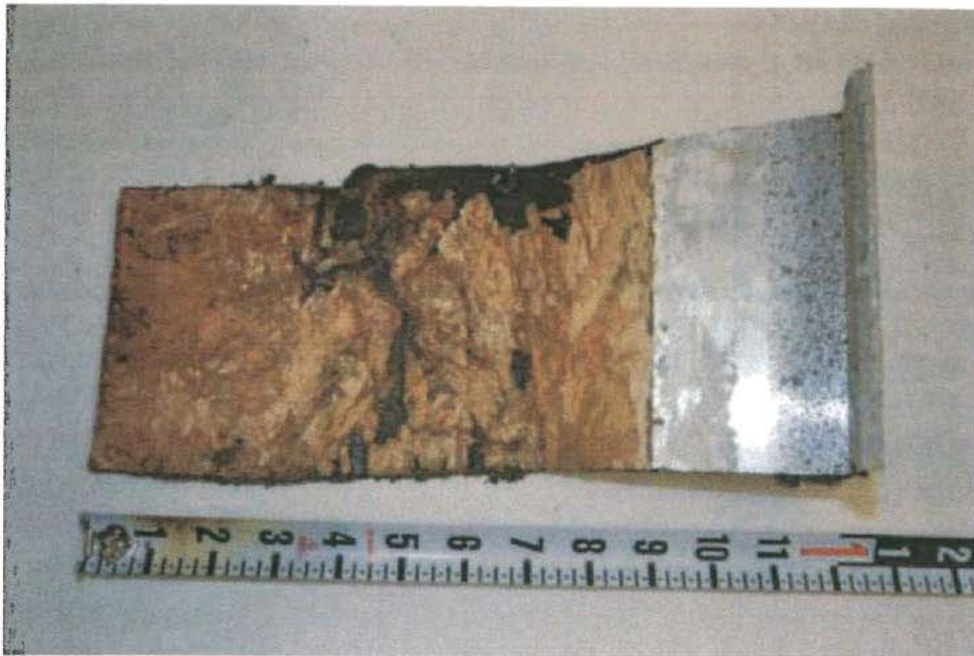
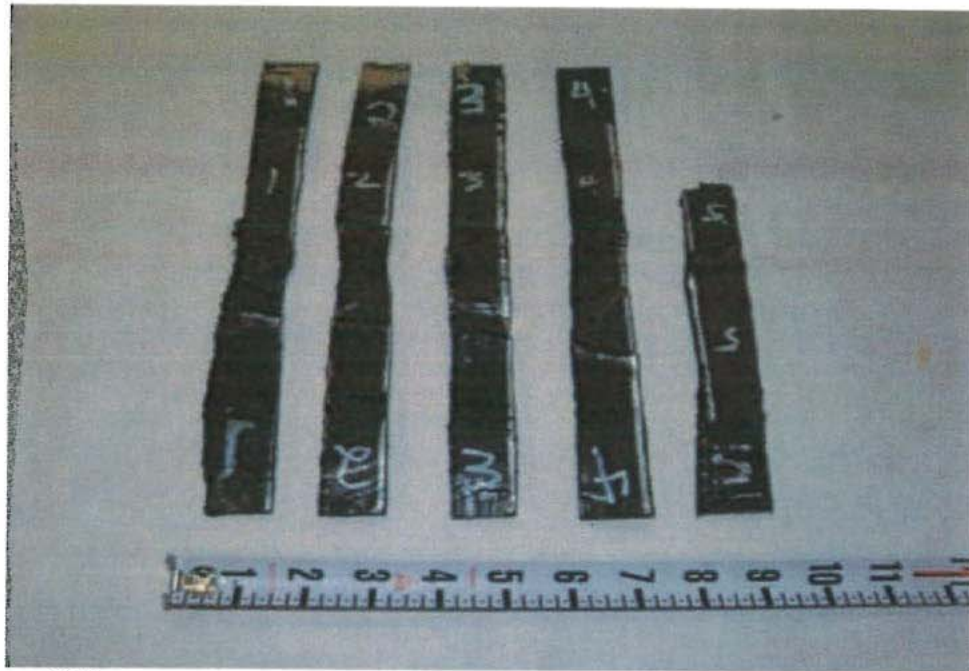
Figure 2– Photos of Sample 305B showing (a) as received Bituthene layer (b) as received metal substrate and OSB layer (c) cut specimens.

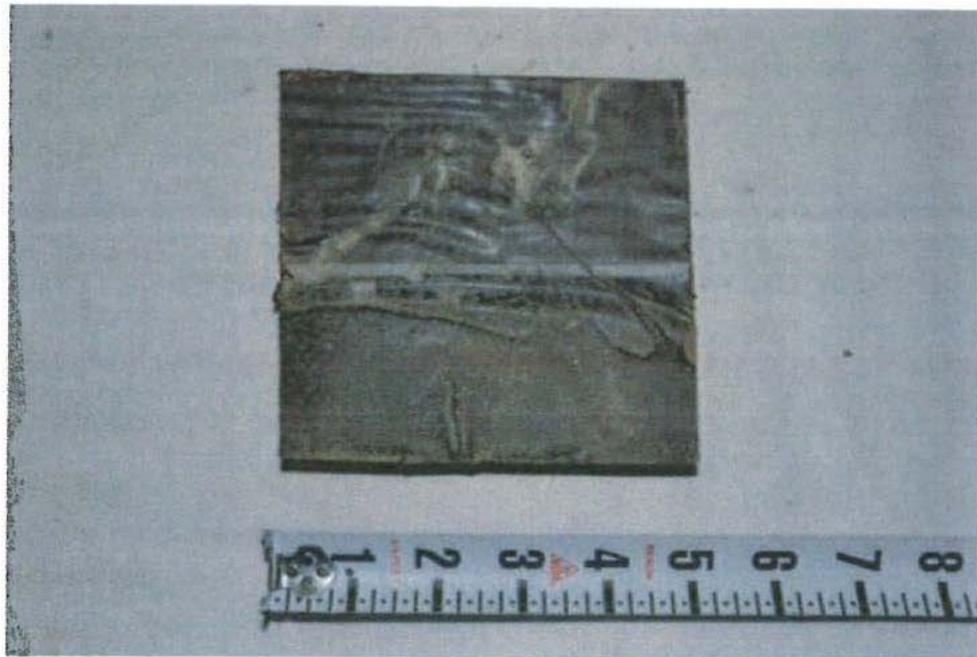
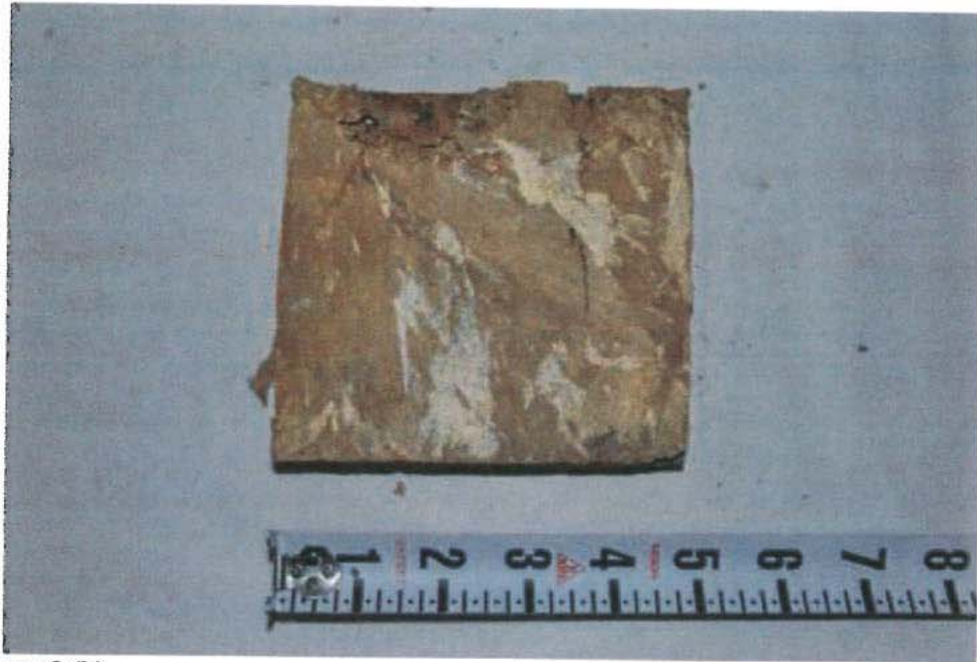
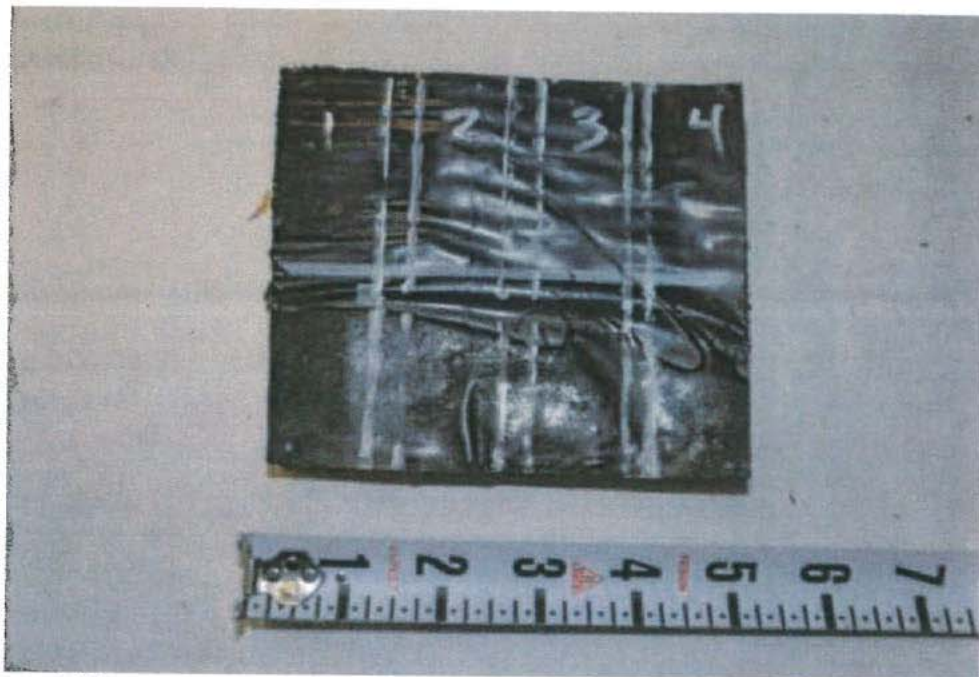
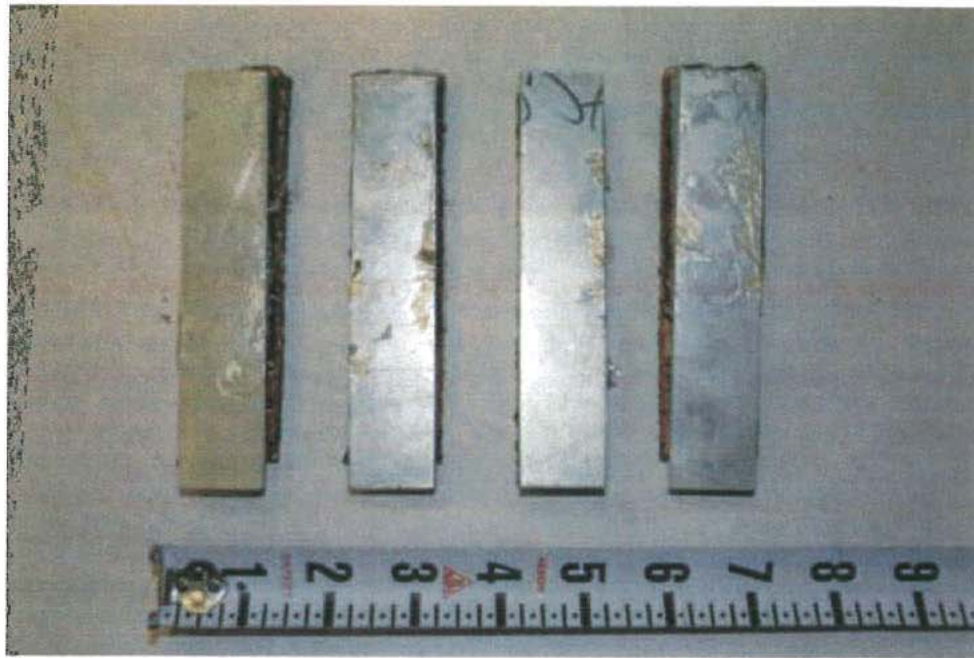
All samples were tested in conformance with ASTM D903-98 except when noted. Specimen 305C-1 and Specimen 305C-3 were unable to be tested, as the OSB delaminated from itself prior to testing. Specimen 305C-2 and Specimen 305C-4 were tested, but did not properly test peel strength, as the OSB delaminated from itself during testing. Specimen 305E-1-Fortiflash and Specimen 305E-2-Fortiflash were unable to be tested, as they did not contain Fortiflash 40. Specimen 305E-4-Substrate Metal and Specimen 305E-7-Fortiflash were unable to be tested, as the bond peeled after specimen preparation. Sample 405B was unable to be tested after the concrete was removed, as it was discovered the bond had failed prior to receiving the sample.

Based upon the microscopic examination and the FTIR spectra obtained on Sample 305C, a layer of similar polyurethane type membrane was utilized above and below a single layer of "Bituthene" type self-adhered membrane on a 1.5 inch by 5 inch section of the sample. The remaining 3.5 inch by 5 inch section of the sample was absent of polyurethane membrane and showed only the one layer of "Bituthene" type self-adhered membrane. Based upon the FTIR spectra obtained and published product information, the polyurethane type membrane found present could be "Bituthene Liquid Membrane LM and Deck Prep" – an asphalt-modified polyurethane – or "BASF MasterSeal HLM 5000" – a bitumen-modified polyurethane.

Figure 3— Photos of Sample 305C showing (a) as received Bituthene layer (b) as received OSB (c) cutting lines (d) cut specimens bonded to aluminum backing.

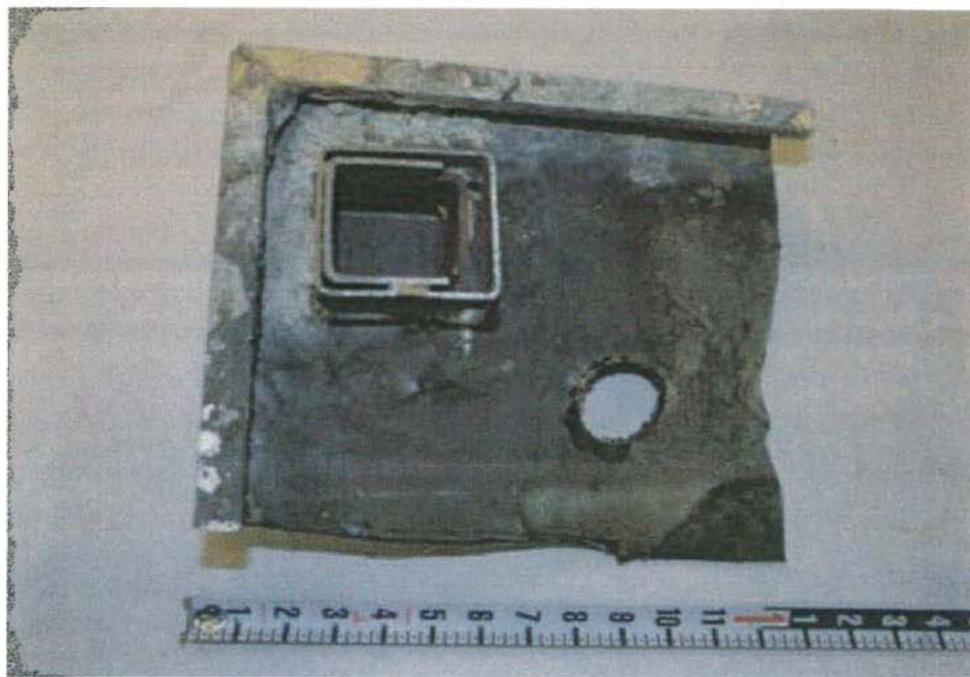
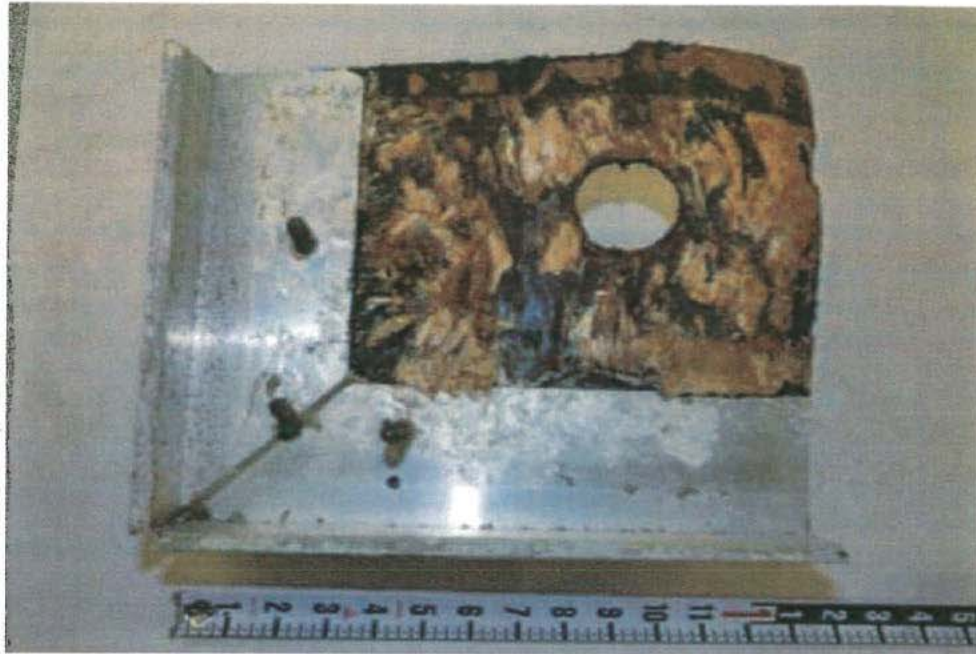
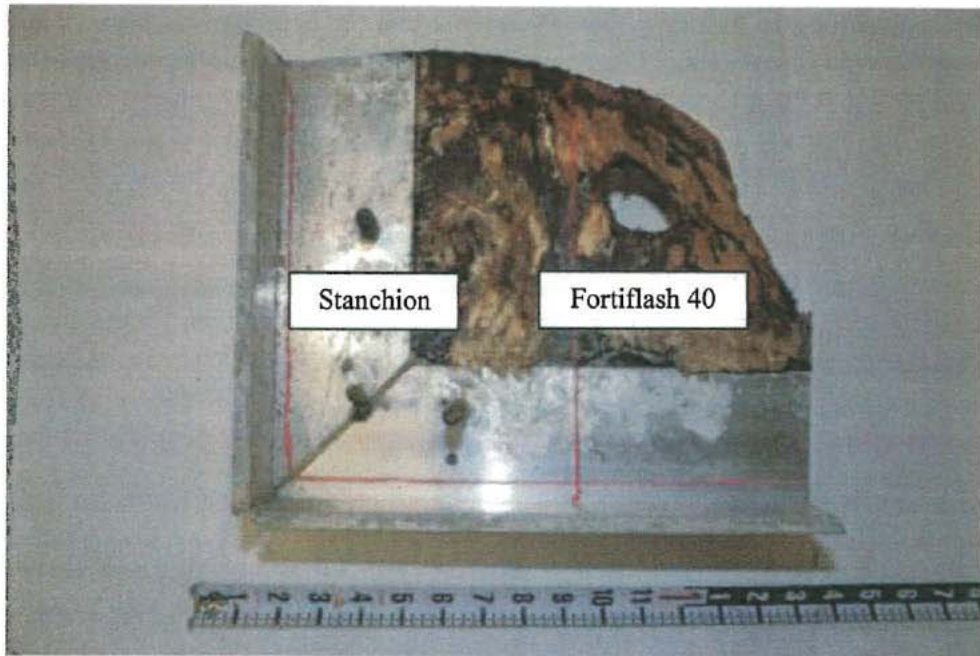
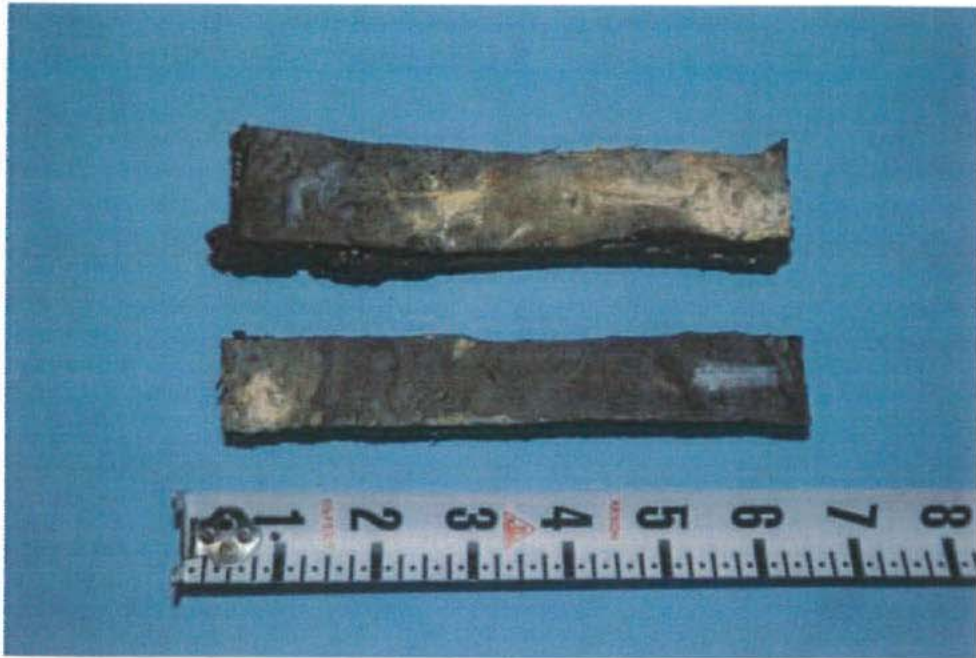
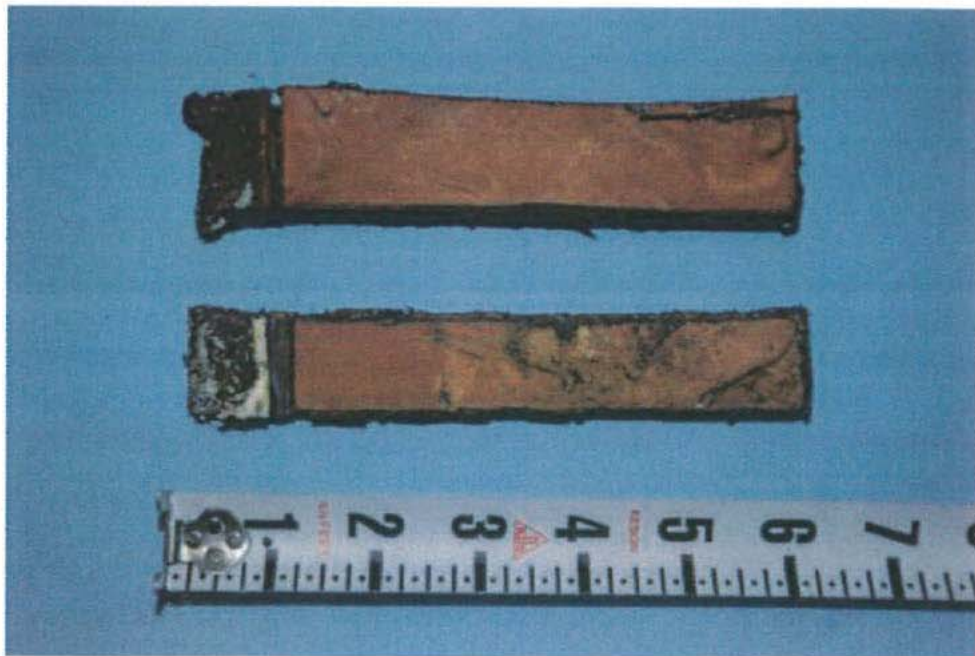
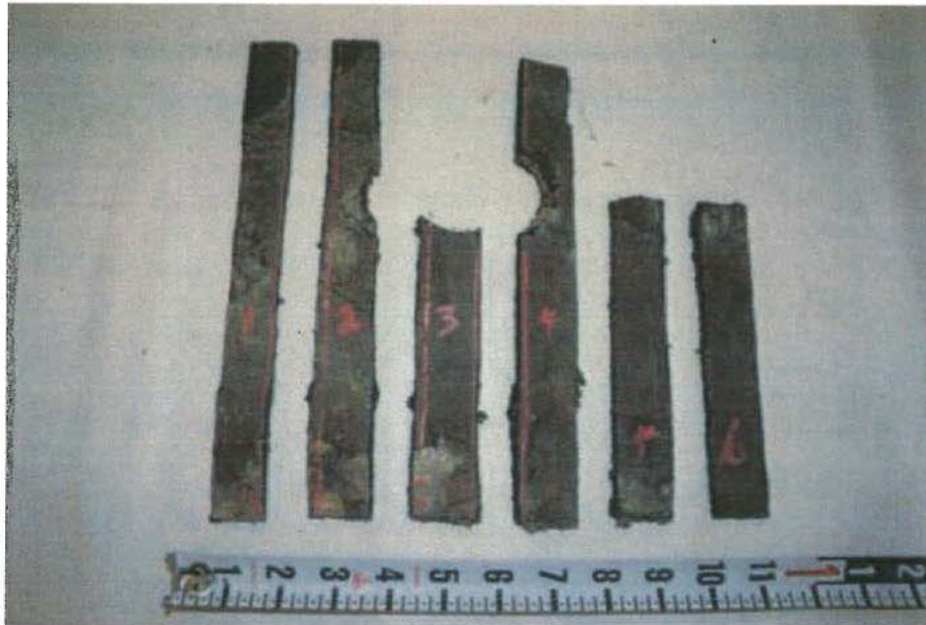
Figure 4 – Photos of sample 305D/E showing (a) as received Bituthene layer (b) as received substrate metal and OSB layer (c) cutting lines and stanchion vs. Fortiflash 40 samples (d) Bituthene layer from cut 305D specimens (e) metal stanchion from cut 305D specimens (f) cut 305E specimens.

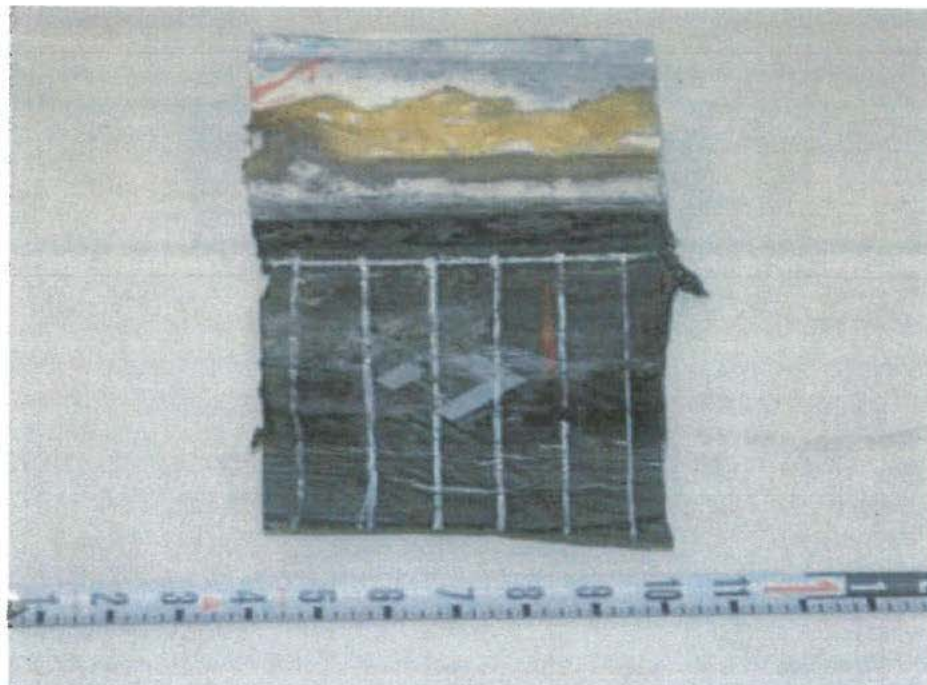
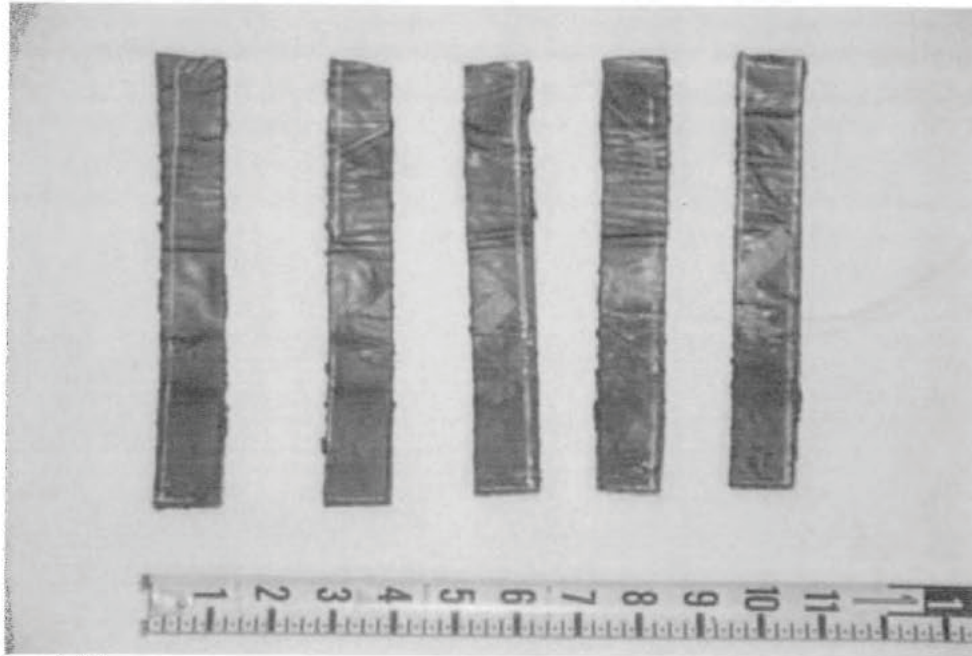
Figure 5 – Photos of sample 405A showing (a) as received Bituthene layer with cutting lines (b) cut specimens.

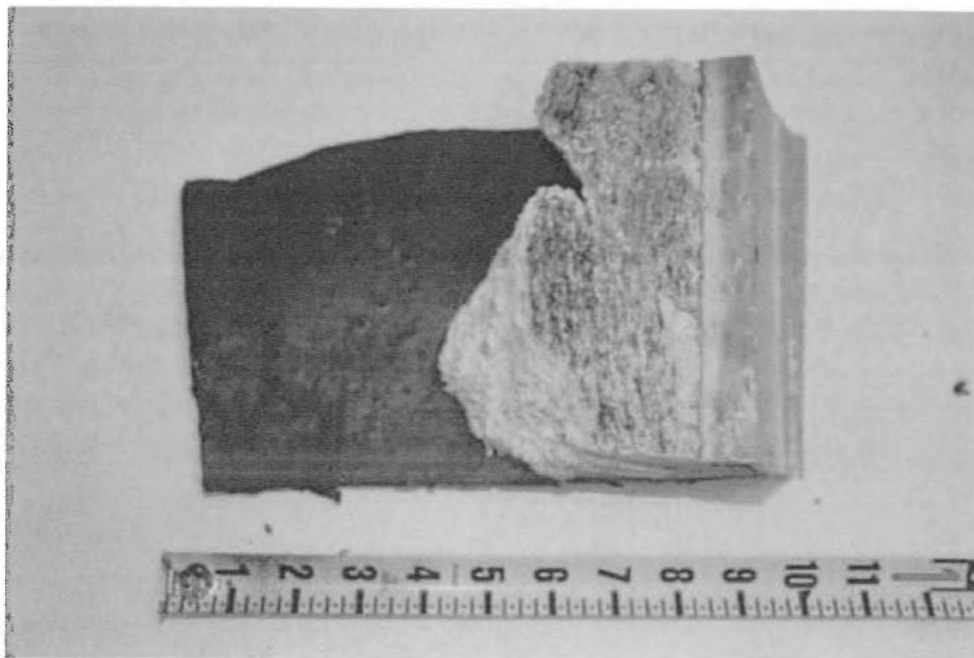
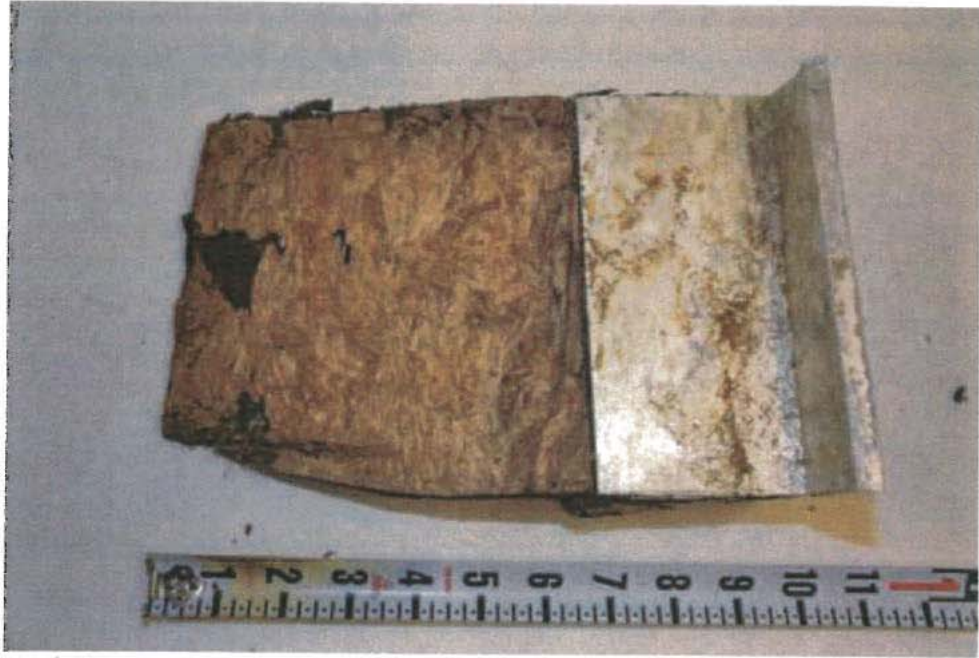
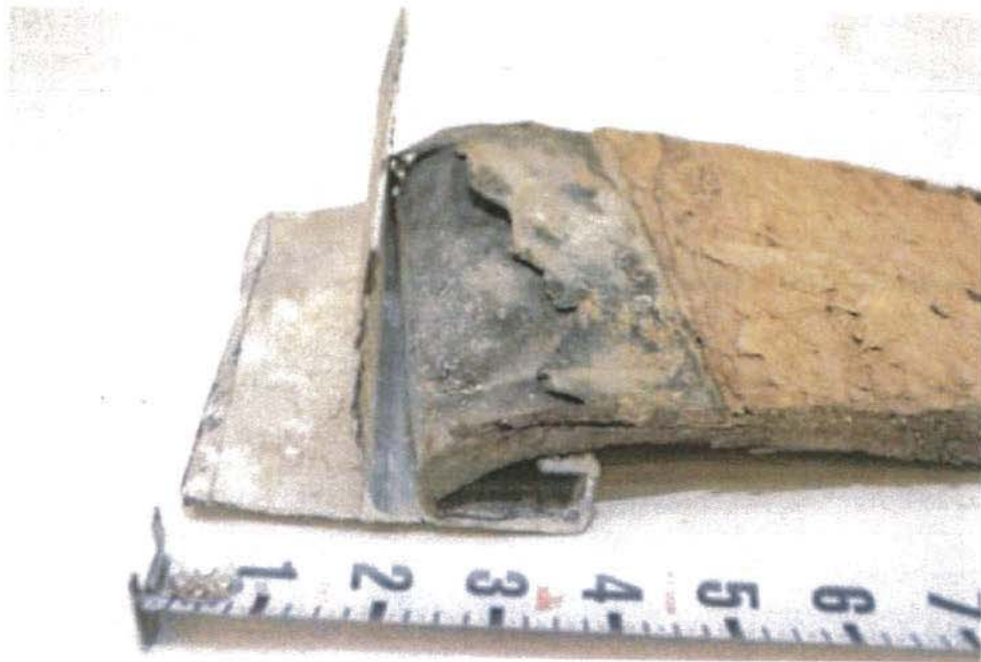
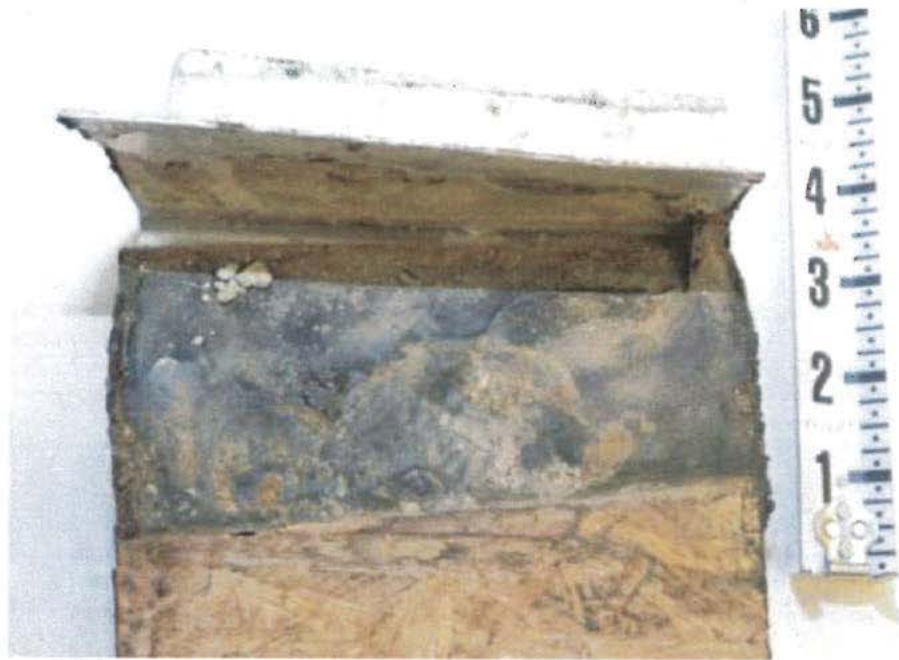
Figure 6 – Photos of sample 405B showing (a) as received Bituthene layer with concrete block (b) as received OSB layer (c) side view of pre-testing failure (d) top view of pre-testing failure.

Once the concrete block was broken away from the sample, it was determined that it was unable to be tested for peel strength, as the bond had failed prior to receiving the sample.

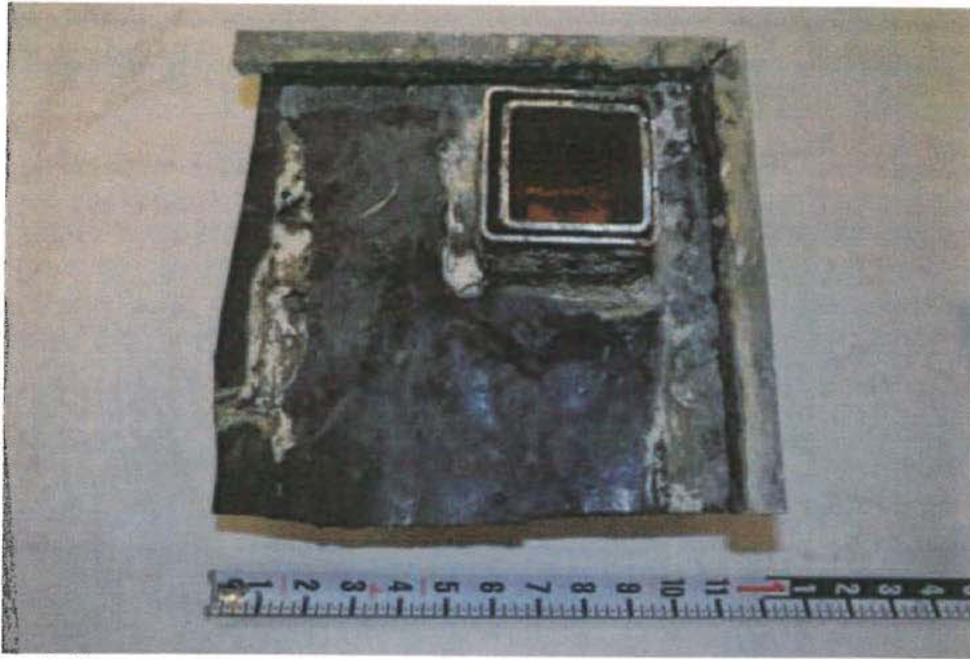
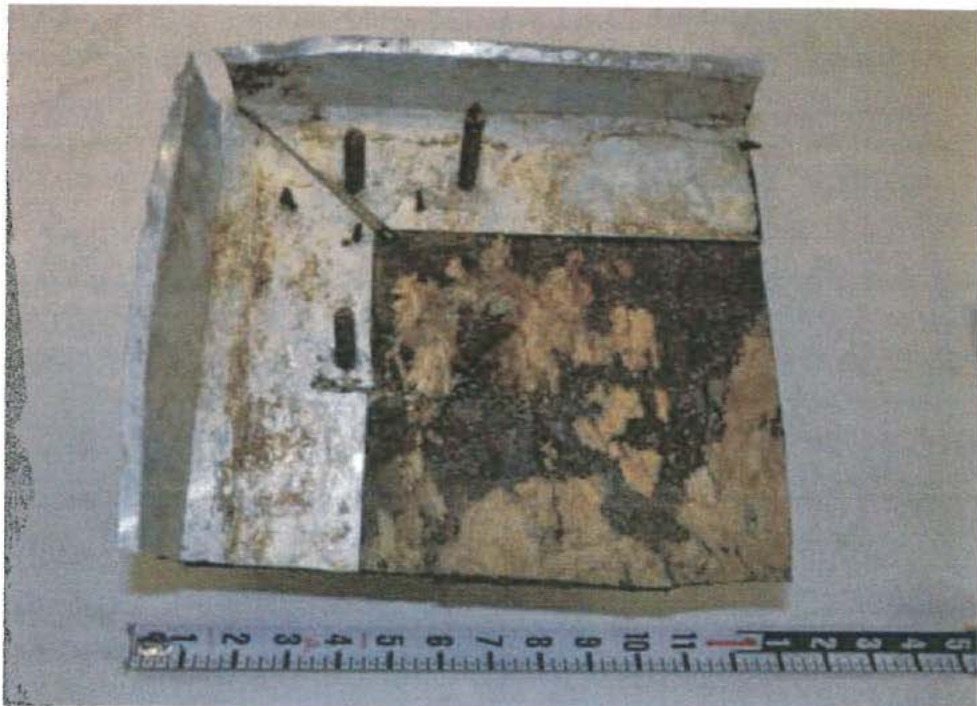
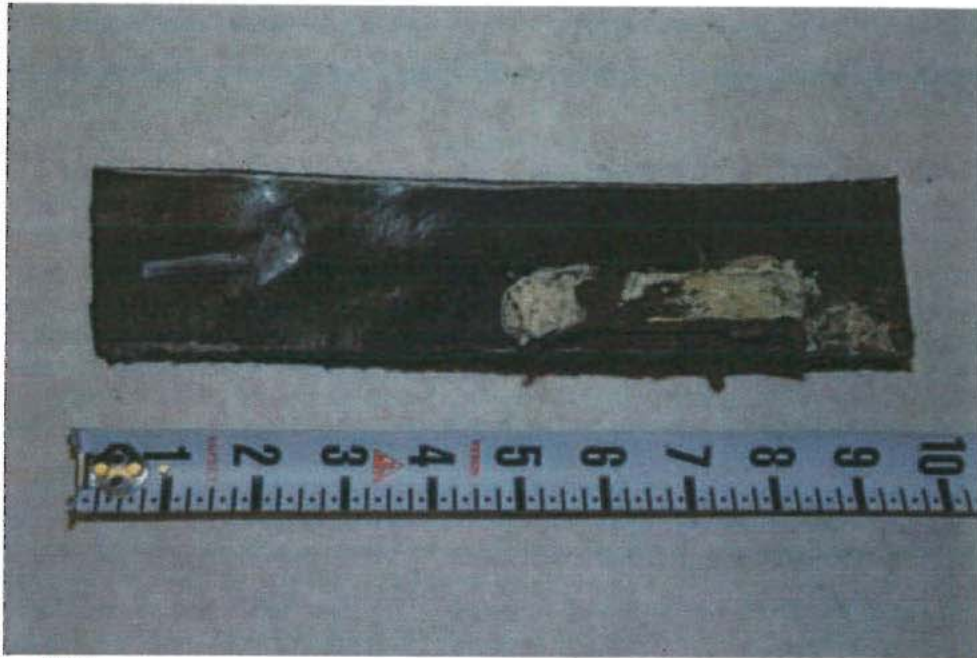
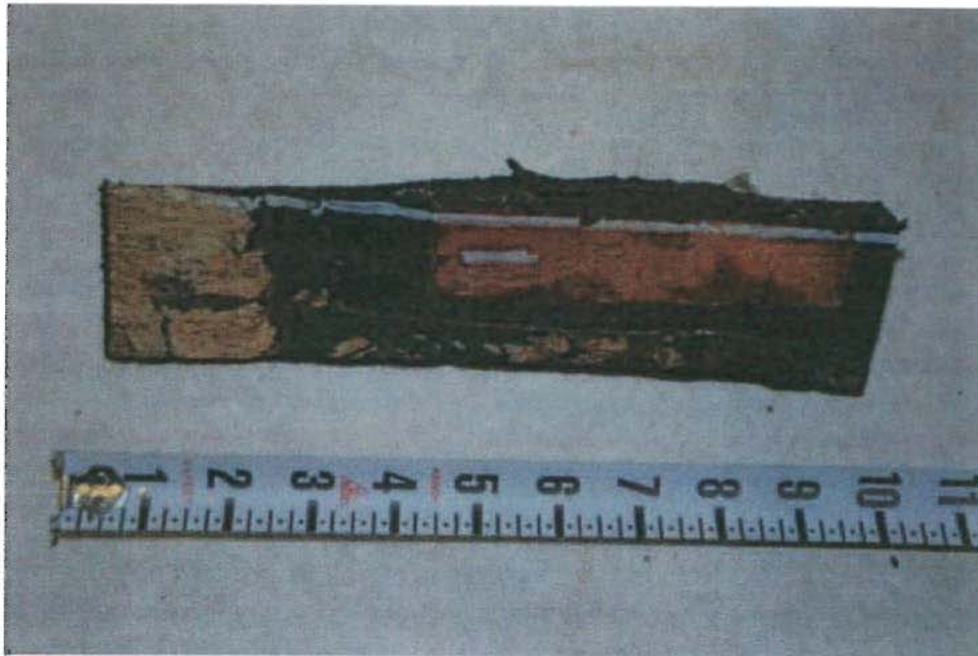
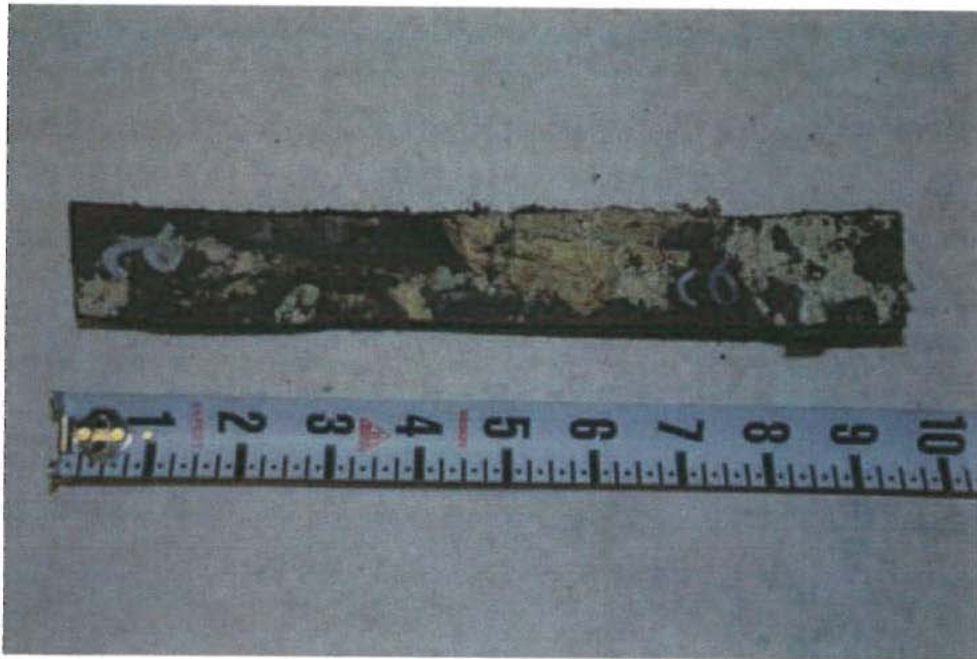
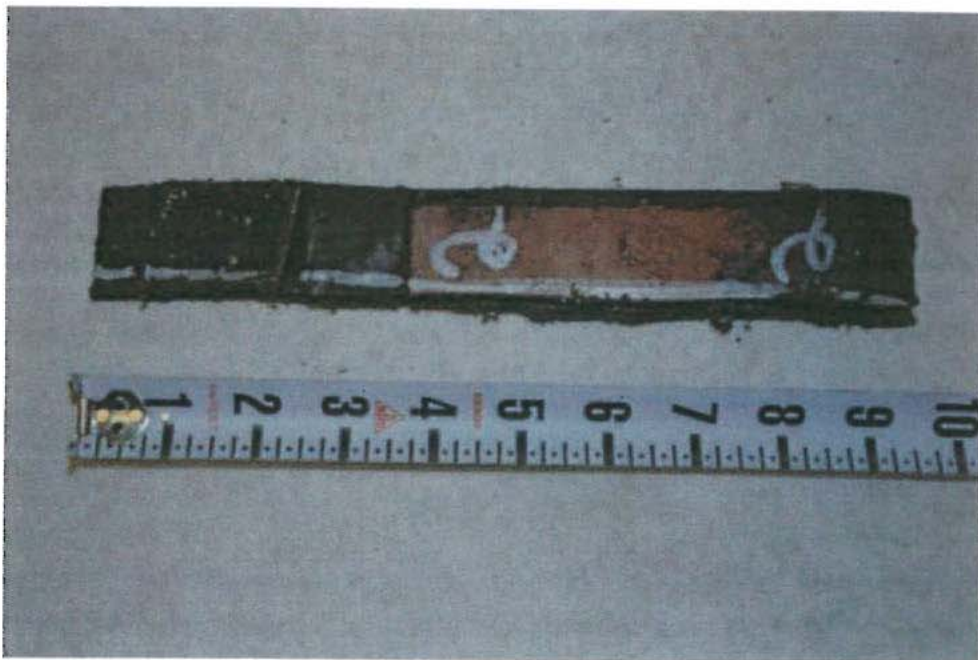
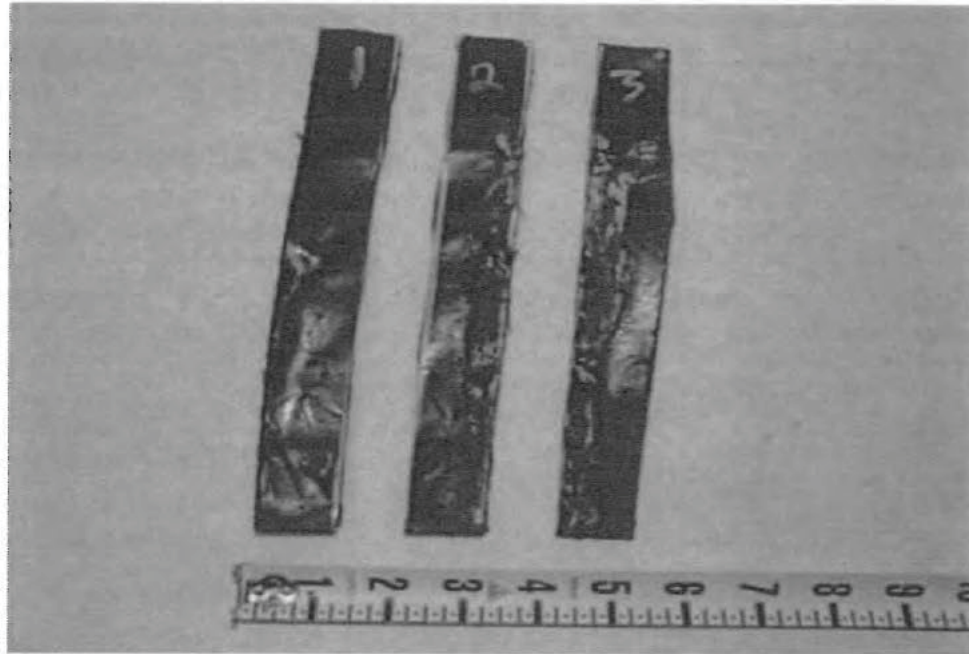
Figure 7 – Photos of sample 405D/E showing (a) as received Bituthene layer (b) as received OSB layer (c) Bituthene layer of specimen 405D-1 (d) metal stanchion layer of specimen 405D-1 (e) Bituthene layer of specimen 405D-2 (f) metal stanchion layer of cut specimen 405D-2 (g) 405E cut specimens.
