# Bridger Foothills Entrapment and Shelter Deployment

Facilitated Learning Analysis

**September 5<sup>th</sup>, 2020**

Montana Department of Natural Resources and Conservation  
USDA Forest Service, Region 1/ Custer-Gallatin National Forest

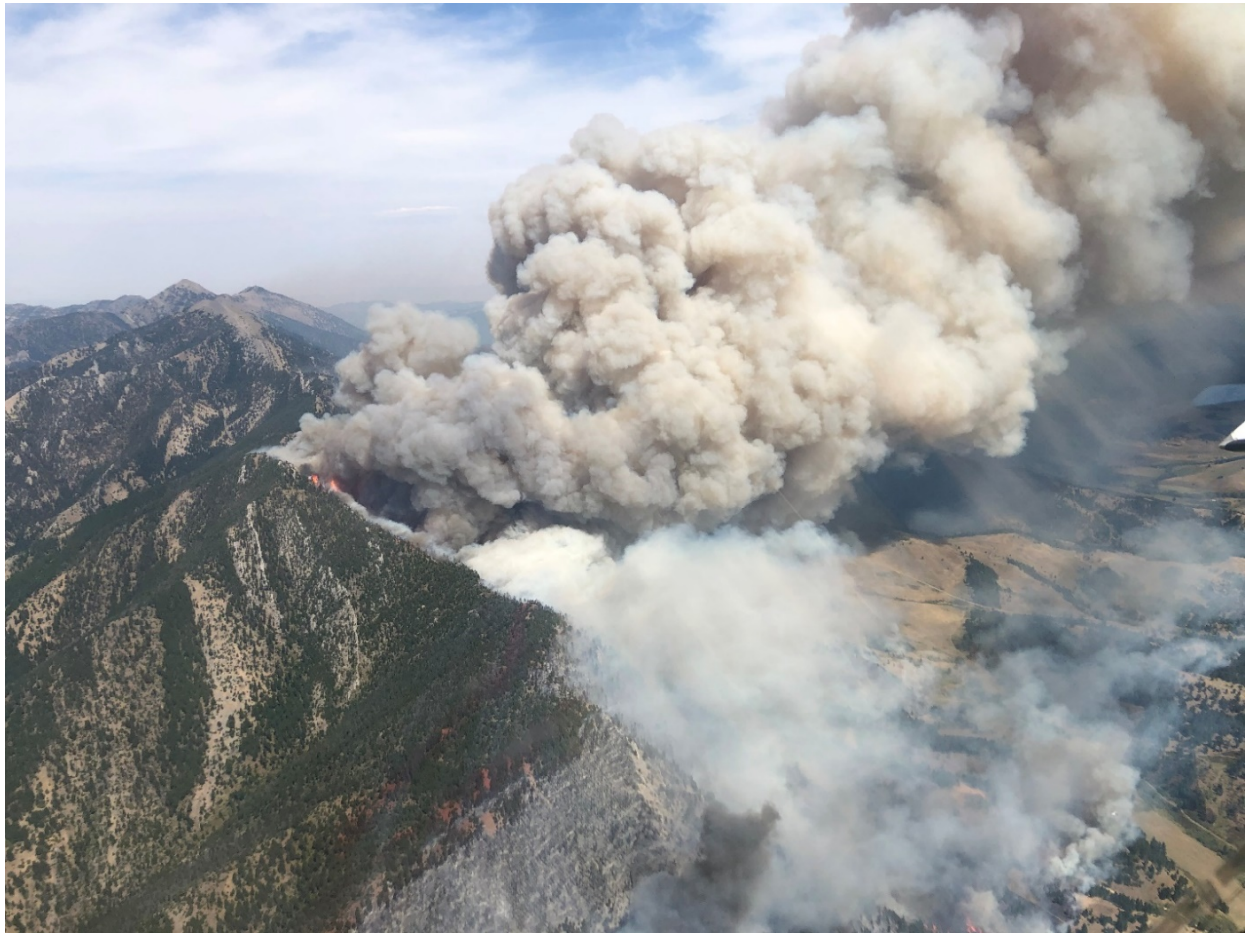
*Figure 1: Photo taken from air attack platform at approximate time of deployment*

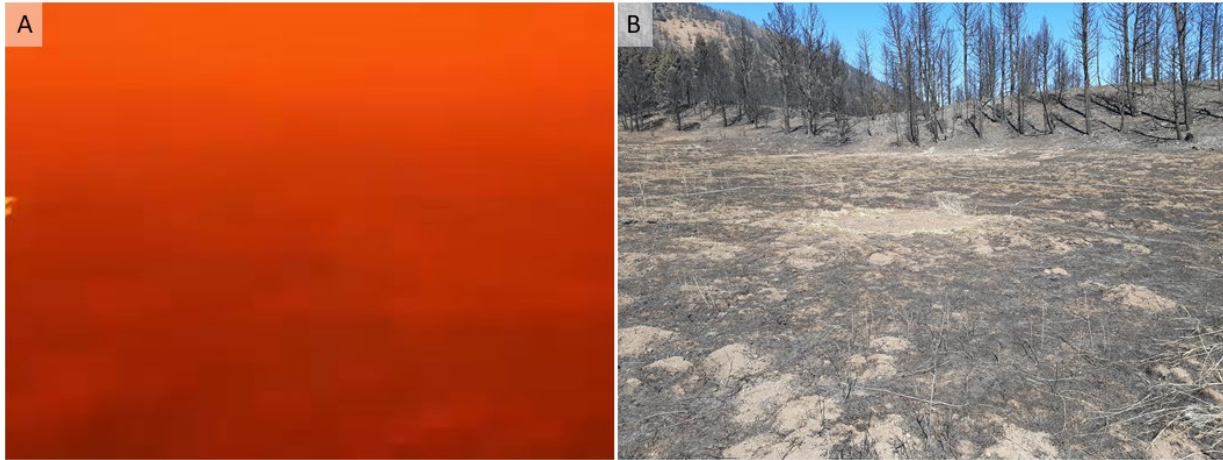
Figure 2A: Picture taken from the deployment site, when Casey and Charlie first emerged from their shared shelter and 2B: picture of the deployment site, taken a week after the incident.

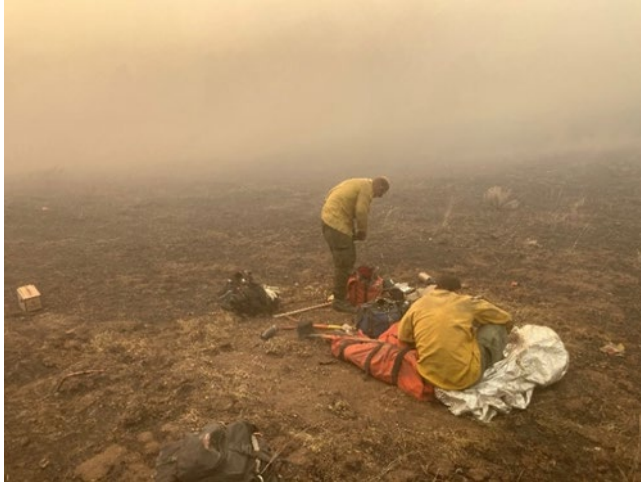
*Figure 12: Photo taken by one of the crew members, immediately post-deployment.*

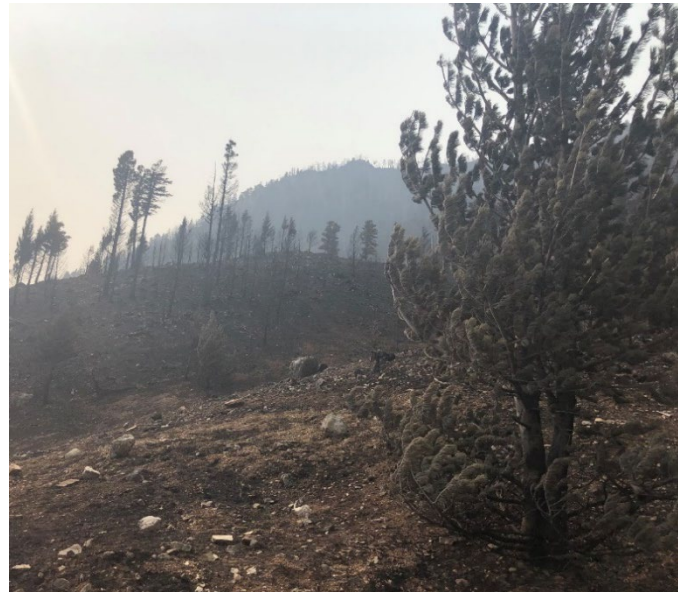
*Figure 13: A tree “frozen” in place by wind from the fire event. This picture was taken over a week after the deployment, near the fork in the two-track where the Helitack Crew waited for possible extraction before returning to the helispot.*

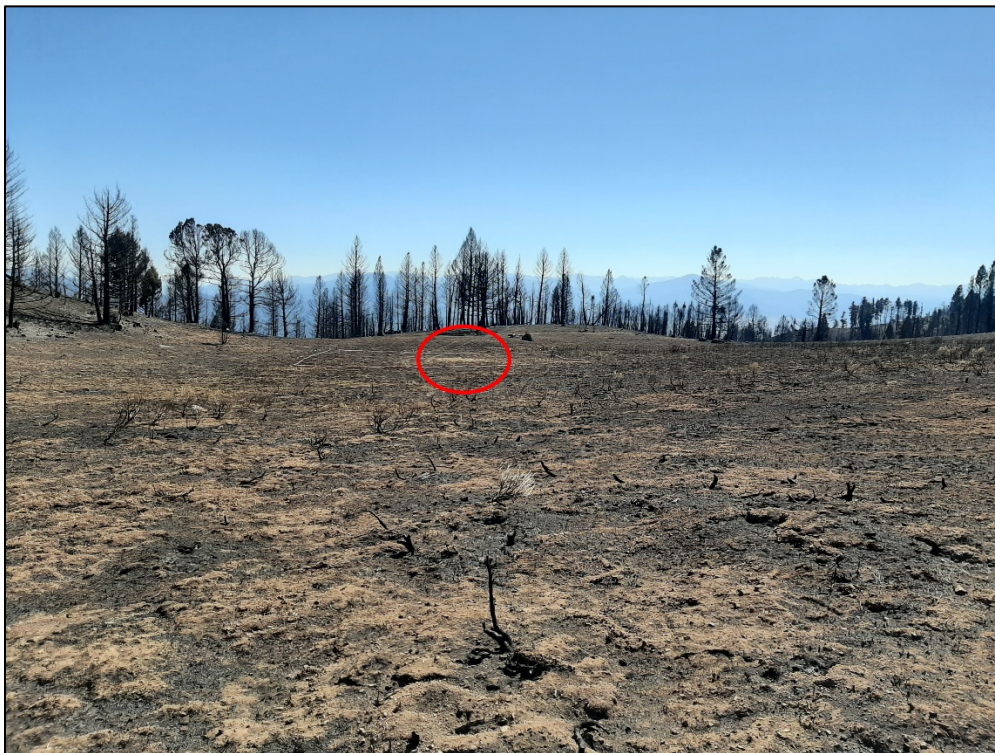
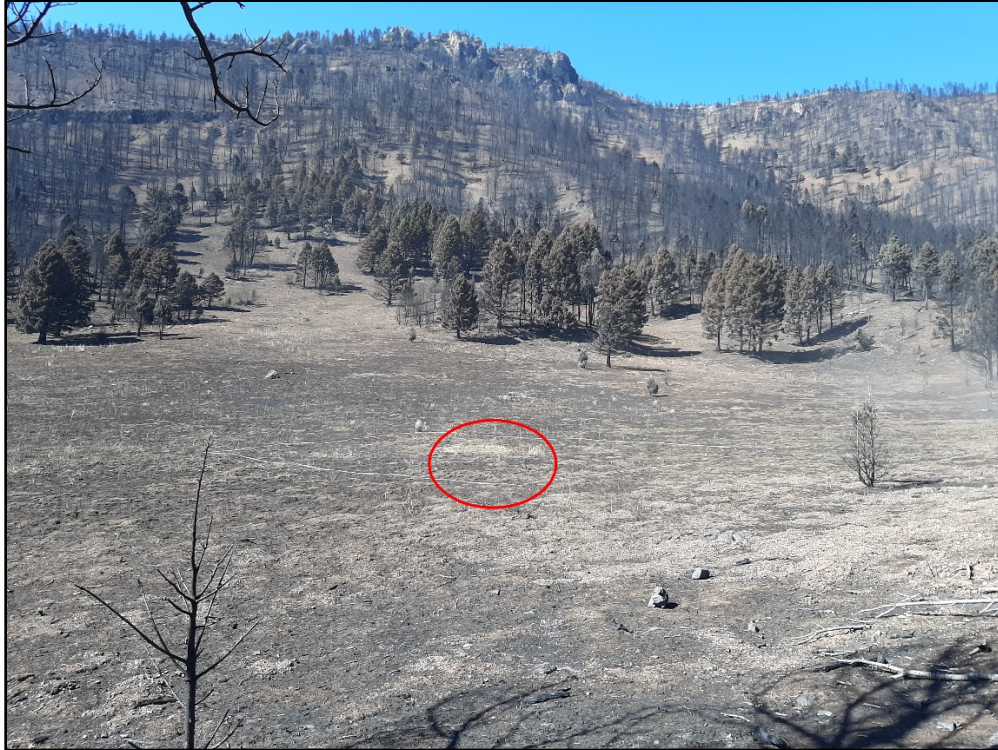
The shelter deployment site was located near the edge of a 12-acre, flat bench that dropped off into the valley below. The opposite end of the bench transitioned into rising terrain. The fuels around the deployment site consisted of 18- to 24-inch tall grass, sagebrush, and adjacent mixed conifers. The firefighters estimated that the winds were 35 to 40 miles per hour (mph), which shifted in many directions and gusted to higher wind speeds as the flame front passed over them. See figures 1 and 2.

*Figure 1: The area surrounding the deployment site looking towards the edge of the bench that drops into the valley below. The deployment site is circled in red.*

*Figure 2: The area surrounding the deployment site looking towards the rising terrain. The deployment site is circled in red.*

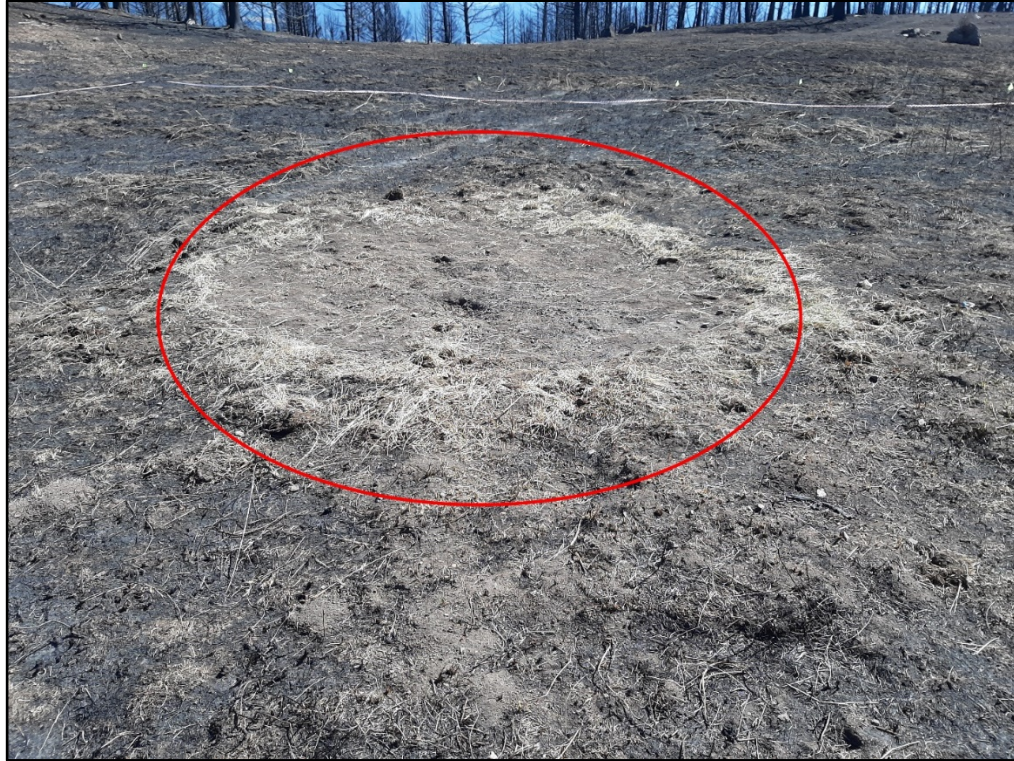
The shelter deployment site was an 8- by 10-foot oval that the firefighters had previously lined and scraped down to mineral soil. The firefighters used this area of bare ground to stage their extra equipment (food, water, flight helmets, overnight gear, etc.) during the shift. See figure 3.

Figure 3: A close-up of the deployment site. The deployment site is circled in red.

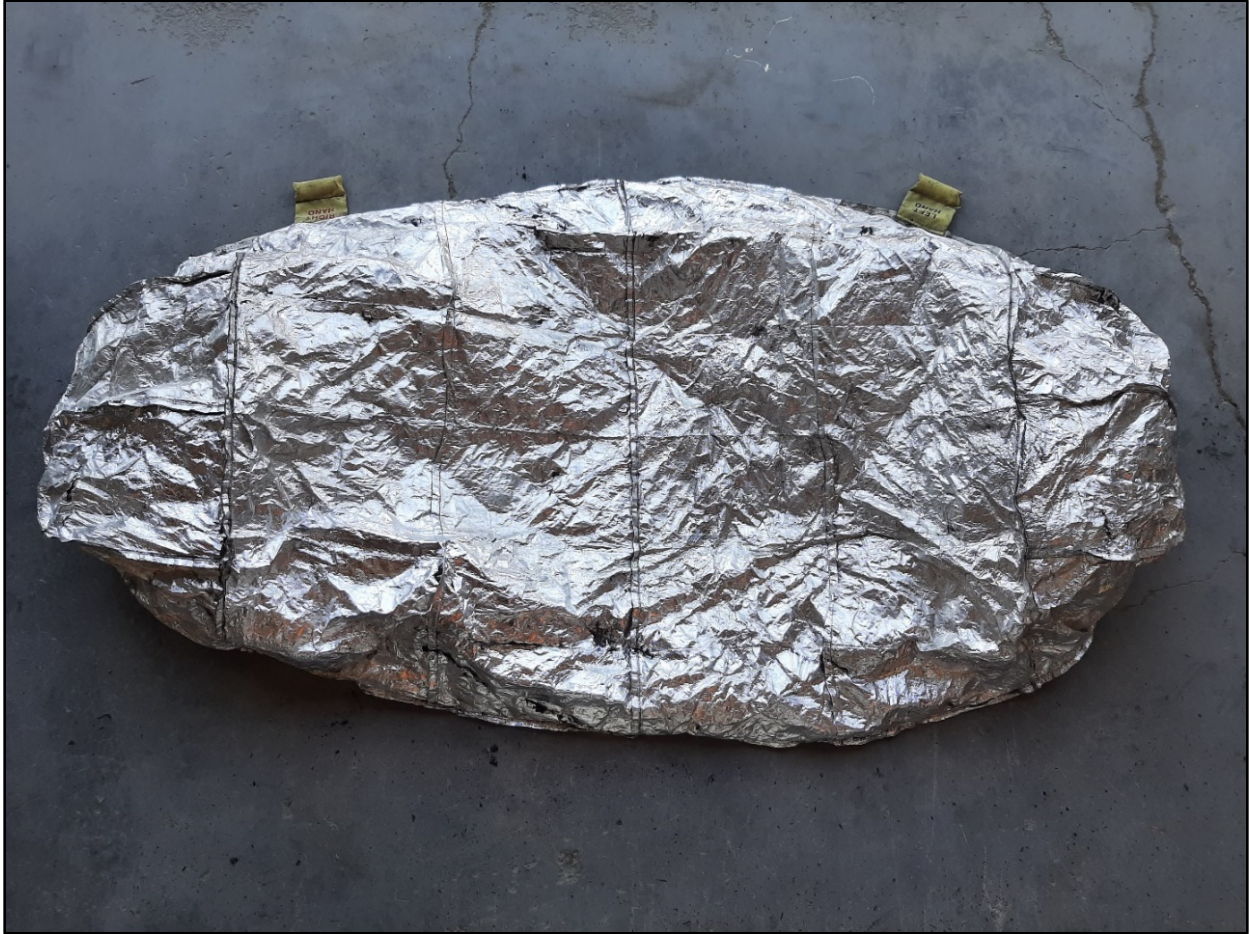
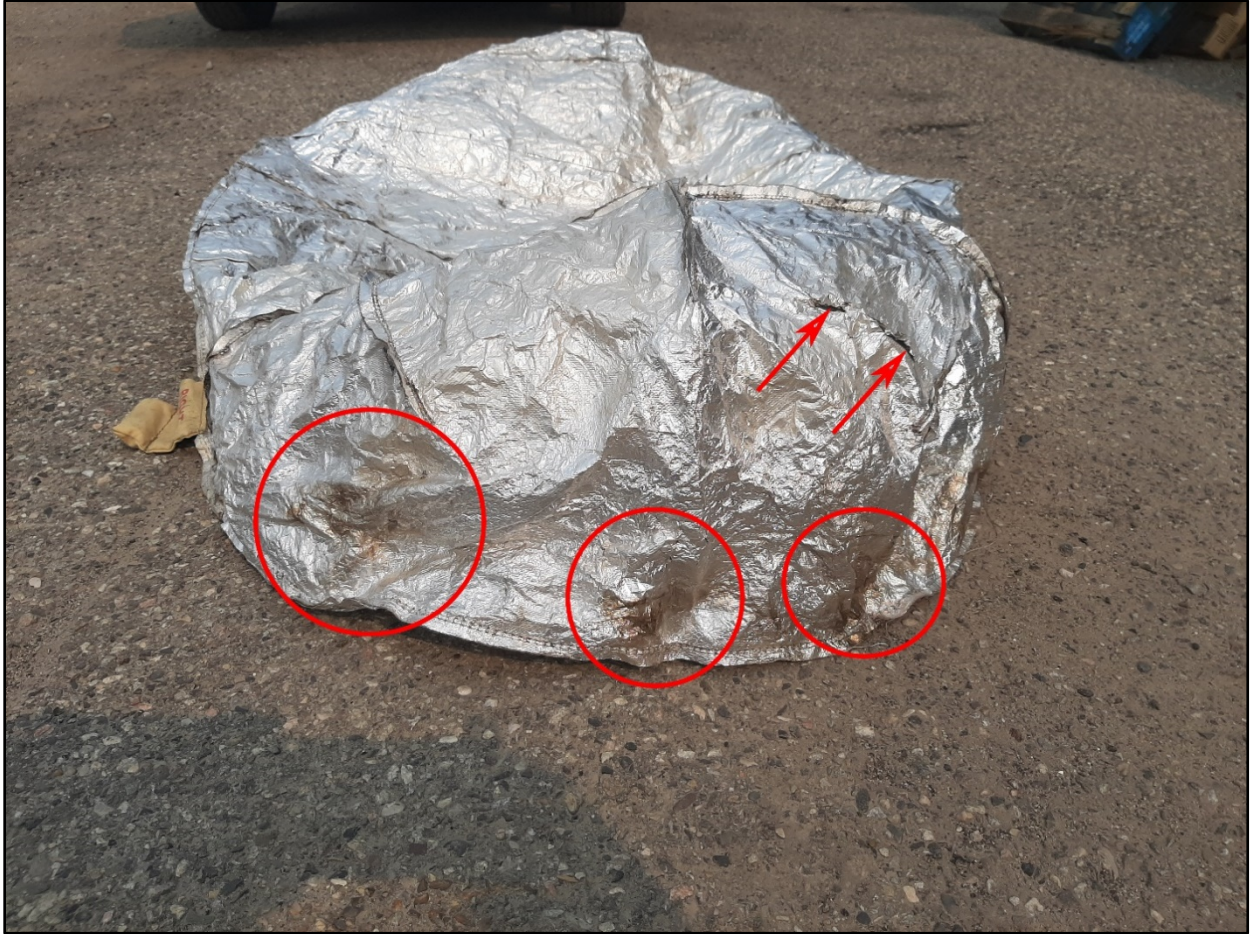
- Shell outer laminate: The foil had visible evidence of exposure to heat and delamination. The foil had 4-inch tears in two spots on the end cap. See figures 5 and 6.

*Figure 5: The fire shelter used by firefighter 1 (FF1) showing the conditions of the shell outer laminate and two (2) yellow shake handles.*

*Figure 6: The fire shelter used by firefighter 1 (FF1) showing the conditions of the end cap portion of the shell outer laminate. The foil shows visible signs of heat in three (3) areas that are circled in red. Two (2) red arrows point to the torn foil.*

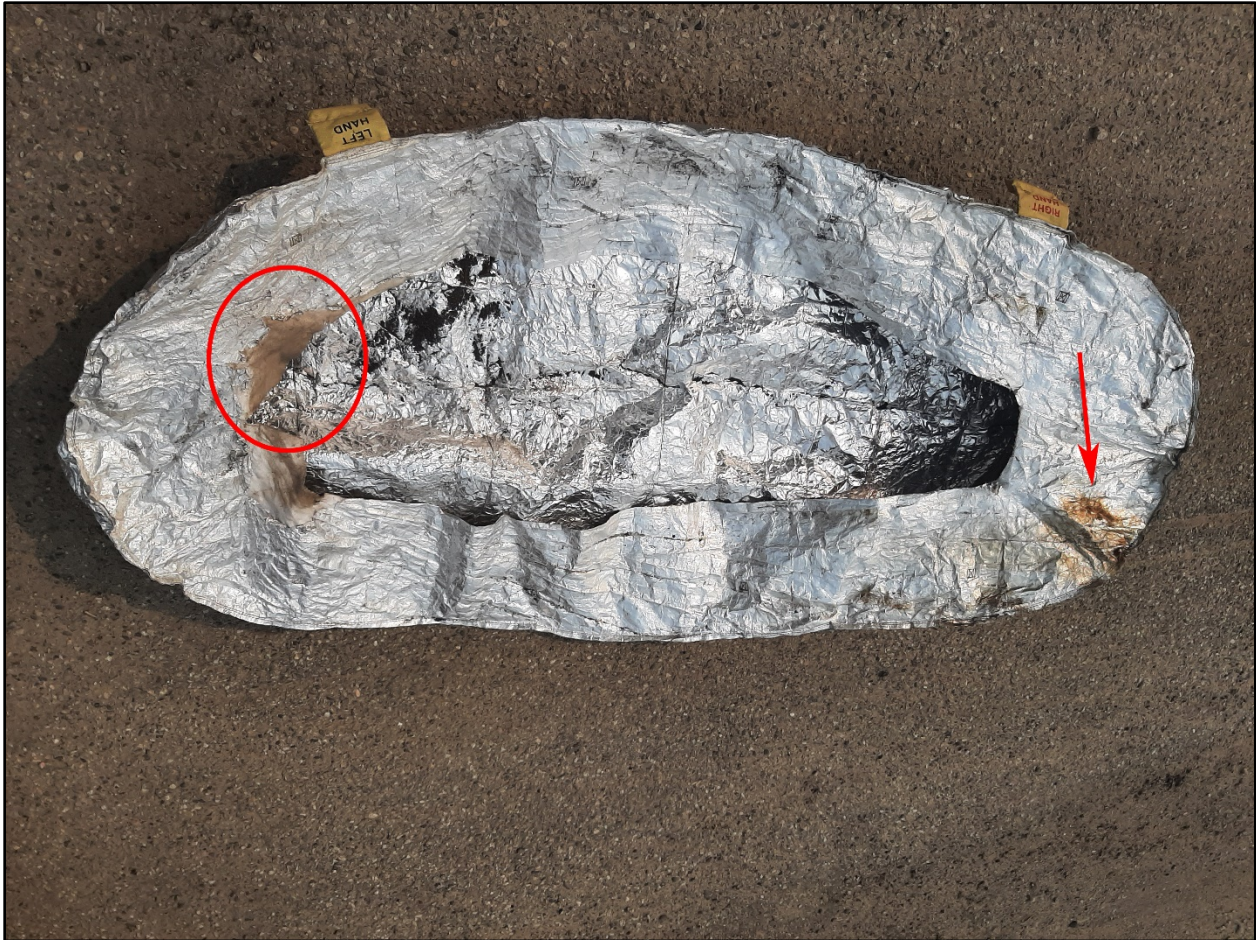
- Shell inner laminate: Nothing to note.
- Seams: Nothing to note.
- Hold-down straps: Nothing to note.
- Floor laminate: The foil had visible evidence of exposure to heat on the floor of one end cap. The opposite end cap had a 4-inch tear and visible evidence of physical abrasion. See figure 7.

*Figure 7: The fire shelter used by firefighter 1 (FF1) showing the conditions of the shell inner laminate, floor laminate, and shake handles. The physically abraded and torn laminate is circled in red. A red arrow points to the visible signs of heat on the foil.*

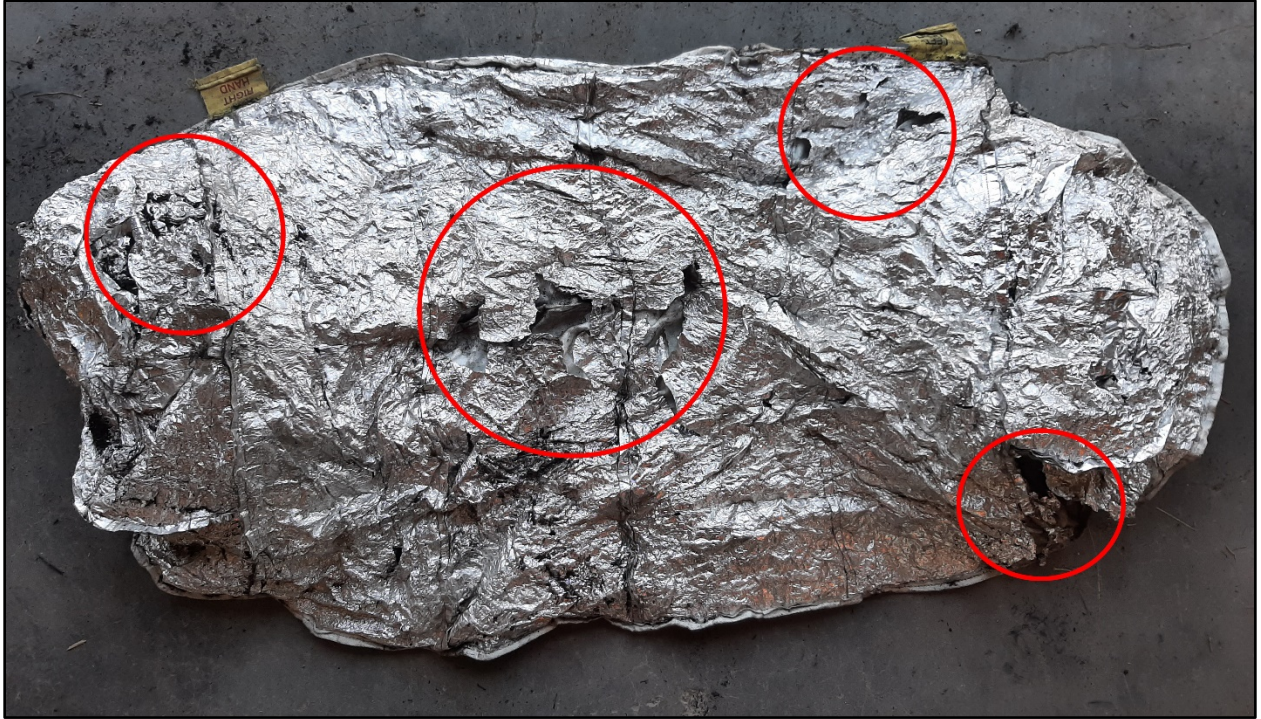
- Firefighter information: FF2 was 74 inches (6 foot 2 inches) tall and weighed 225 pounds. FF3 was 72 inches (6 foot) tall and weighed 190 pounds.
- Fire shelter information: The regular-sized fire shelter was manufactured according to Forest Service Specification 5100-606 in February of 2005.
- Post-deployment fire shelter inspection observations:
  - Shell outer laminate: The foil on the main body and end cap had visible evidence of exposure to heat, physical abrasion, numerous tears, and delamination. See figure 8.

*Figure 8: The fire shelter shared by firefighter 2 (FF2) and firefighter 3 (FF3) showing the conditions of the shell outer laminate and shake handles. There were several areas where the foil is delaminated and abraded away, circled in red.*

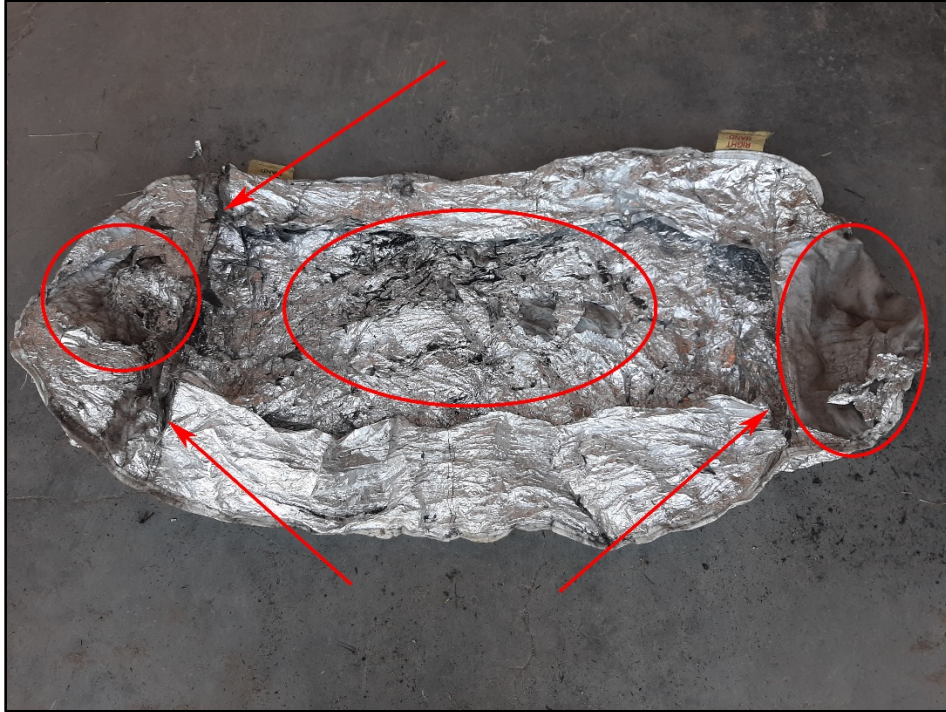
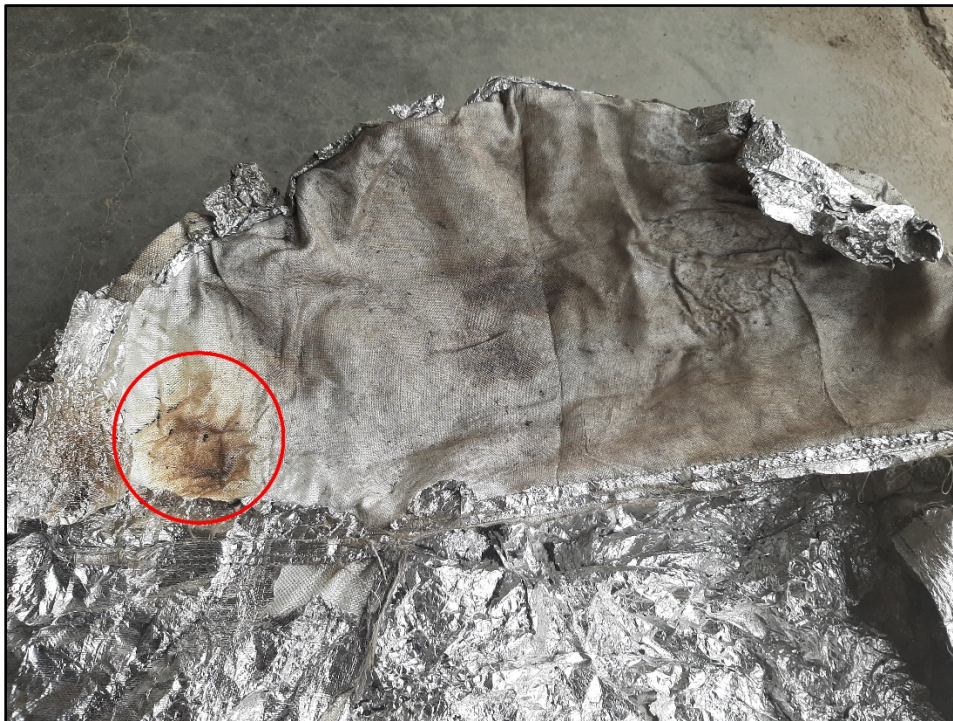
- Hold-down straps: Nothing to note.
- Shell inner laminate: The foil of the main body had visible evidence of delamination and was abraded away.
- Seams: Two of the floor seams had 8-inch tears. One of the floor seams had a 6-inch tear.
- Floor laminate: The foil of both end caps had visible evidence of delamination and was abraded away. The silica cloth on one of the end caps showed signs of heat and embrittlement. The laminate had two circular abrasion holes. See figures 9 and 10.

*Figure 9: The fire shelter shared by firefighter 2 (FF2) and firefighter 3 (FF3) showing the conditions of the shell inner laminate, floor laminate, and two (2) shake handles. There were several areas where the foil was abraded away, circled in red. Red arrows point to torn floor seams.*

*Figure 10: The floor laminate portion of the end cap. The heat-embrittled silica cloth is circled in red.*

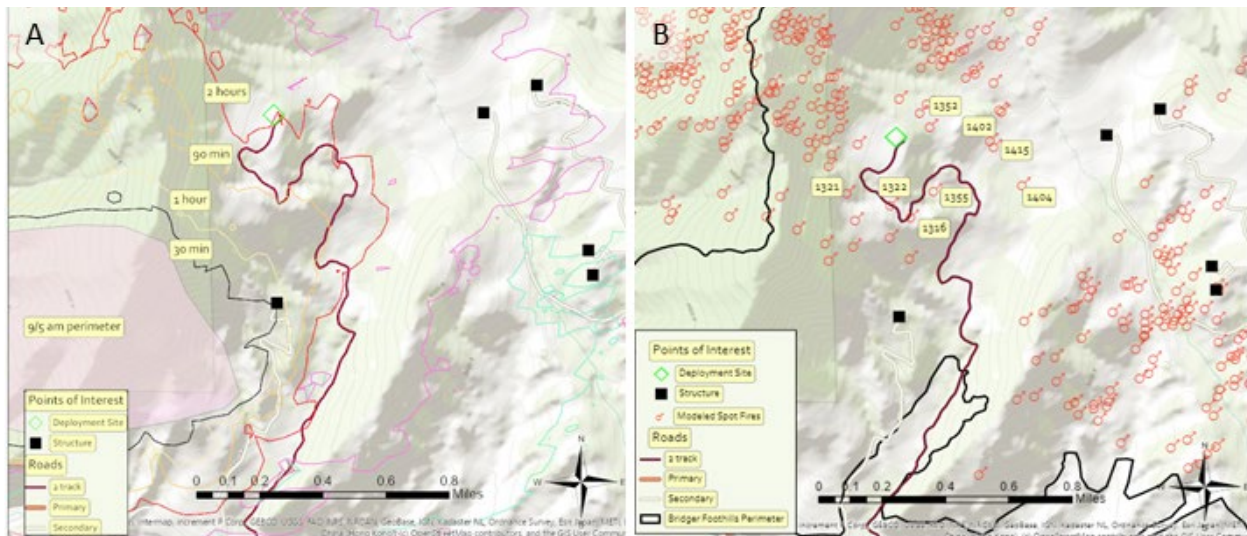
Crown fire is indicated to be passive, torching and spotting, not active crown fire. It is likely that passive crown fire approached the site three different times in rapid succession; first from the east, second from the south and third, from the north.

Figure 3A: Fire perimeter progression for the Bridger Foothills Fire, beginning approximately 1200 hours and 3B: modeled spot fires around the deployment site with approximate time of ignition
