Informational Summary Report of Serious or Near Serious Injuries, Illnesses and Accidents

GREEN SHEET

Firefighter Burn Over

Silverado Incident

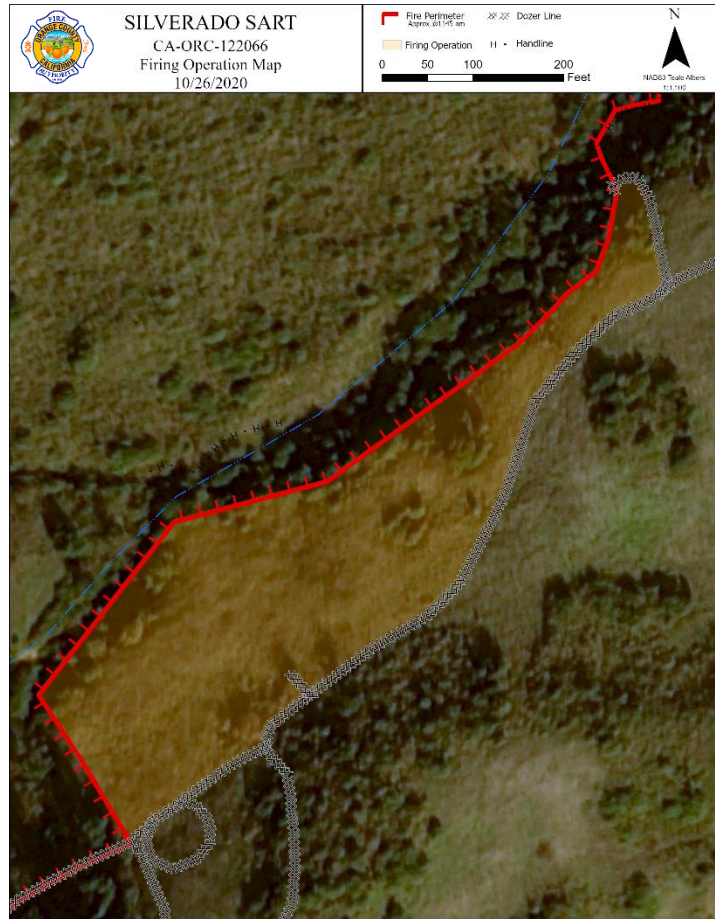
Map and VIDEO 1 (fire run prior to firing): Shaded area showing area to be fired by C1.

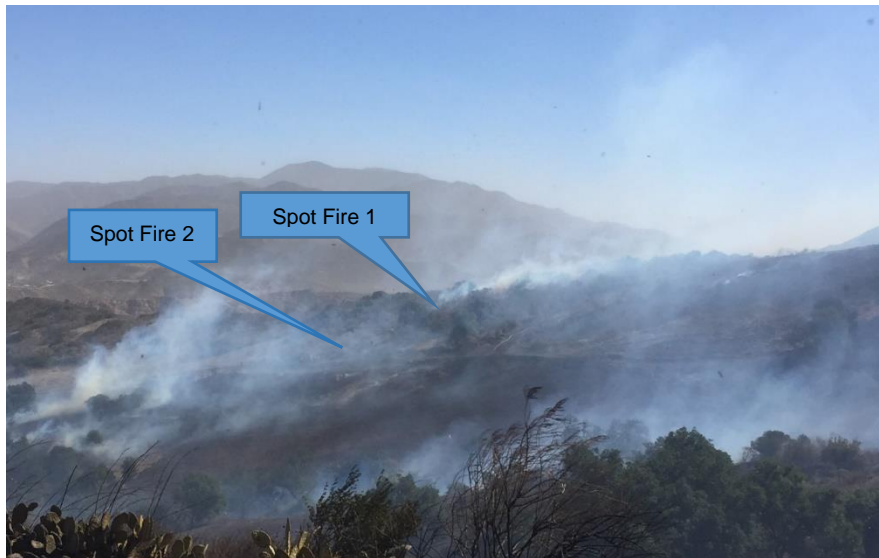
A total of eight C1 members made their way to Spot Fire 1, which had grown to approximately 100-feet by 100-feet in an

Photo: Spot Fire 1 engaged by HCFF's moments before Spot Fire 2 occurs

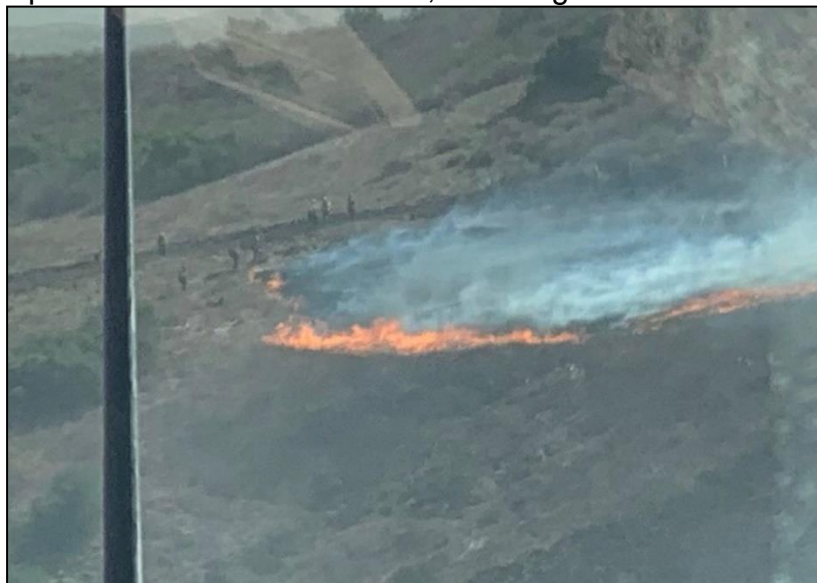
Photo: C1 conducting the firing operation below the mid-slope dozer line.

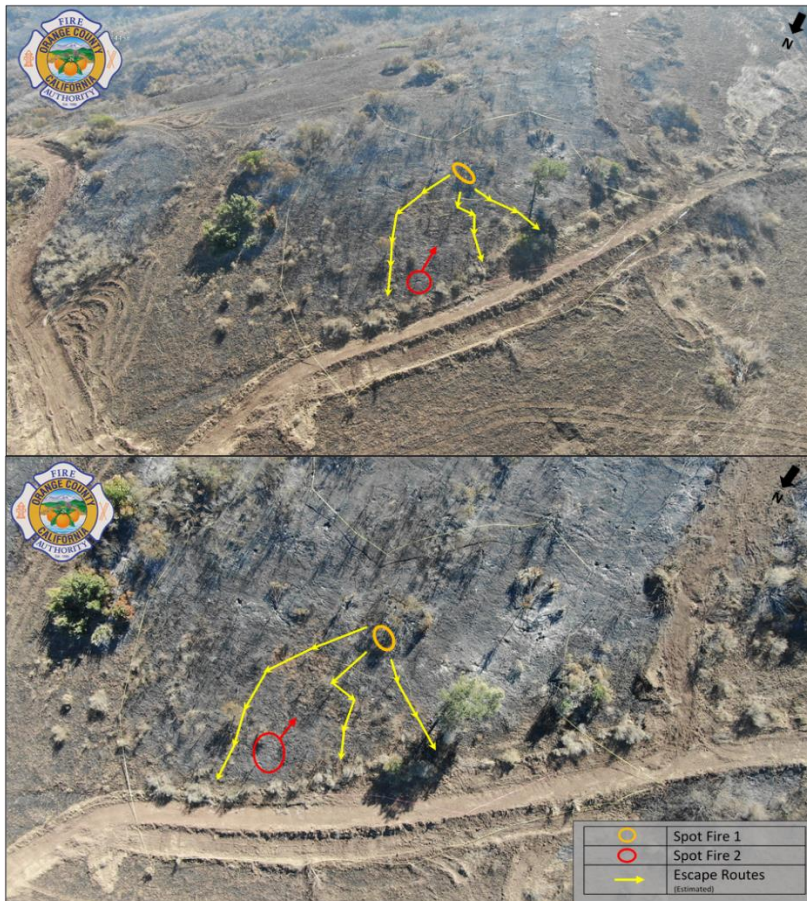
Simultaneously, another spot fire (Spot Fire 2) was established downhill and upwind of the crew members working Spot Fire 1. A C1 member shouted, “Get out of there, there’s a spot!” The eight C1 members that engaged Spot Fire 1 and the three engine firefighters began to rapidly disperse out of the area and back down to the dozer line.

Photo and Videos: Spot Fires one and two with estimated escape routes ([Video 2](#), [Video 3](#))

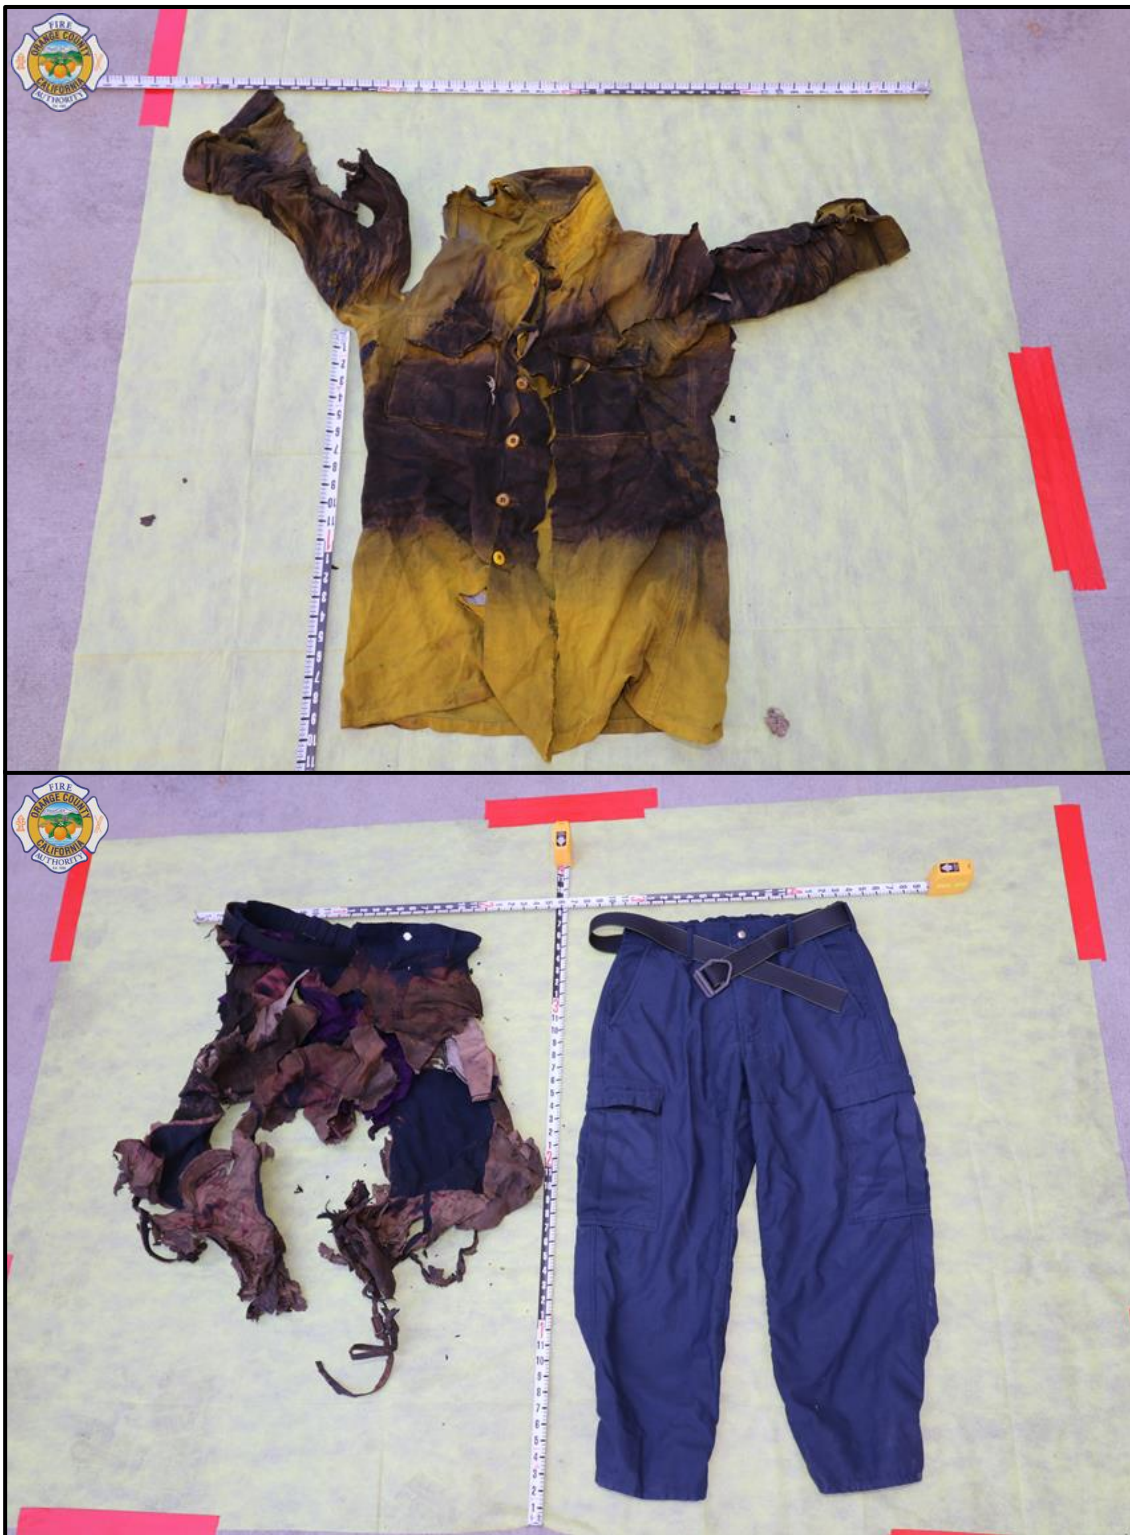
- HCFF1 suffered critical burn injuries and major damage to their PPE
- HCFF2 suffered critical burn injuries and major damage to their PPE
- HCFF3 suffered radiant heat injuries
- Additional HCFF's suffered superficial heat injuries

*HCFF Personnel Protective Equipment after burn over. *PPE was exposed to extreme heat from direct flame impingement for an unknown duration **

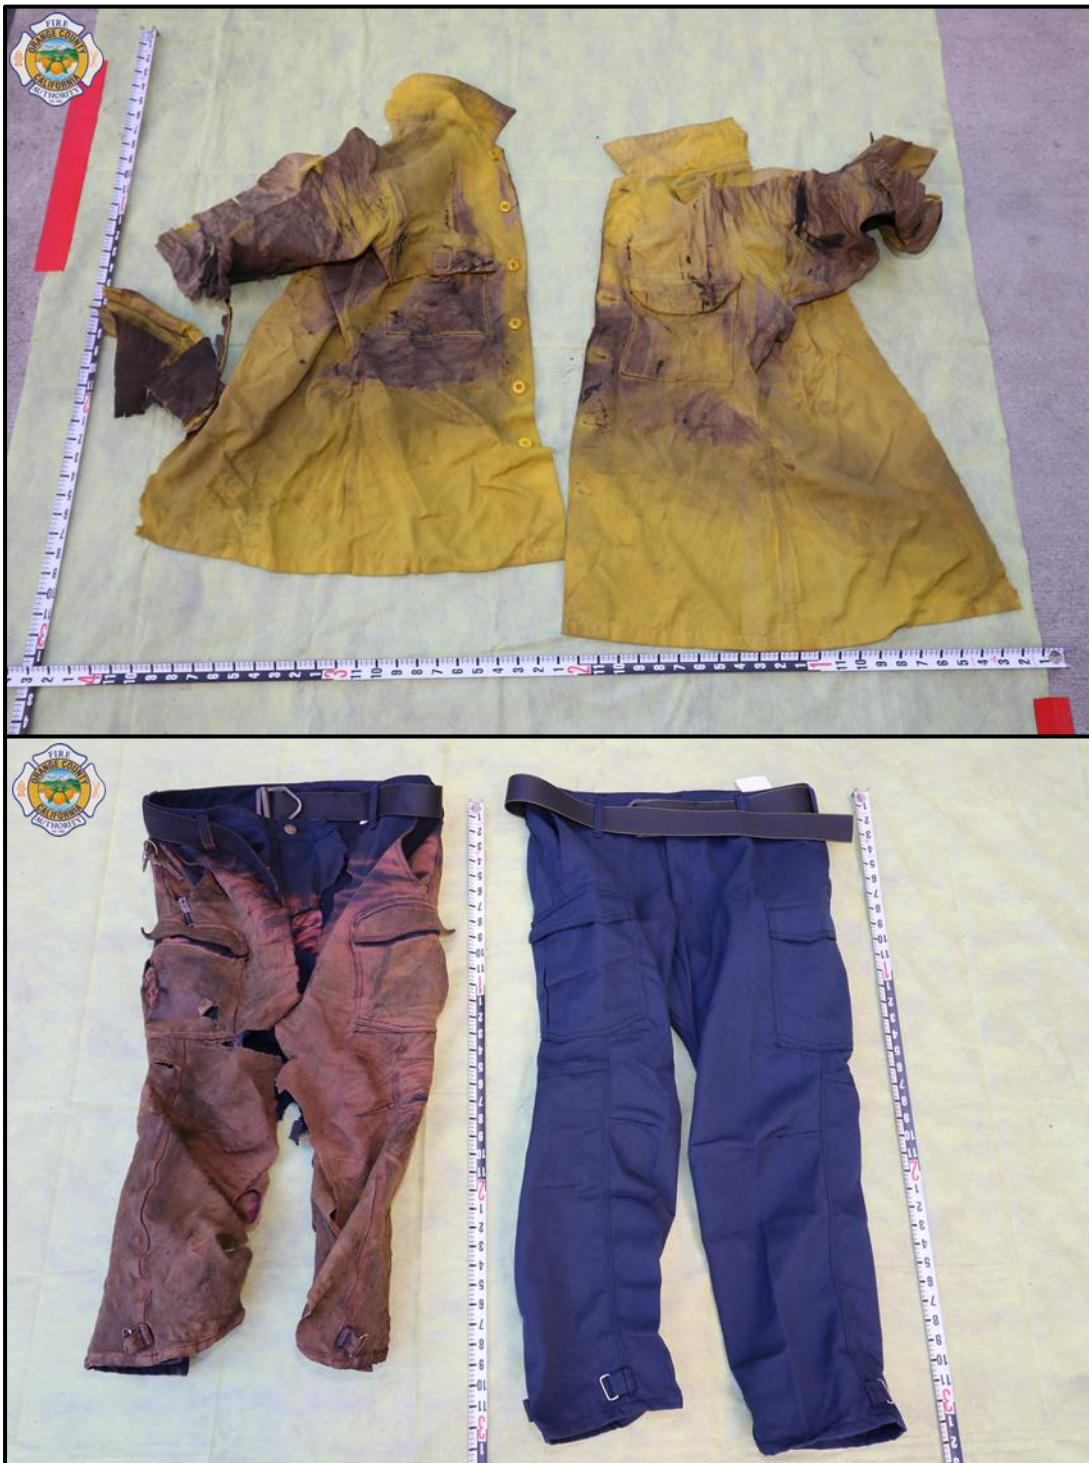
*HCFF Personnel Protective Equipment (PPE) after burn over. *PPE was exposed to extreme heat from direct flame impingement for an unknown duration **

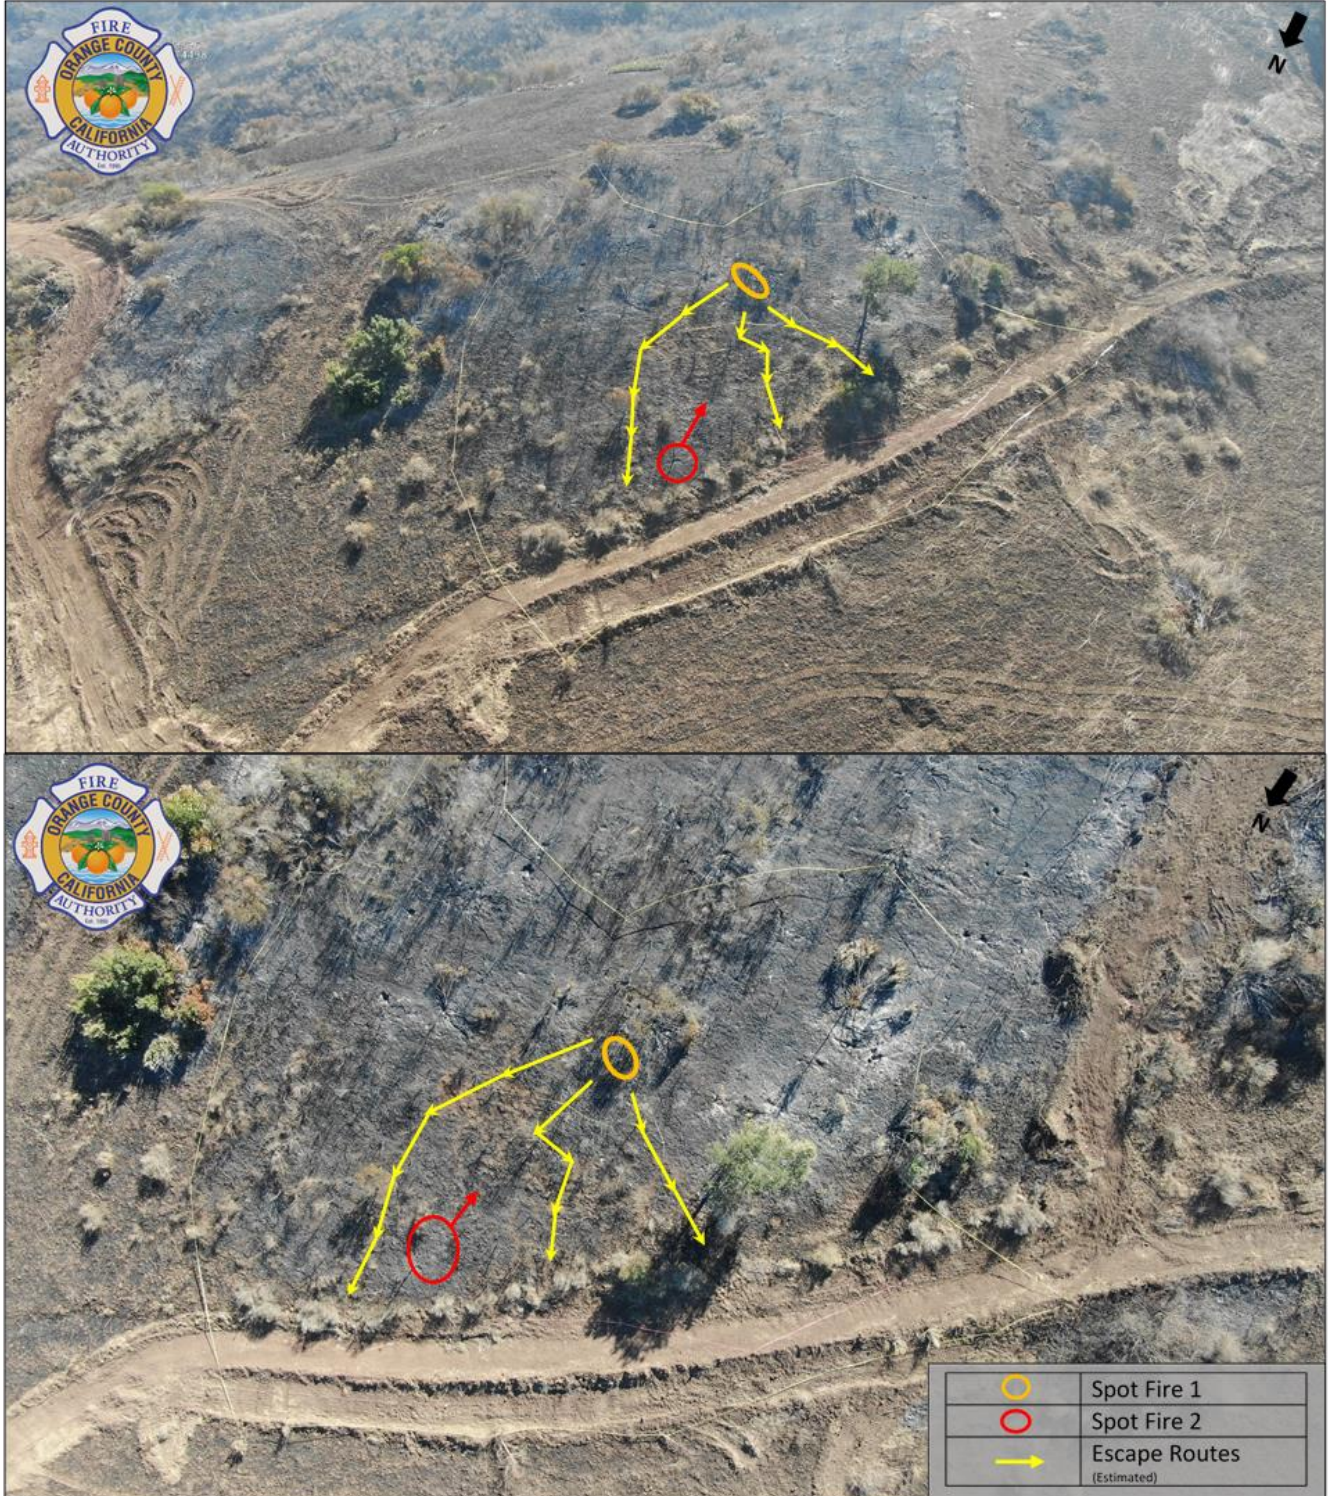
Photo and Videos: Spot Fires 1and 2 with estimated escape routes
