**Appendix 2.** Site photos.

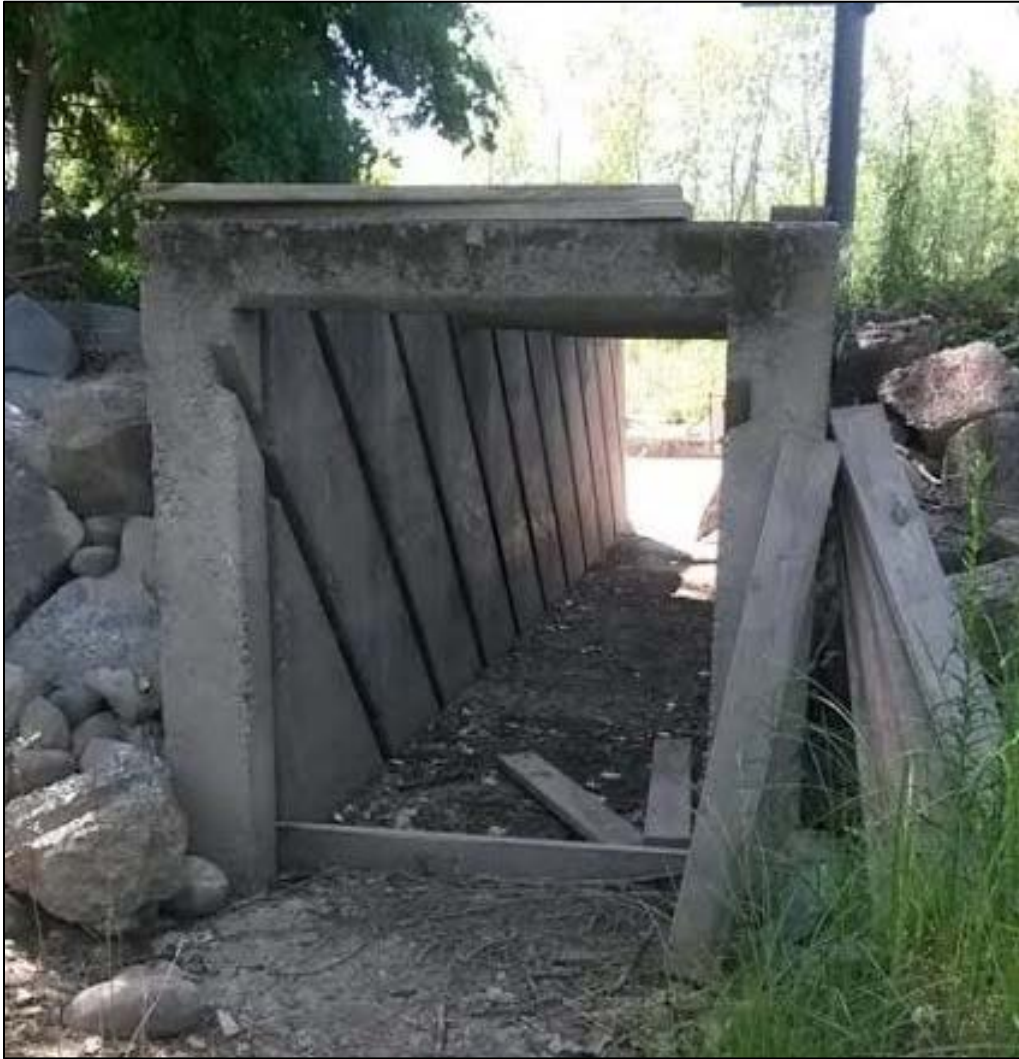
**Photo 1.** View of Existing Denil-type Fish Ladder with Stoplogs and Interior Baffles Removed, Looking Downstream.

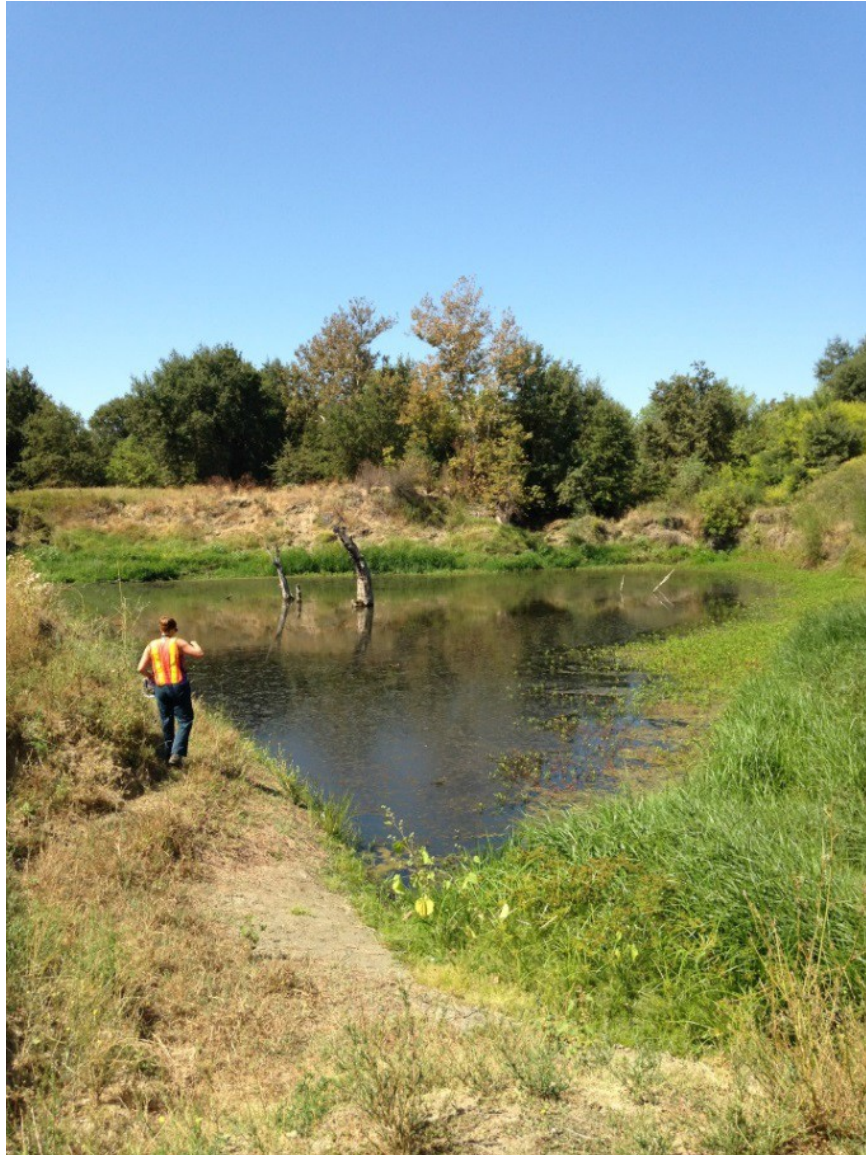
**Photo 2.** View of the deep pond looking north from the outlet to the scour channel.

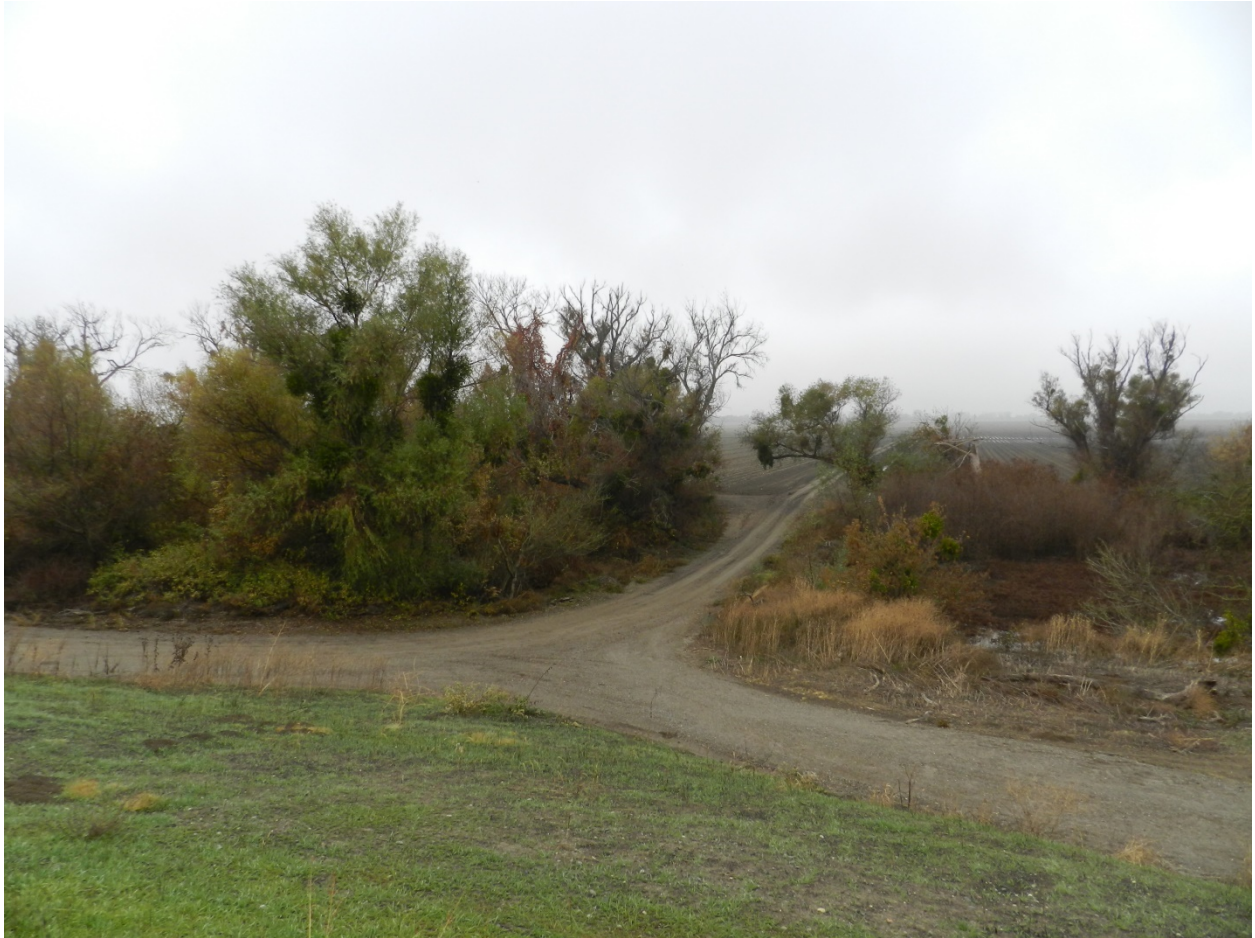
**Photo 3.** View of Agricultural Road Crossing 2 from the Yolo Bypass east levee.

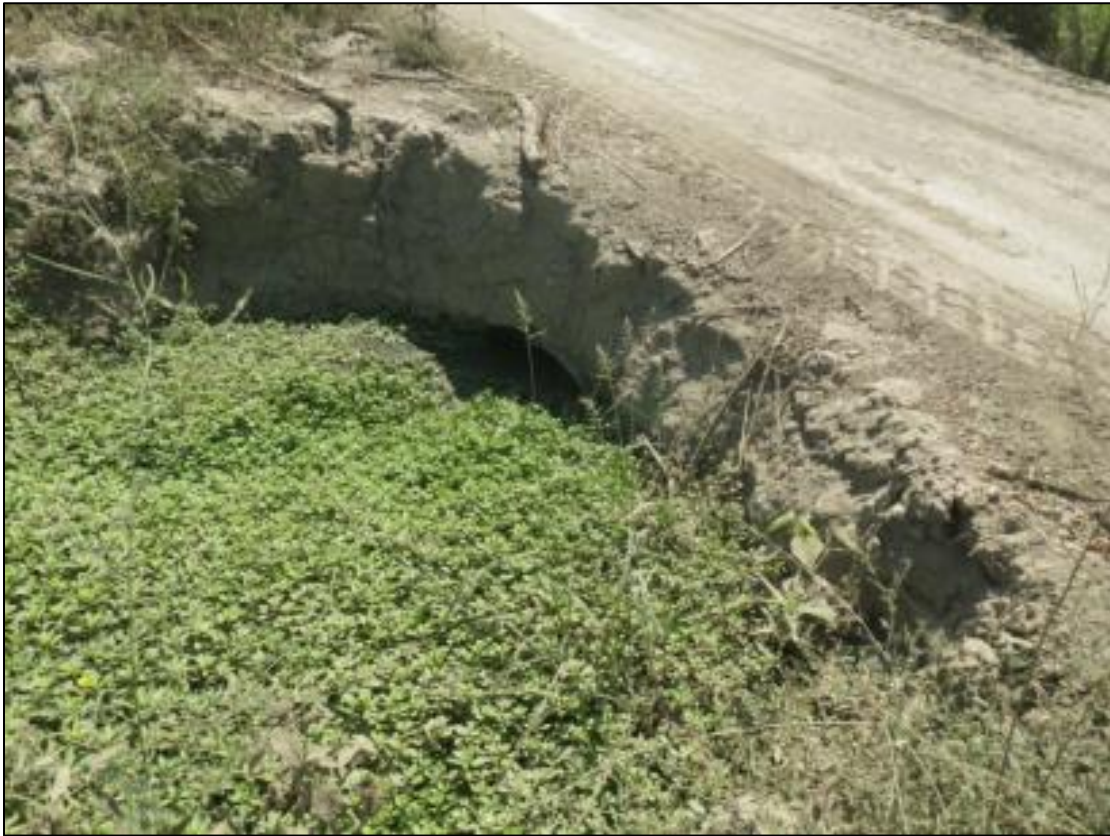
**Photo 4.** View of upstream, northern face of Agricultural Road Crossing 2 (looking south) showing excessive vegetation build-up clogging an undersized culvert.

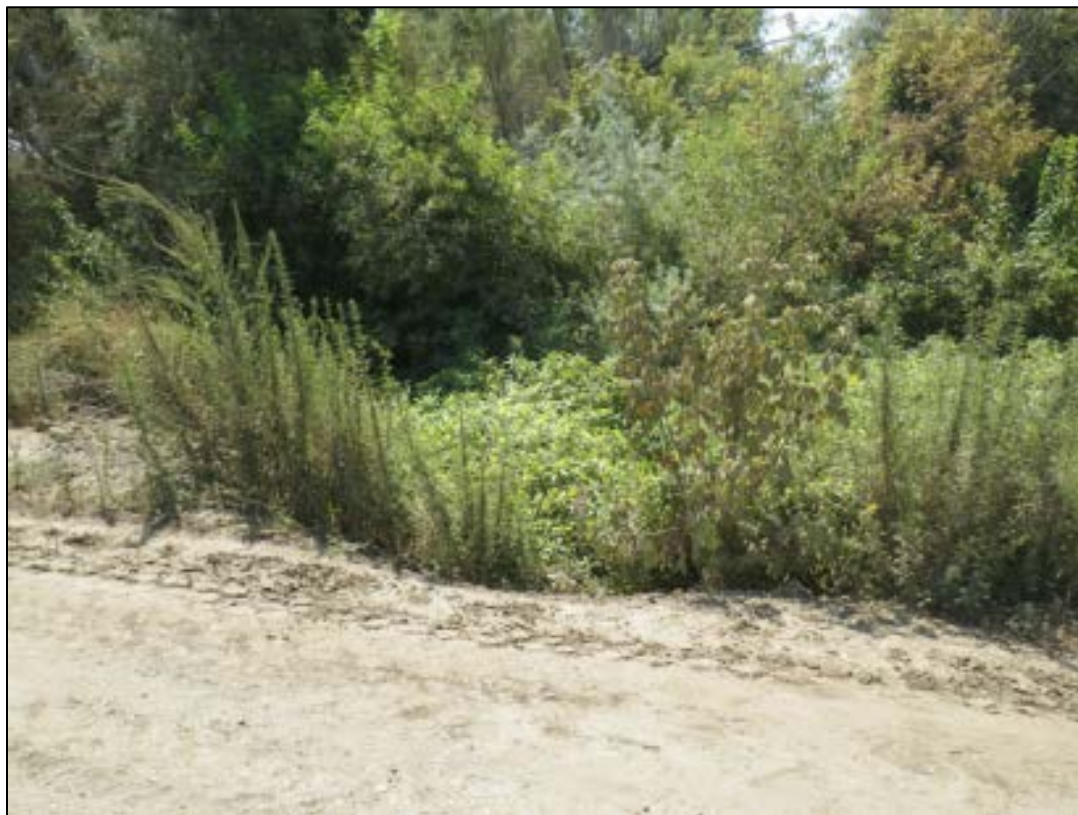
**Photo 5.** View of downstream face of Agricultural Road Crossing 2 (facing south) showing vegetation build-up.

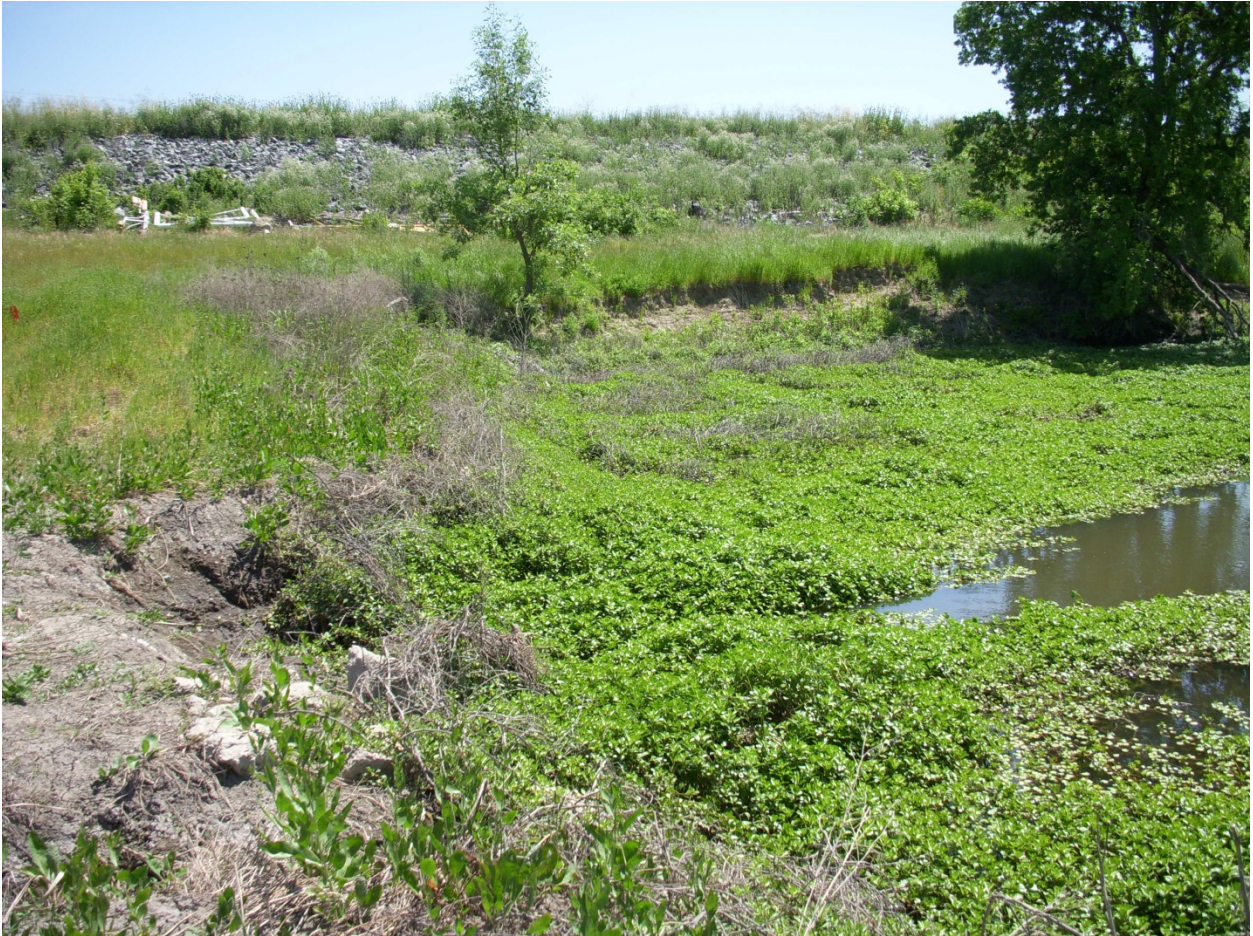
**Photo 6.** View of Agricultural Road Crossing 3 looking towards the Yolo Bypass east levee.

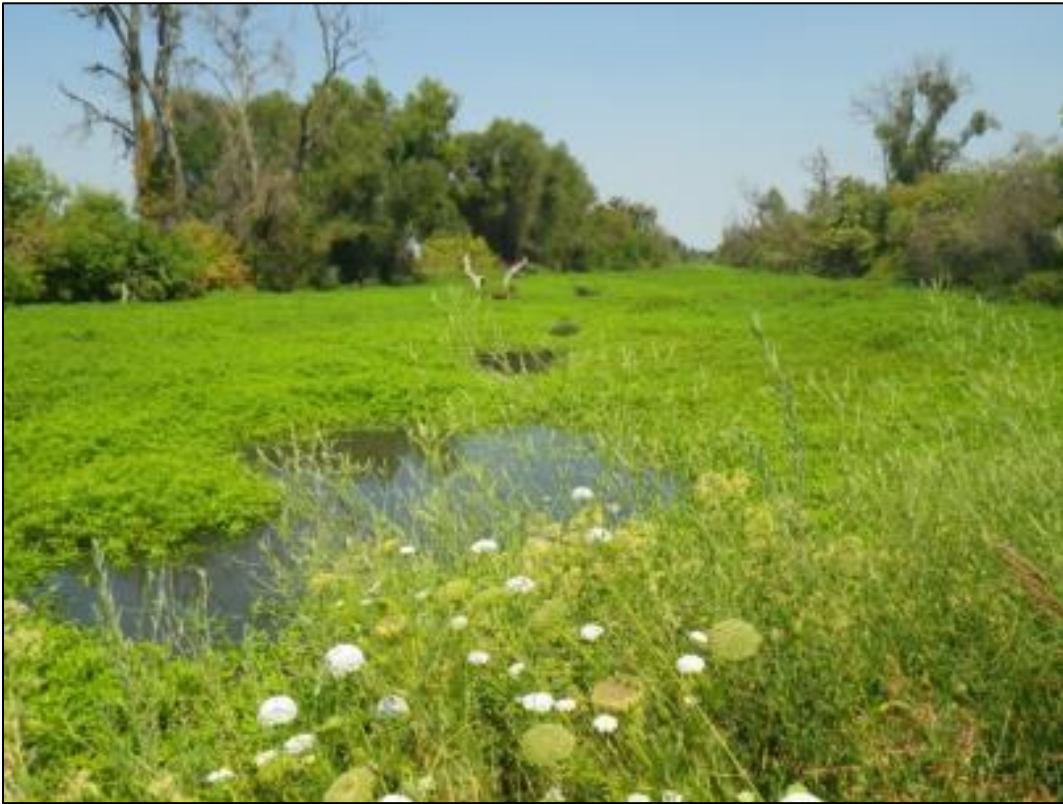
**Photo 7.** View upstream of Agricultural Road Crossing 3, showing vegetation growth concealing an undersized culvert looking north on road crossing.
