**Appendix D:**  
**Lower Meramec River Basin**  
**Nonstructural Flood Mitigation Assessment by**  
**USACE National Nonstructural Committee**

February 2019

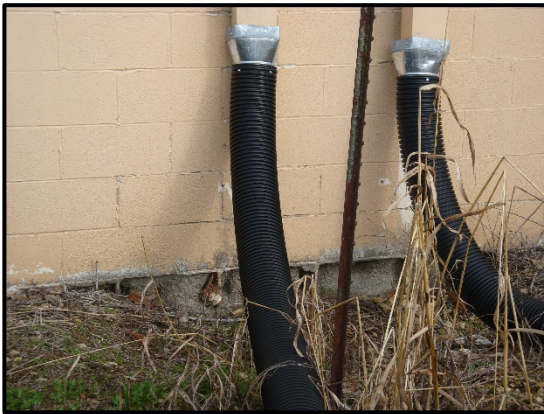
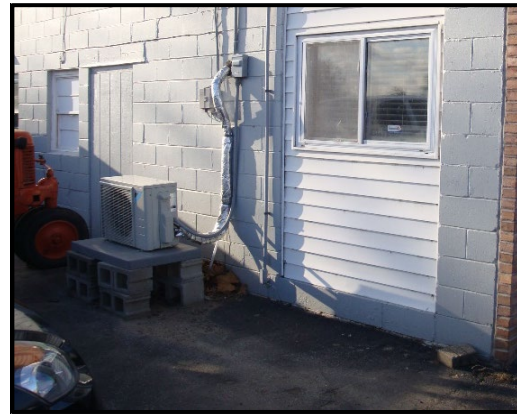
**Figure 11 Localized Interior Drainage and Utilities**

During the field assessment, it became apparent from viewing some of the sample structures that local drainage problems and utility damages were prevalent within the study area and that owners could take actions to minimize future damages. As shown in Figure 11, these are two examples of actions being taken to reduce future flood damages. Many of the downspouts discharging rooftop runoff (photograph on left) were not properly directing water away from the foundation, causing erosion and thereby exposing and weakening the foundation and providing potential pathways for floodwaters to enter or further damage some structures. The owner in this instance connected corrugated plastic drains to the downspouts and routed the runoff away from the structure.

After having had floodwaters damage an external HVAC system, the owner elevated the replacement system (photograph on right) onto layers of concrete modular units. It is also recommended that the owner secure and stabilize the platform to ensure that in the future, moving floodwaters do not cause the platform to fail.

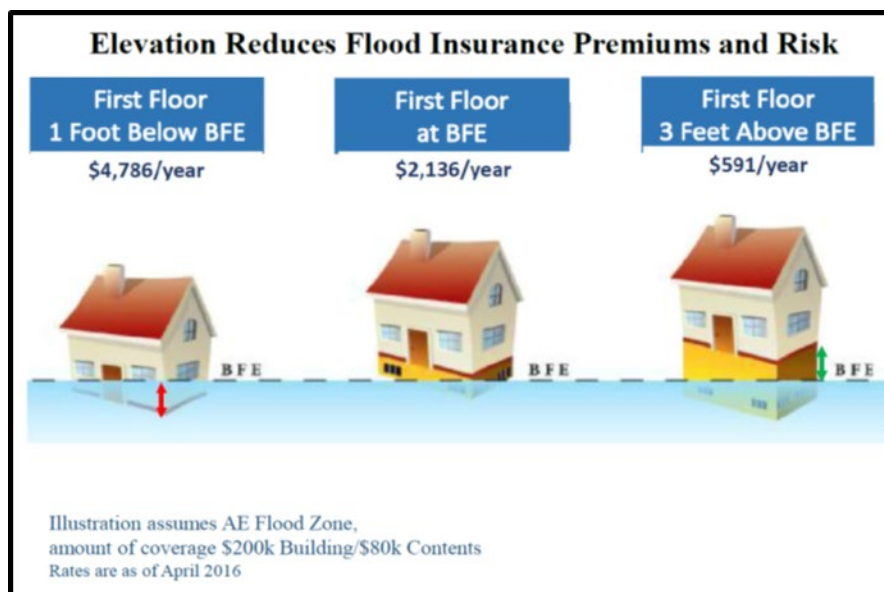
**Figure 12 Flood Insurance Premium Reduction through Elevation**

For residential structures, elevation has the effect of reducing the flood insurance premium because the structure is being moved away from the flood risk. It is important to note that the insurance is based upon a single flood event, the 1% AEP flood event, and not a range of flood events. If the residential structure is elevated to be above the 1% flood, there is still a possibility that a larger flood event could occur. Figure 15 illustrates the potential reduction in insurance premium for a sample structure elevated on extended foundation walls.

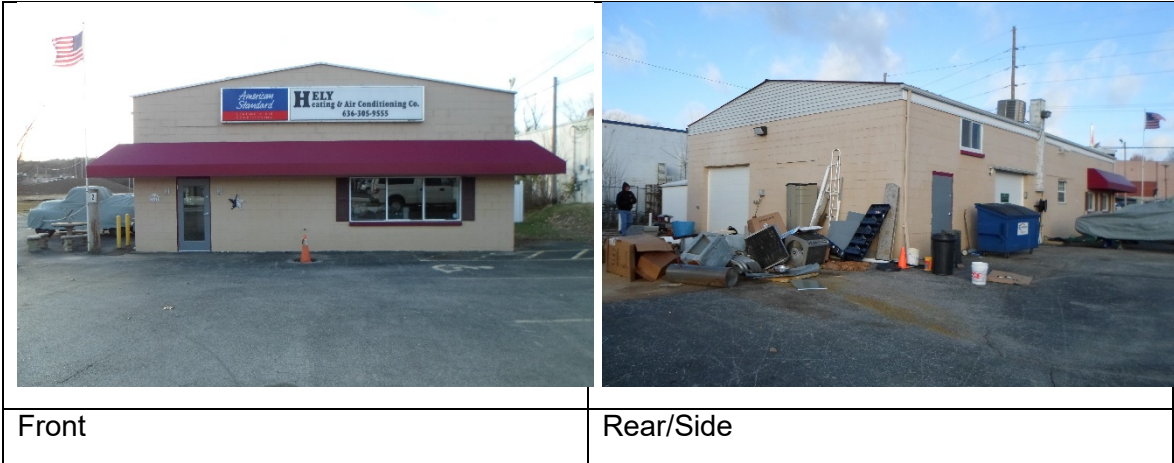
Structure ID	Structure Address
#5	62 Gravois Rd, Fenton, MO

Structure Characteristics	
Characteristic	Description
Occupancy - ...	Nonresidential (Commercial – HVAC / Plumbing sales and service).
Configuration -	One story, concrete slab on grade, gable roof.
Construction -	Masonry exterior bearing walls with wood truss roof. Wood framed interior.
Condition -	Good.
Other -	Auxiliary structure adjacent to main structure – Metal building/slab on grade.

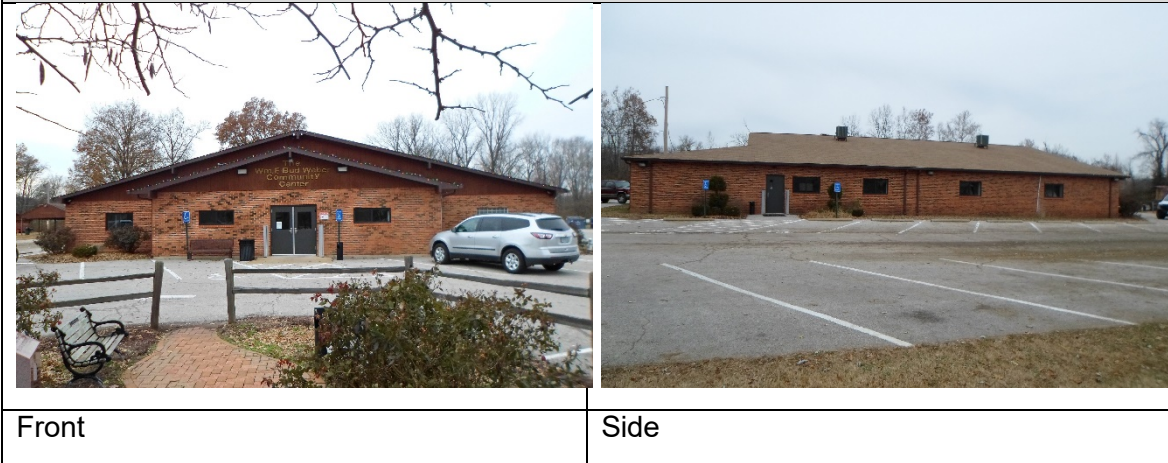
Structure ID	Structure Address
#11	333 Bald Hill Road, Eureka, MO

Characteristic	Description
Occupancy -	Nonresidential (Public – office / community center).
Configuration -	One story, concrete slab on grade, gable roof.
Construction -	Masonry exterior bearing walls with wood framed roof. Masonry and wood framed interior.
Condition -	Excellent.
Other -	Dry flood proofing measures are in place.

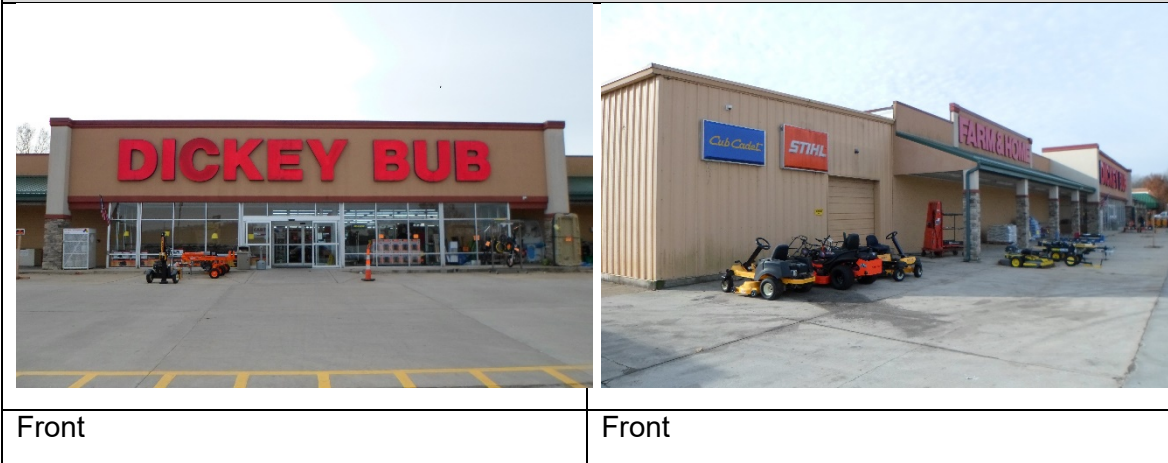
Structure ID	Structure Address
#13	Dickey Bub, 1 Union Village Plaza

Characteristic	Description
Occupancy - ...	Nonresidential (Commercial – Retail Store).
Configuration -	One story, concrete slab on grade, flat roof. Interior storage mezzanine.
Construction –	Metal structure, concrete slab on grade, masonry exterior walls, flat roof. Wood framed interior partitions.
Condition -	Very Good.
Other -	Auxiliary structures adjacent to main structure at the side and rear. Metal buildings / slab on grade.
