APPROVED JURISDICTIONAL DETERMINATION FORM
U.S. Army Corps of Engineers

B. DISTRICT OFFICE, FILE NAME, AND NUMBER: Sacramento District, Trails of Manteca, SPK-2010-00901; ID-1 to ID-12

**January 14, 2013 Site Visit
Photographs**

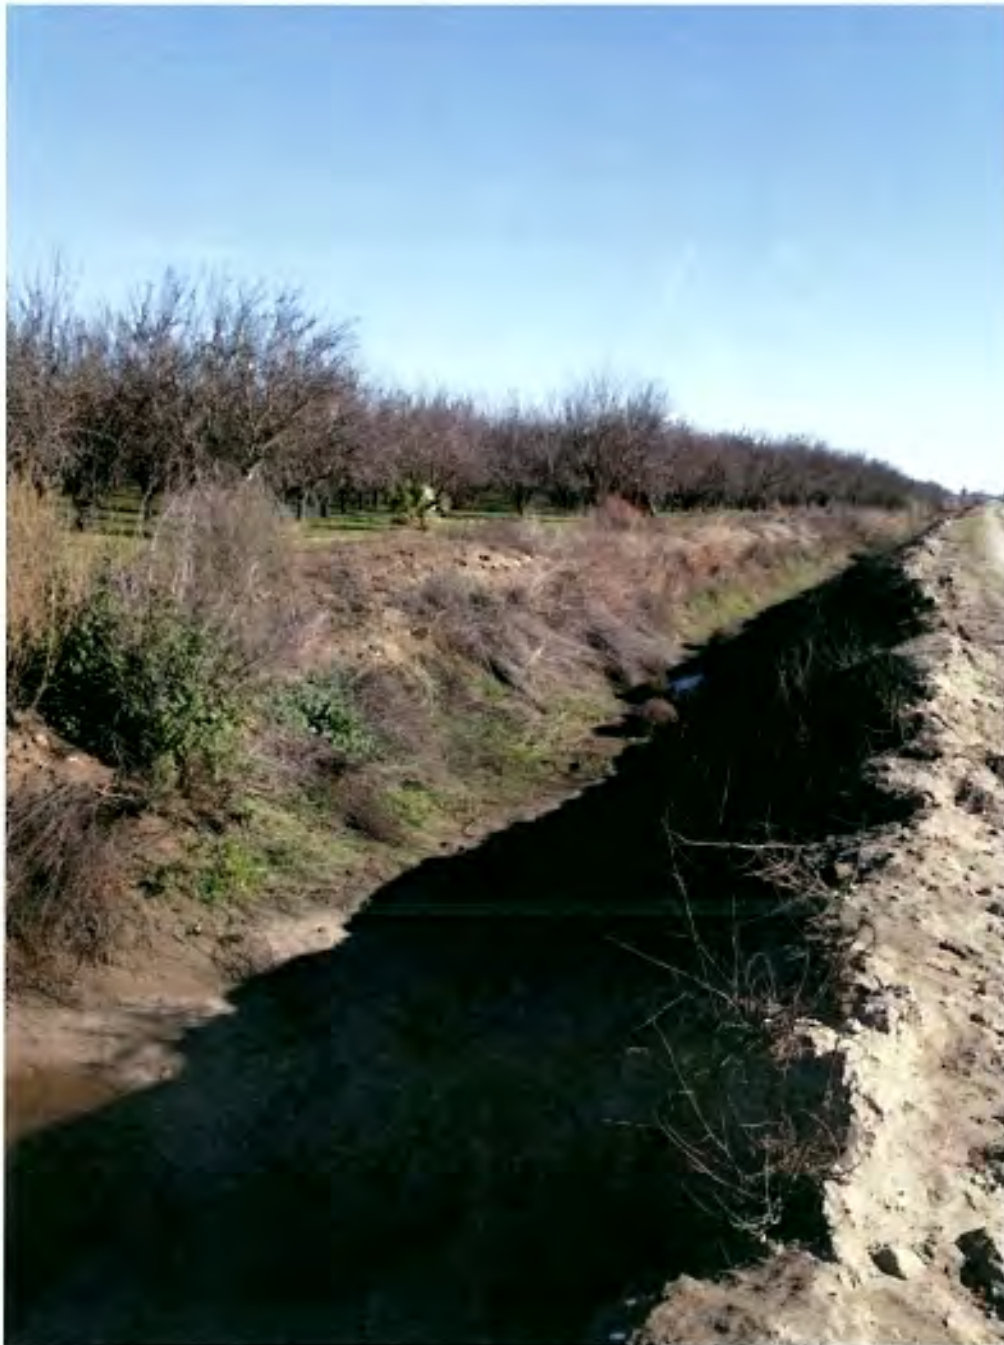
Photo 1

Description: View looking east at ID-5. See January 14, 2012 Site Visit Photo Points drawing for location.

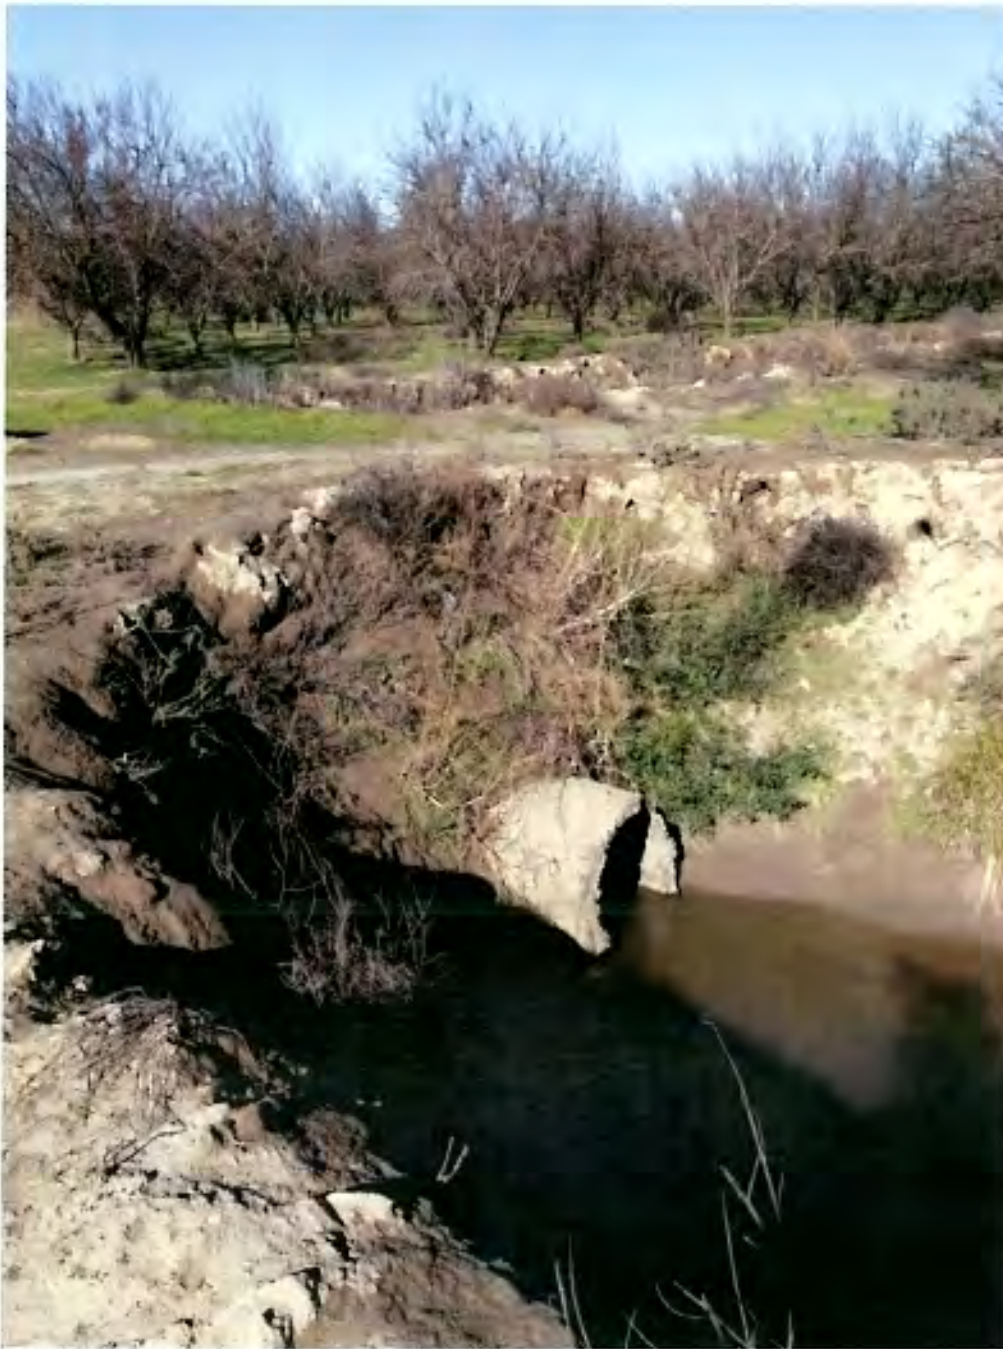
Photo 2

Description: View looking north-west at ID-5. See January 14, 2012 Site Visit Photo Points drawing for location.

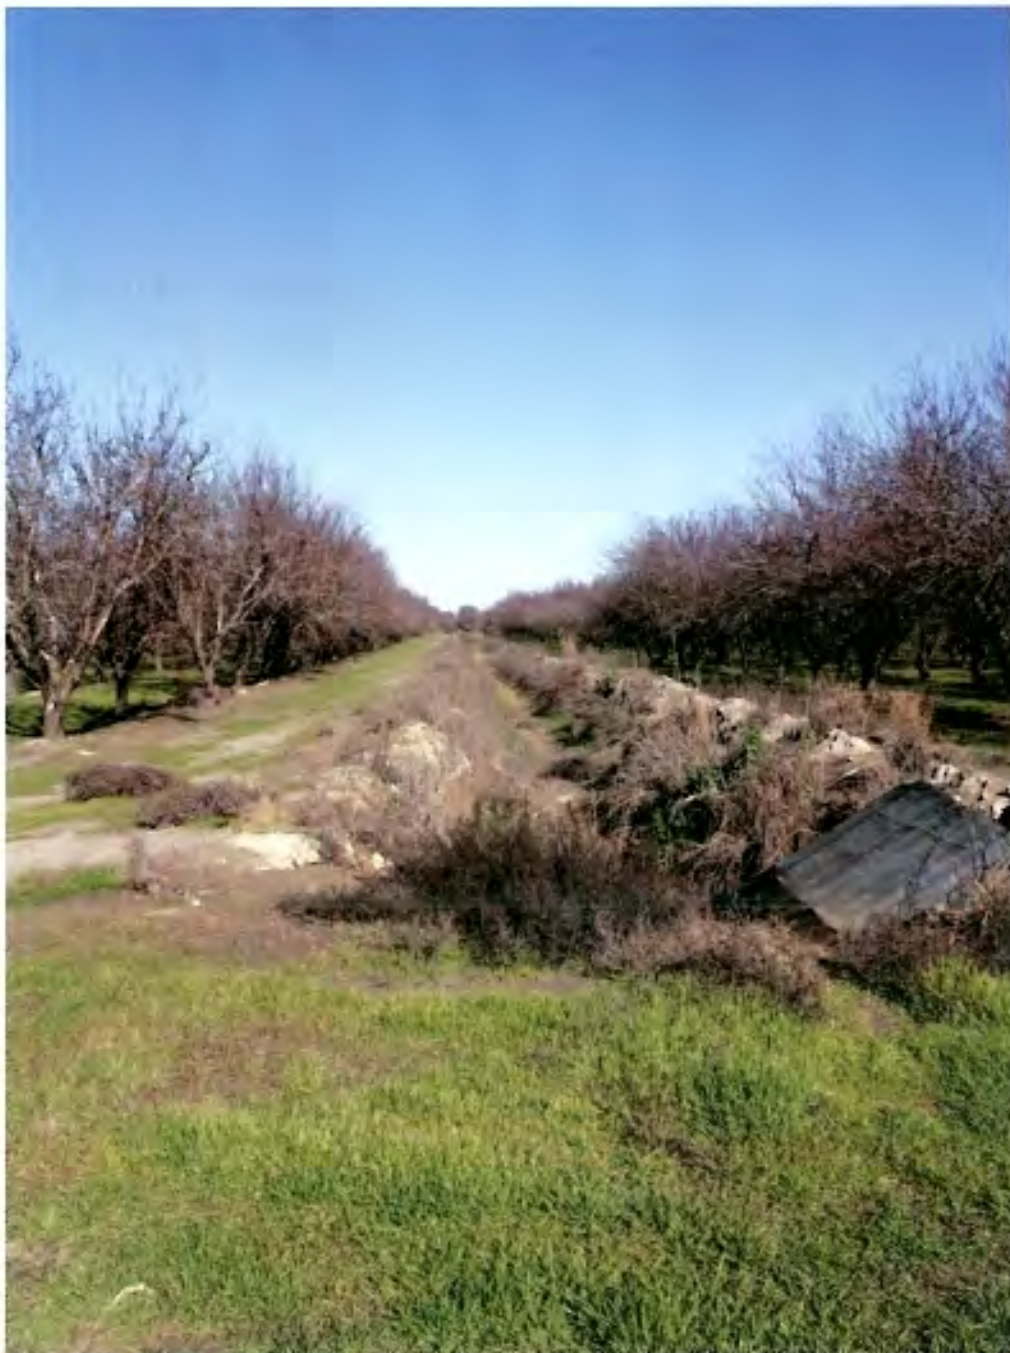
Photo 3

Description: View looking south at ID-7. See January 14, 2012 Site Visit Photo Points drawing for location.

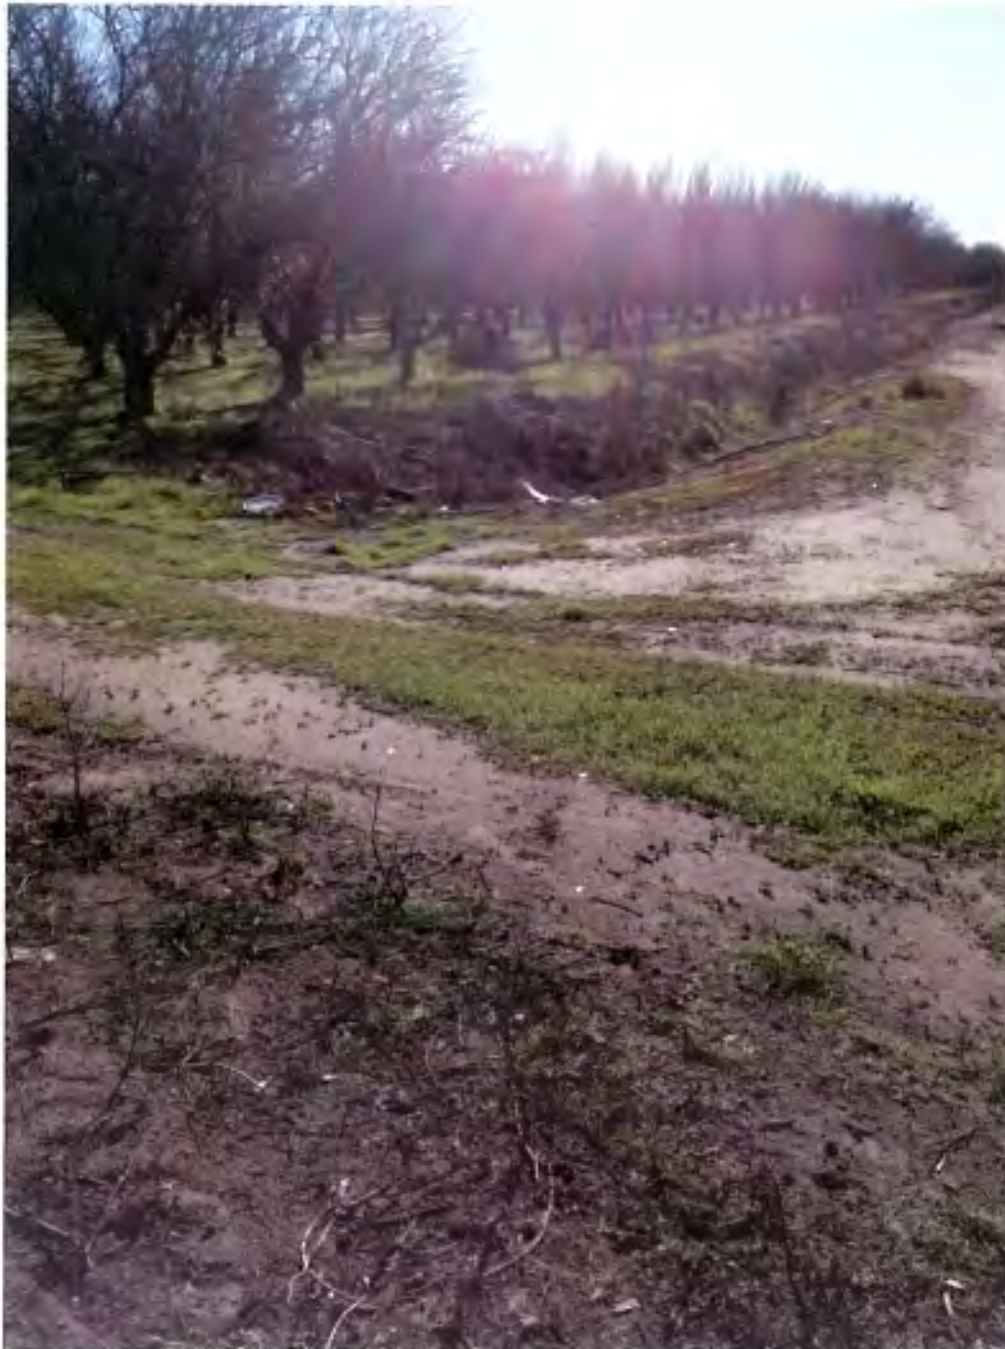
Photo 4

Description: View looking east at ID-8. See January 14, 2012 Site Visit Photo Points drawing for location.

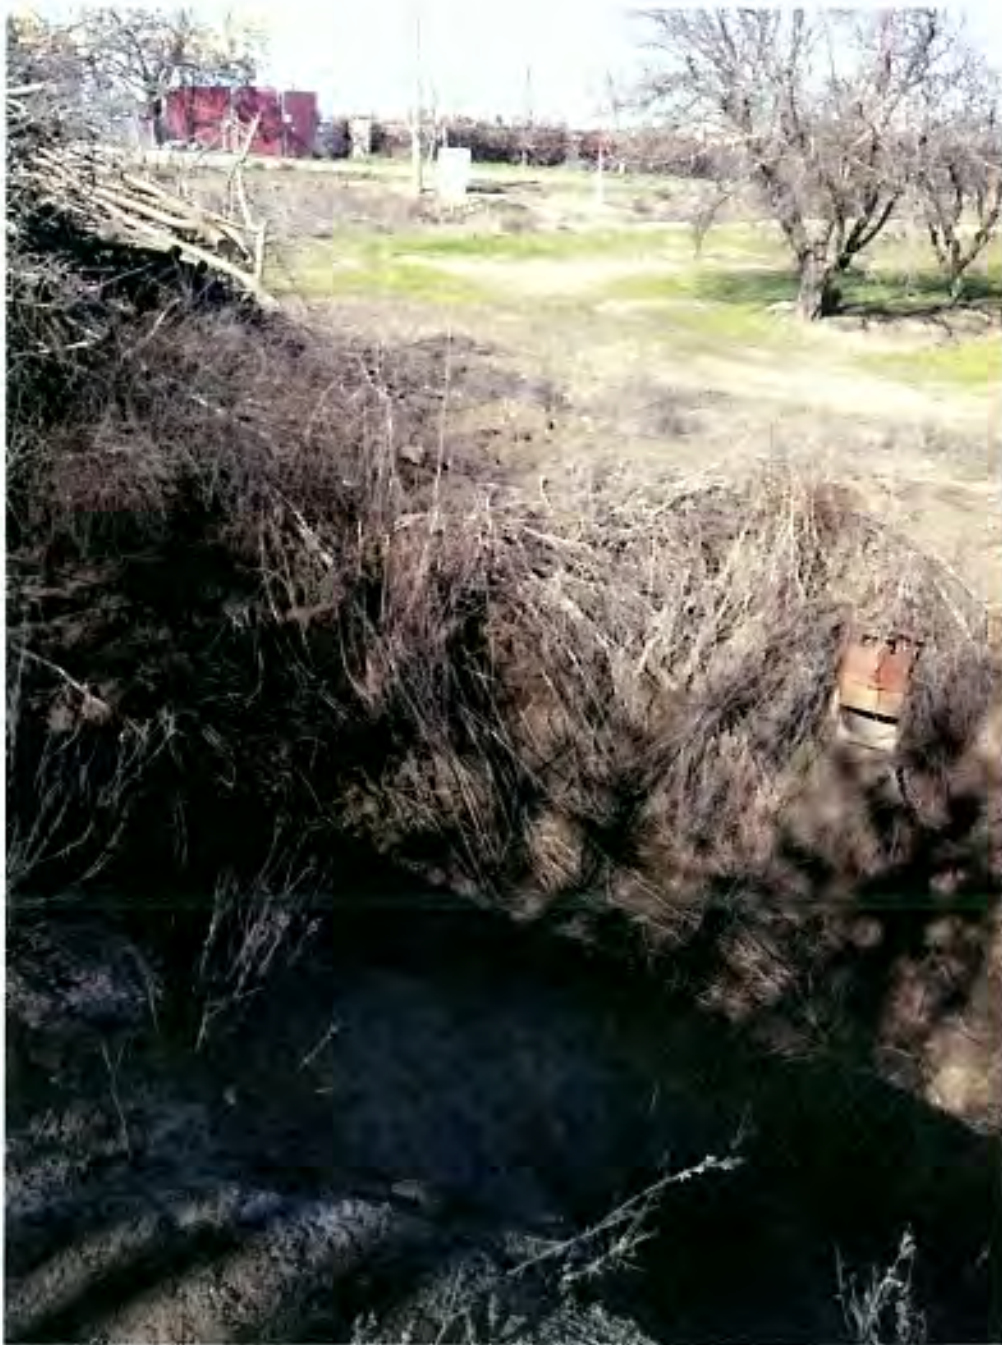
Photo 5

Description: View looking north-west at culvert in ID-8. ID-1 is located east of the road seen in the background. See January 14, 2012 Site Visit Photo Points drawing for location.

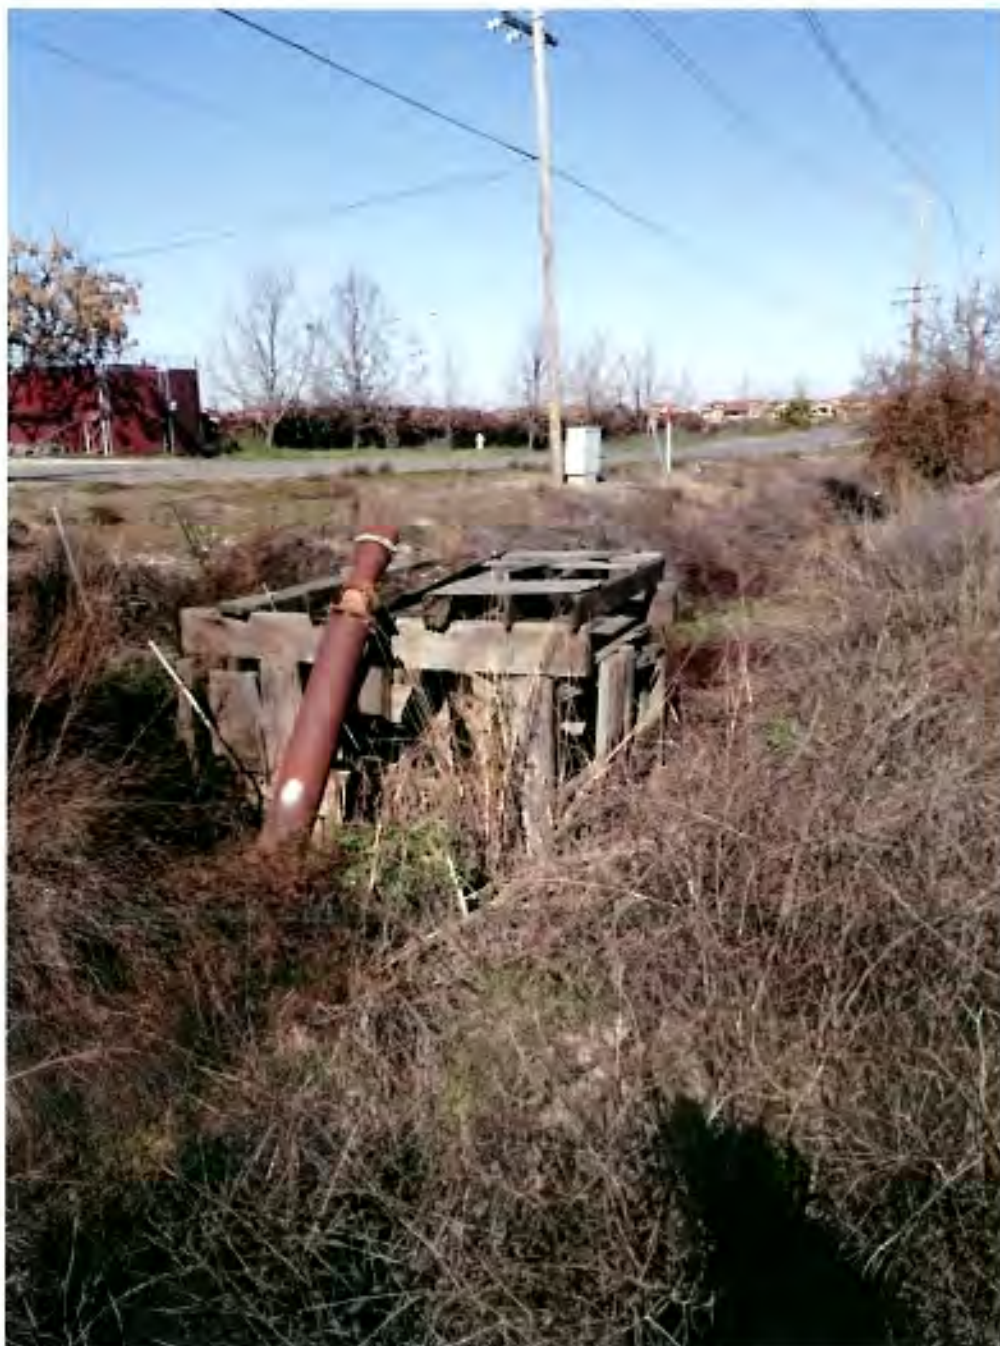
Photo 6

Description: View looking north-west at ID-1 along the north-western property boundary. The structure appears to have once contained a valve, although based on observation; the valve has been removed, with only a buried PVC pipe remaining, which appears to bring water to the site. See January 14, 2012 Site Visit Photo Points drawing for location.

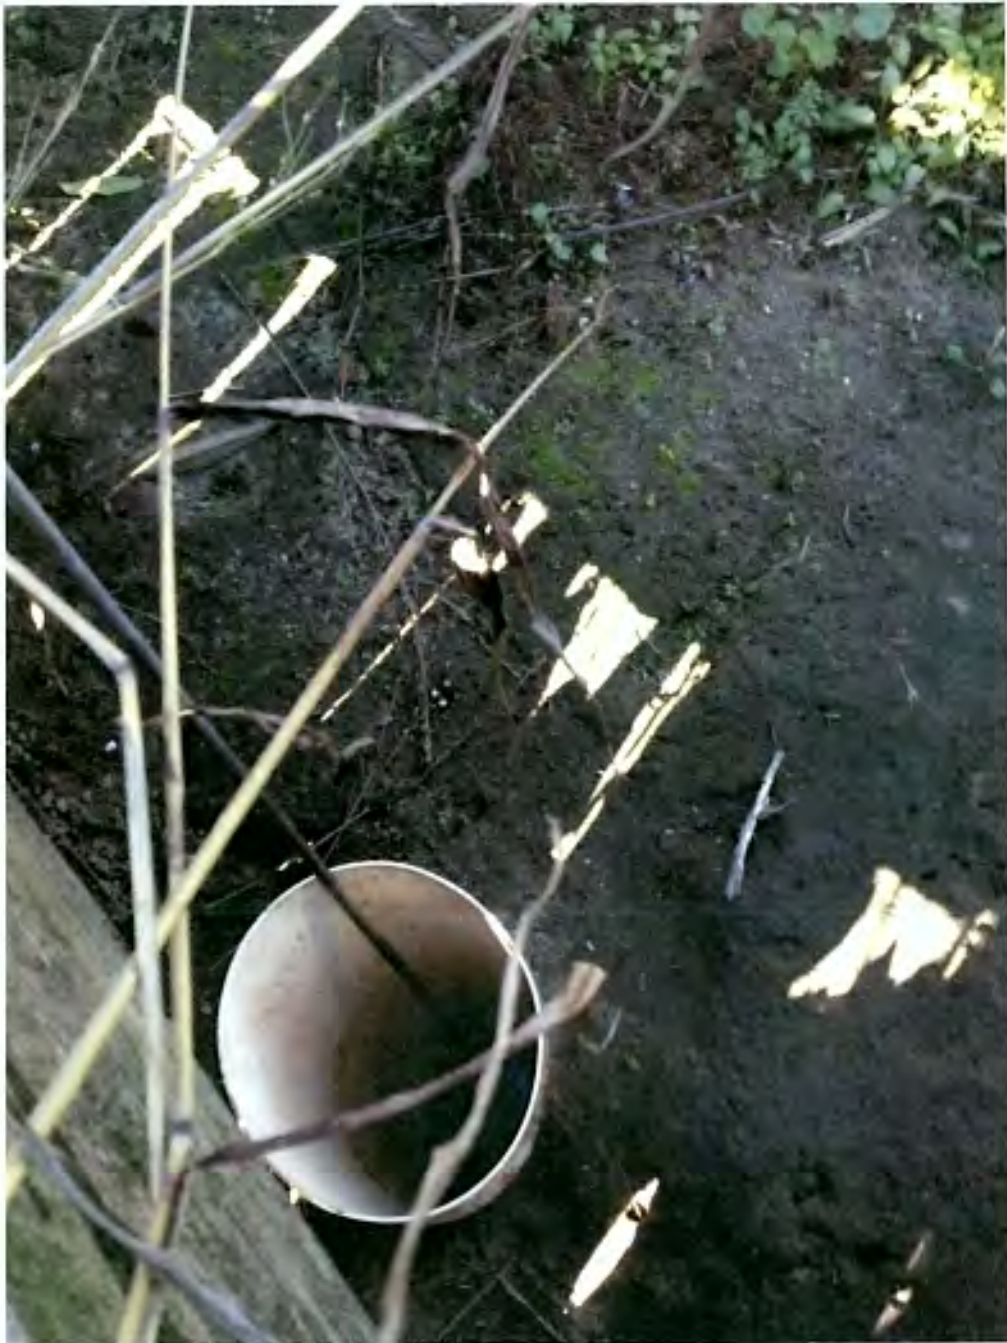
Photo 7

Description: View of PVC pipe located in the structure within the irrigation ditch located on the north-western property boundary. The PVC pipe contained water approximately 1-foot down. See January 14, 2012 Site Visit Photo Points drawing for location.

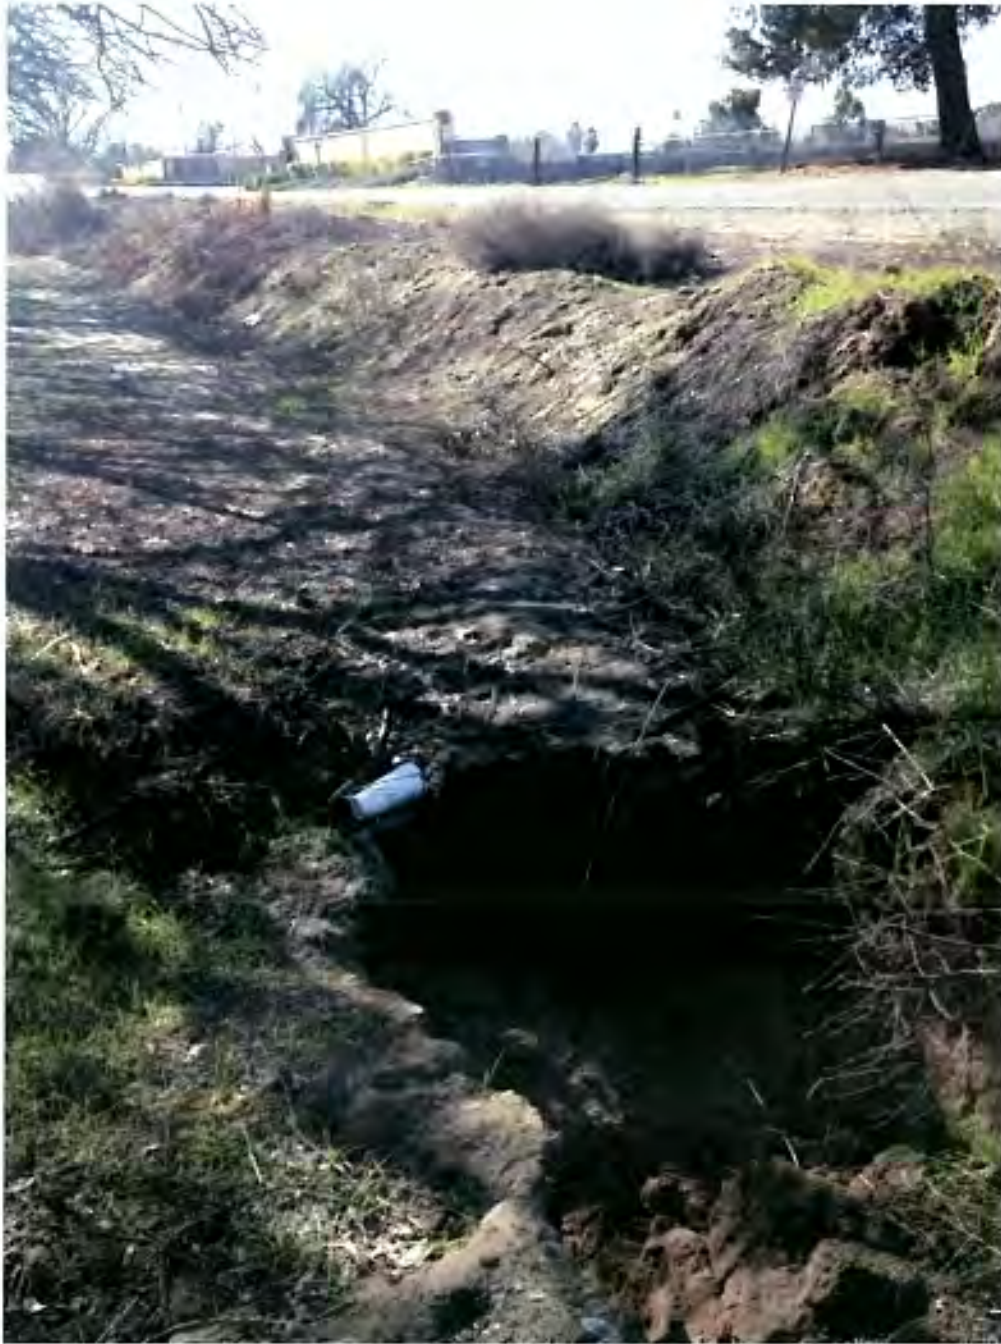
Photo 8

Description: View looking south from the irrigation ditch located on the north-western property boundary. This area appears to have once contained an irrigation pipe, but the area has collapsed. See January 14, 2012 Site Visit Photo Points drawing for location.

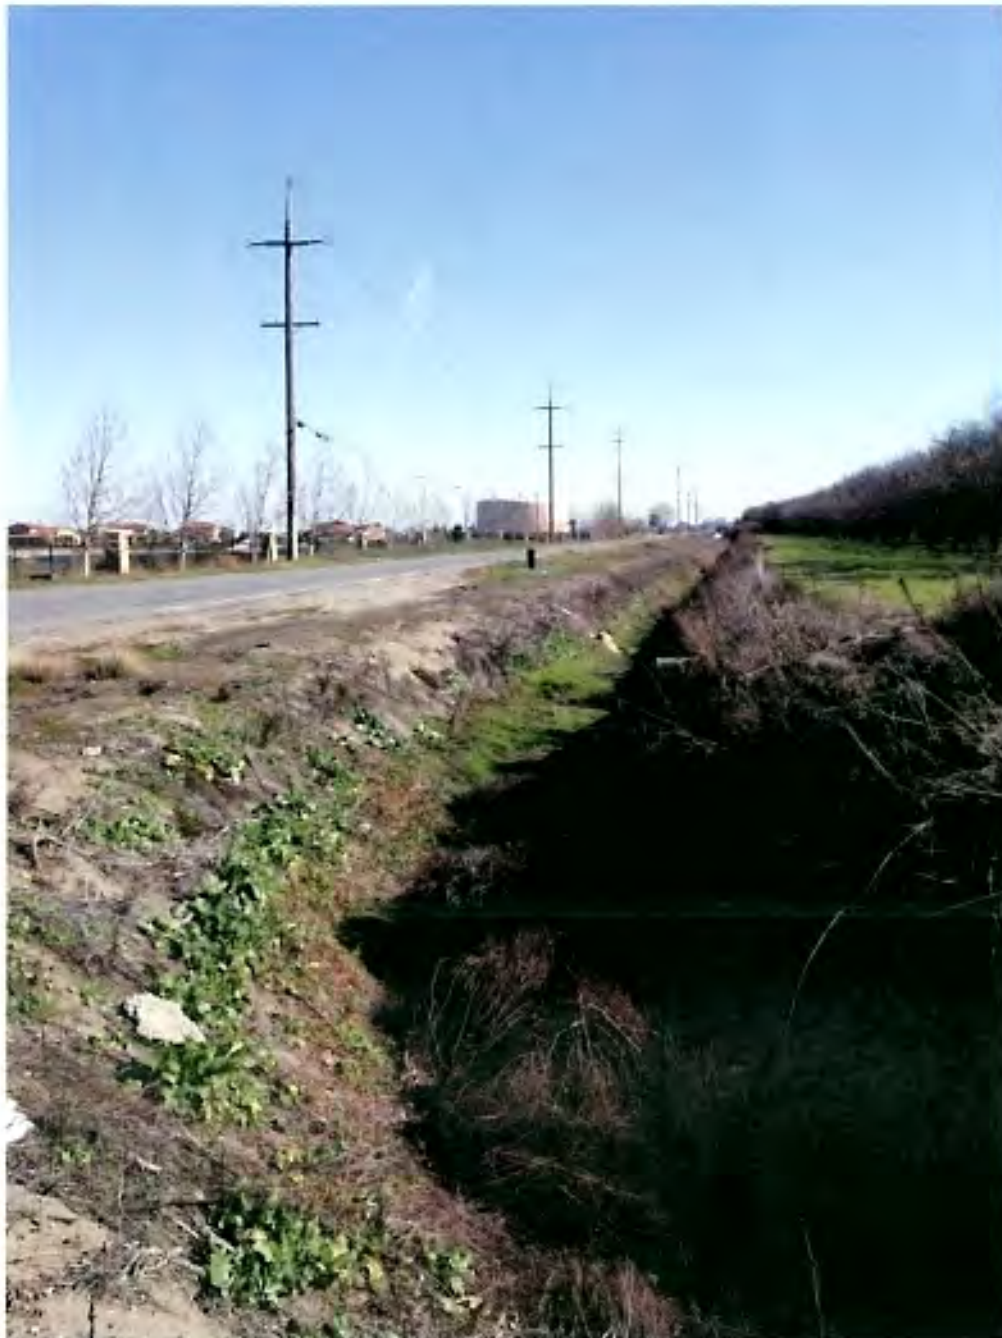
Photo 9

Description: View looking east from the north-western property boundary, at the irrigation ditch that runs along the northern property boundary. See January 14, 2012 Site Visit Photo Points drawing for location.

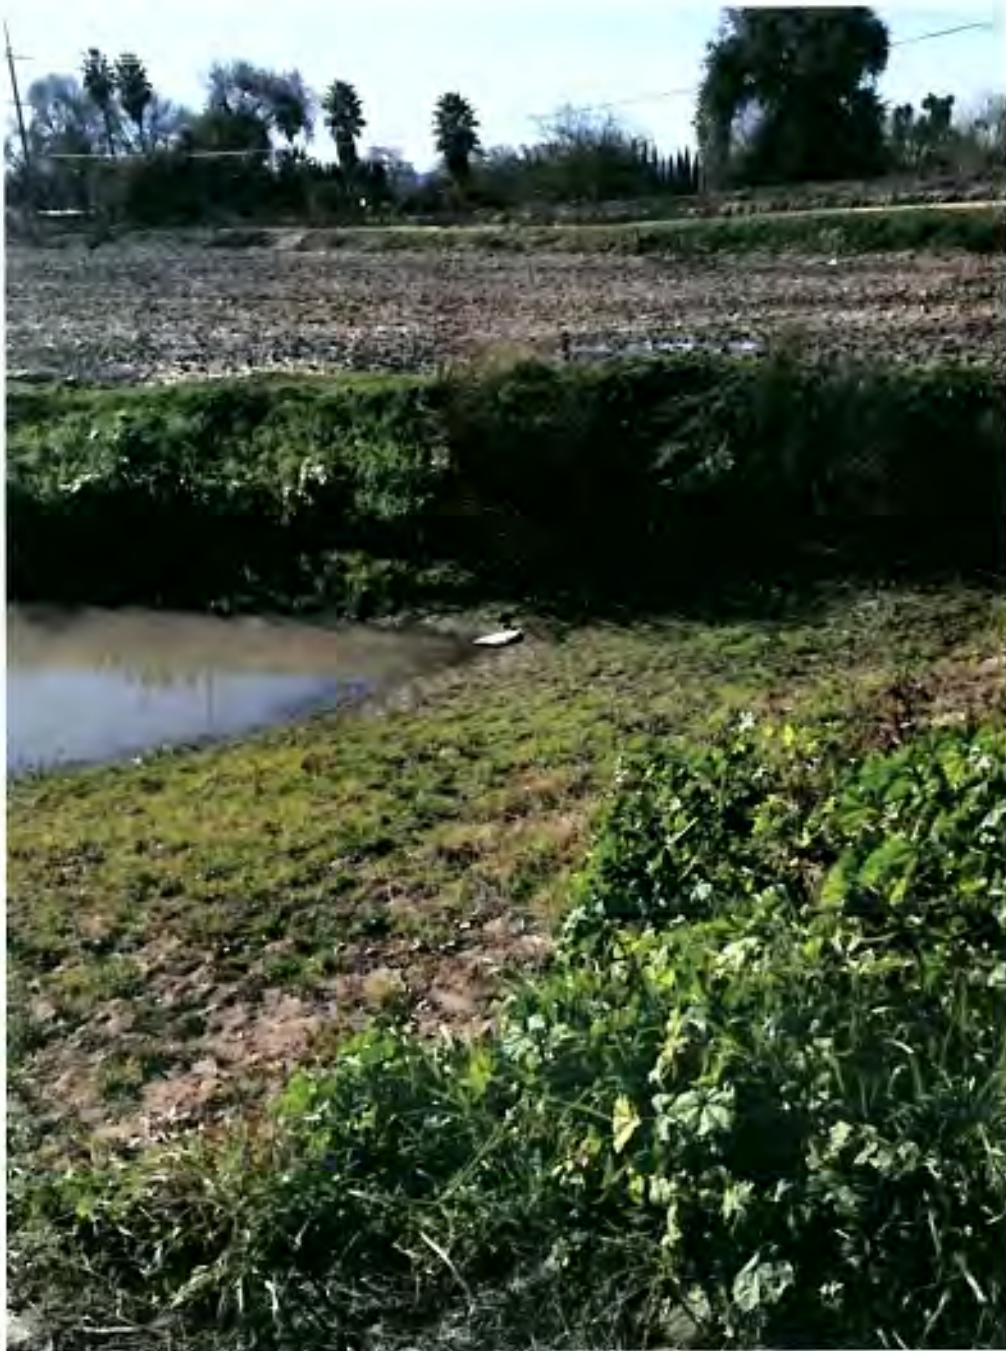
Photo 10

Description: View looking south-east from the levee road located along the west-central portion of the site, at the western end of the irrigation ditch located south of the levee road. See January 14, 2012 Site Visit Photo Points drawing for location.

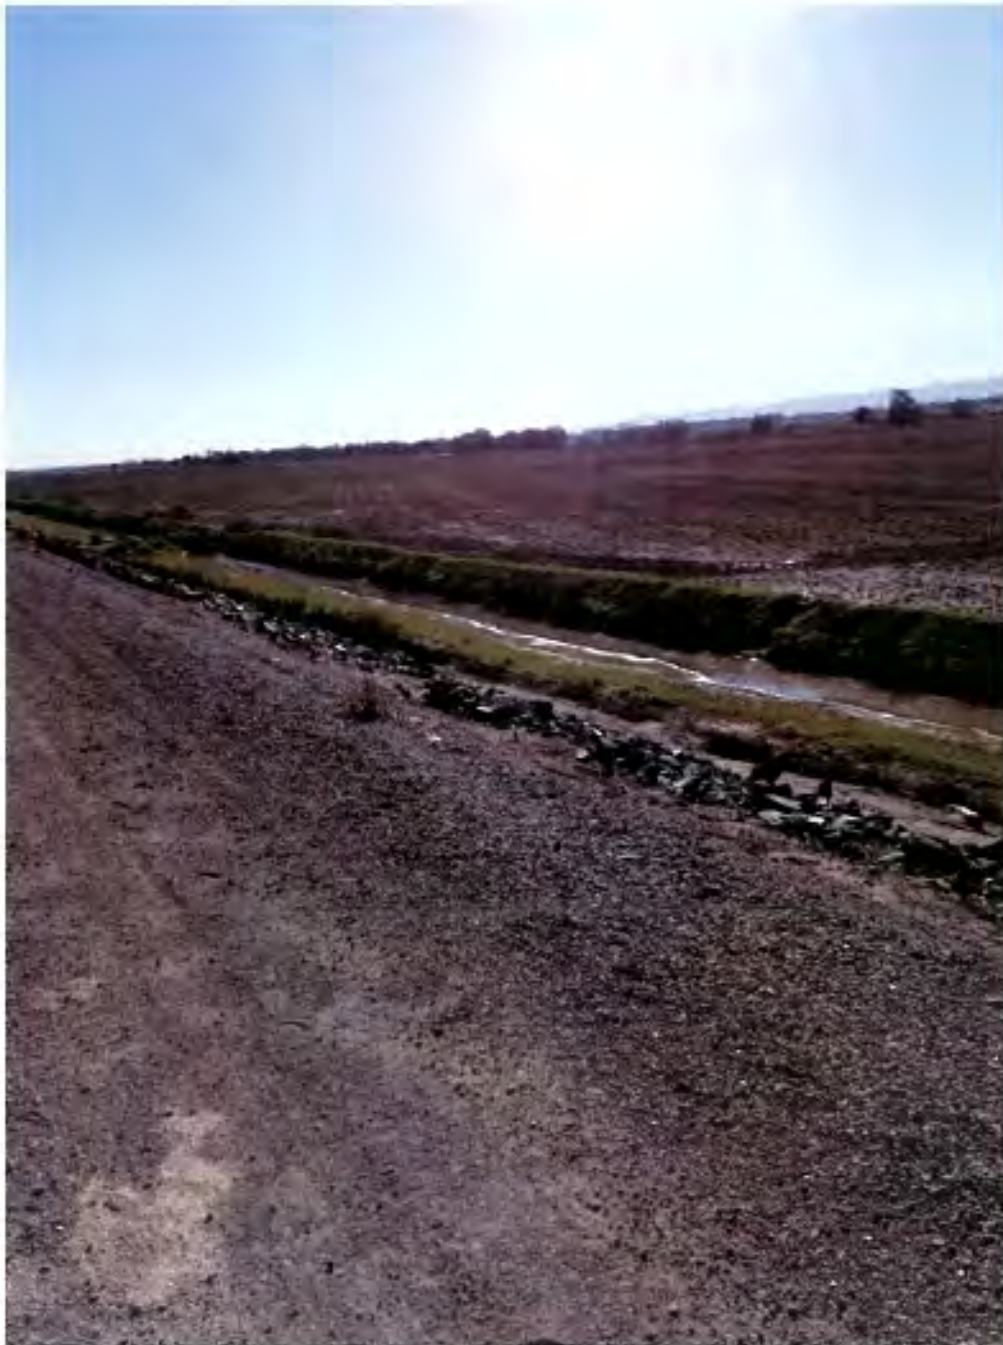
Photo 11

Description: View looking south-east from the levee road at the irrigation ditch that runs along the southern portion of the levee road. See January 14, 2012 Site Visit Photo Points drawing for location.

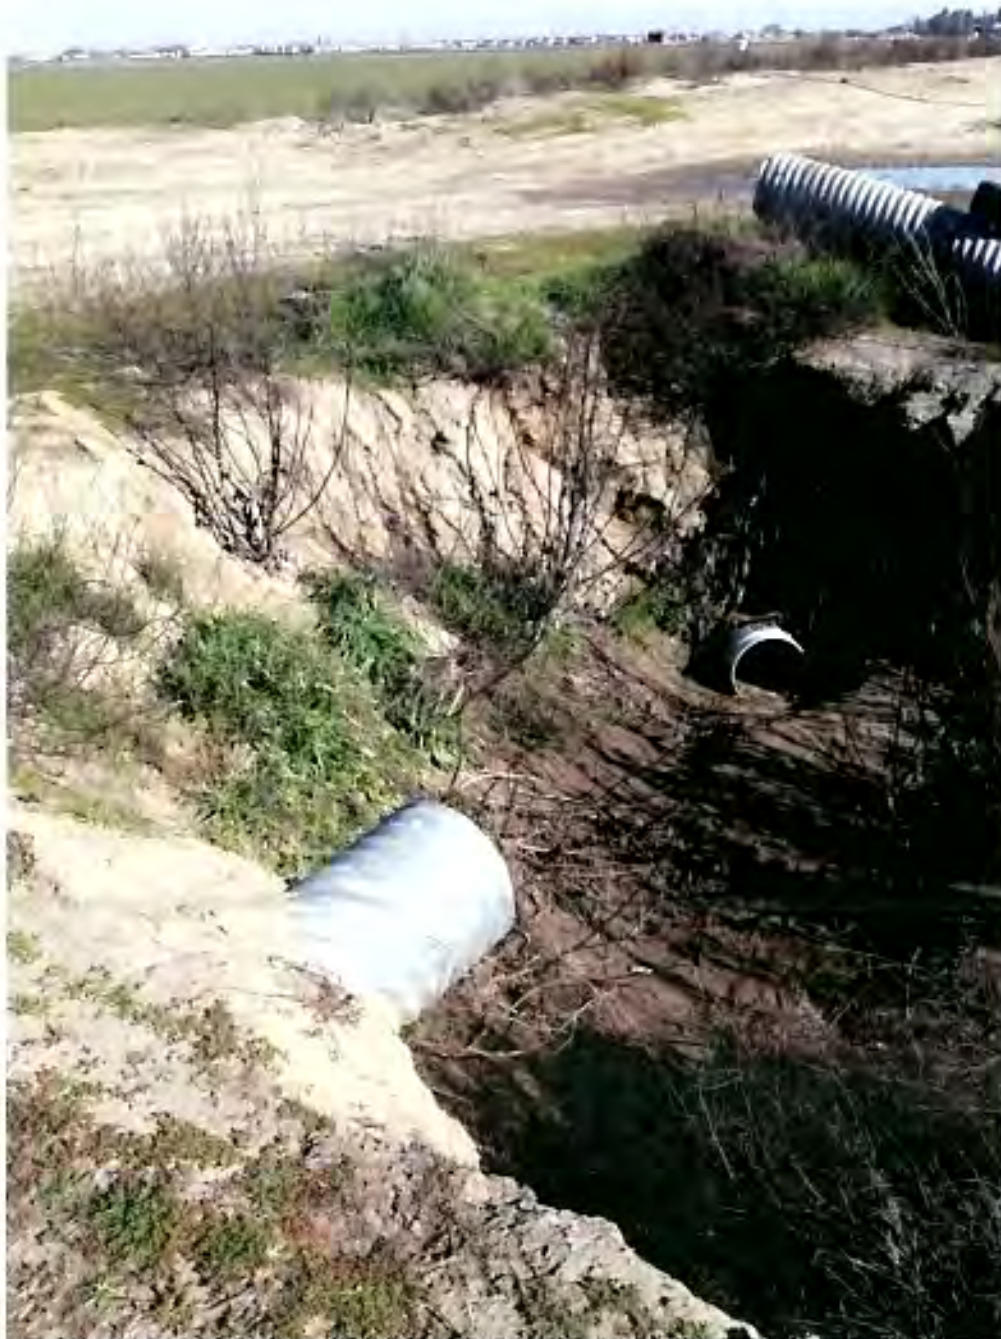
Photo 12

Description: View looking north-west from the irrigation ditch located in the center of the site. There were several ponded area located in the field seen in the background. When soil pits were dug within the ponded areas, the soils consisted of sandy soils with no hydric soil indicators. Therefore, these areas were not mapped. See January 14, 2012 Site Visit Photo Points drawing for location.

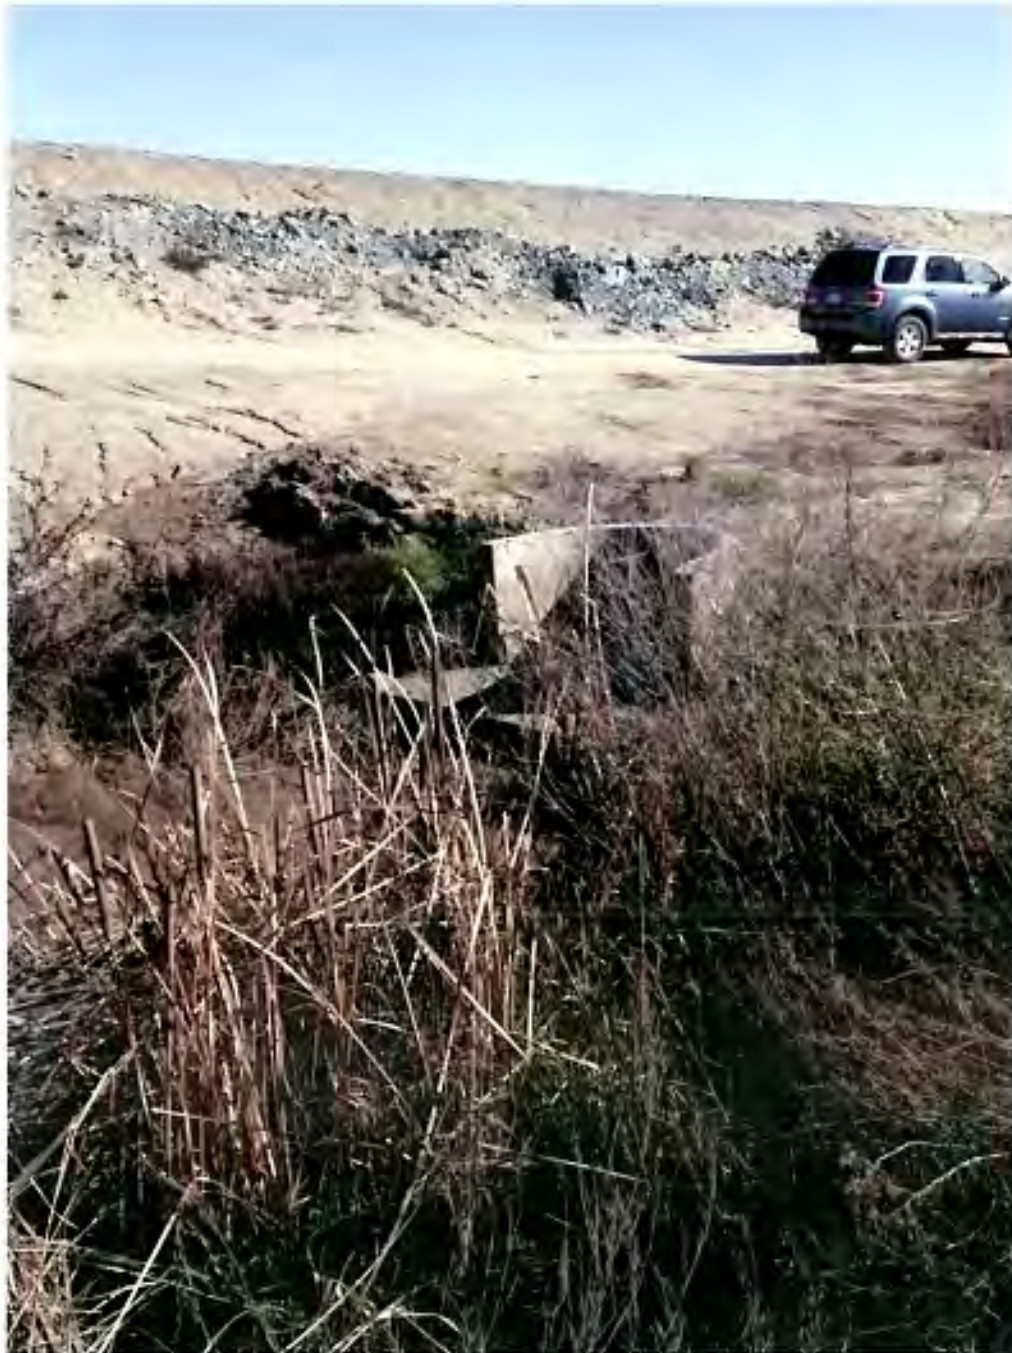
Photo 13

Description: View looking north-east at irrigation ditch that runs along the levee road. Several culverts connect this ditch along the entire length of the levee road. Water is supplied to the ditch through a pump adjacent to Walthall Slough. However, no outlets were found. See January 14, 2012 Site Visit Photo Points drawing for location.

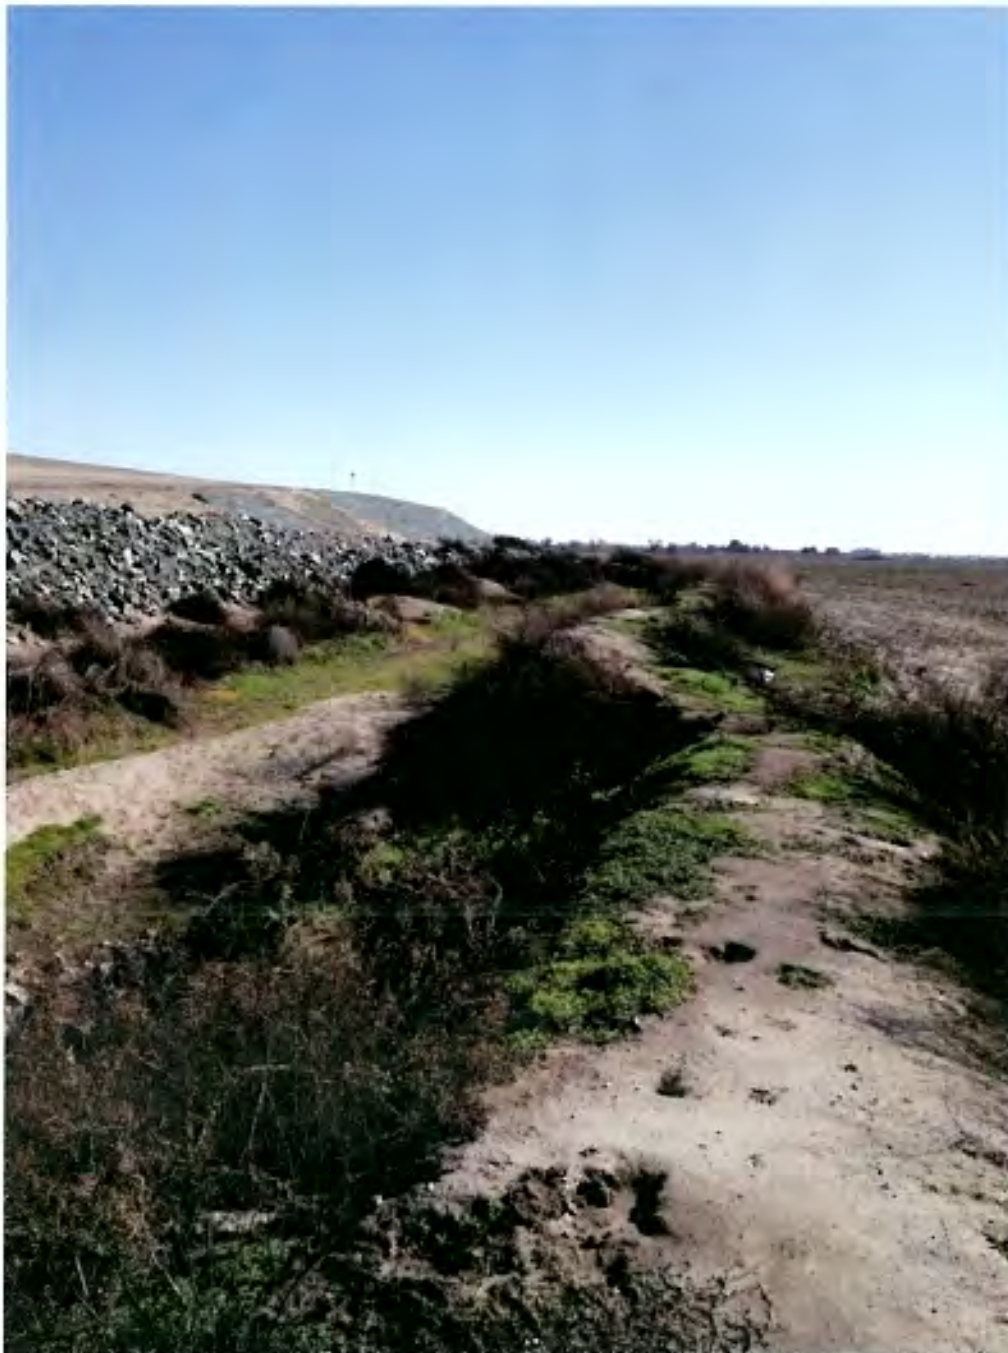
Photo 14

Description: View looking east from the levee road at the irrigation ditch that runs along the southern portion of the levee road. See January 14, 2012 Site Visit Photo Points drawing for location.

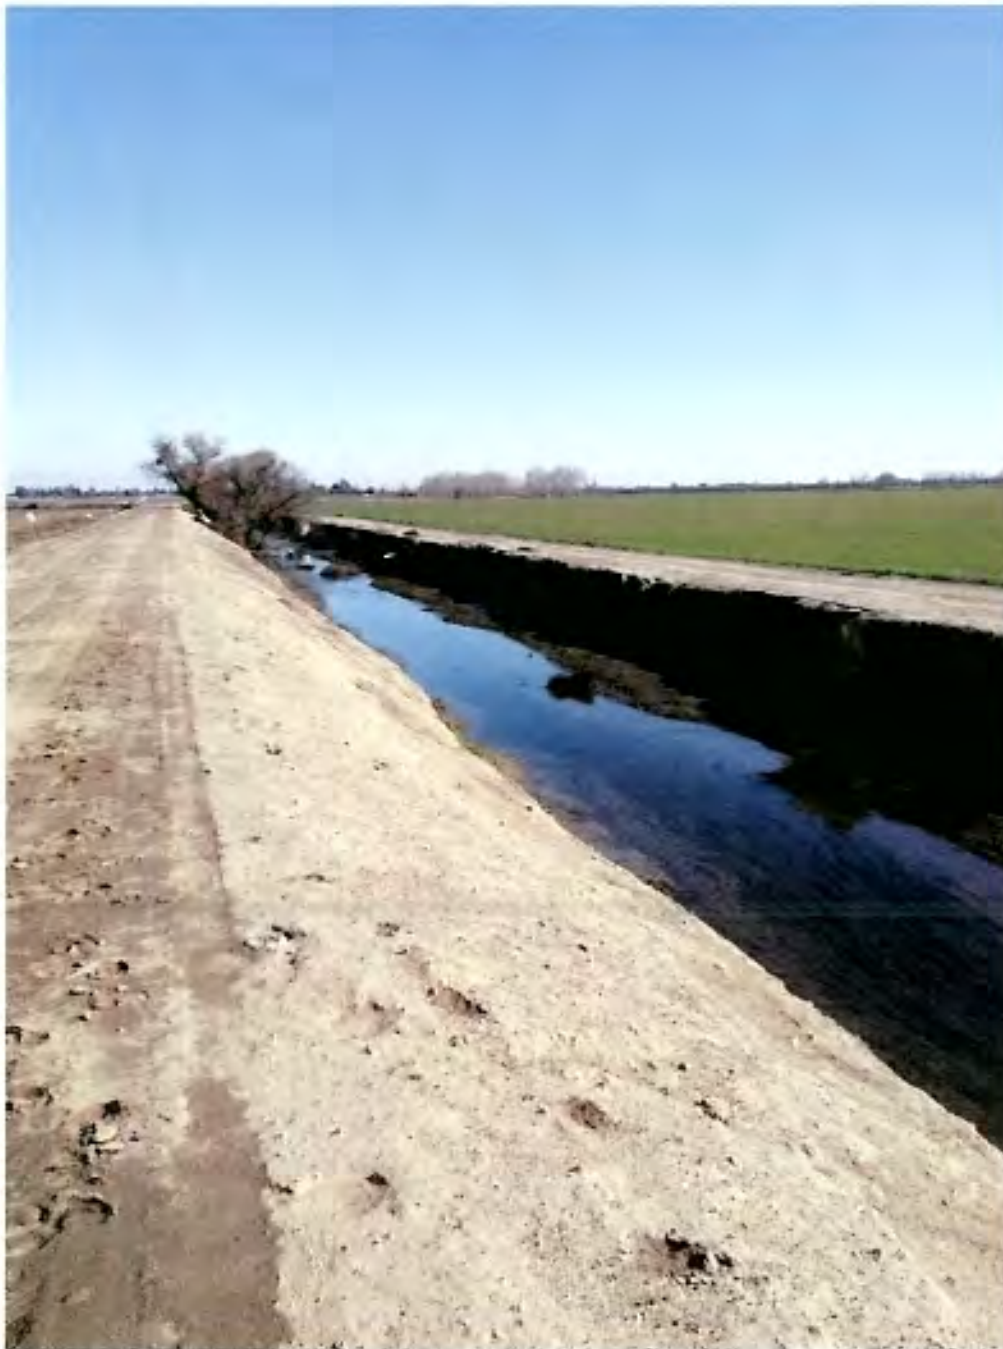
Photo 15

Description: View looking east at the irrigation ditch that runs along the southern portion of the site. See January 14, 2012 Site Visit Photo Points drawing for location.

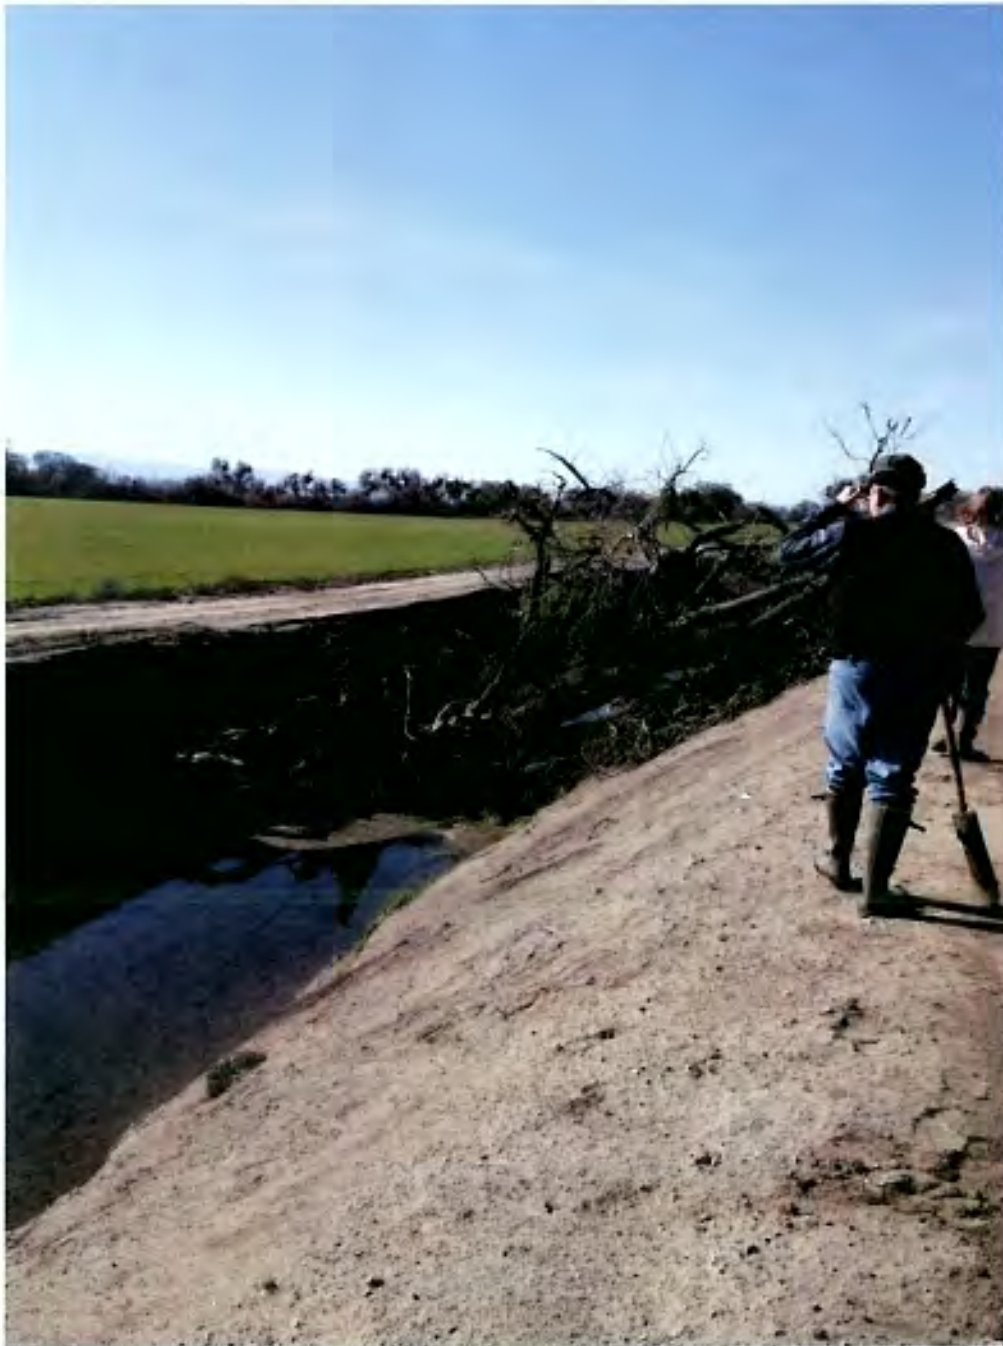
Photo 16

Description: View looking west at the irrigation ditch that runs along the southern property boundary. See January 14, 2012 Site Visit Photo Points drawing for location.
