APPROVED JURISDICTIONAL DETERMINATION FORM
U.S. Army Corps of Engineers

B. DISTRICT OFFICE, FILE NAME, AND NUMBER: Sacramento District, Trails of Manteca, SPK-2010-00901; ID-1 to ID-12

**January 14, 2013 Site Visit
Photographs**

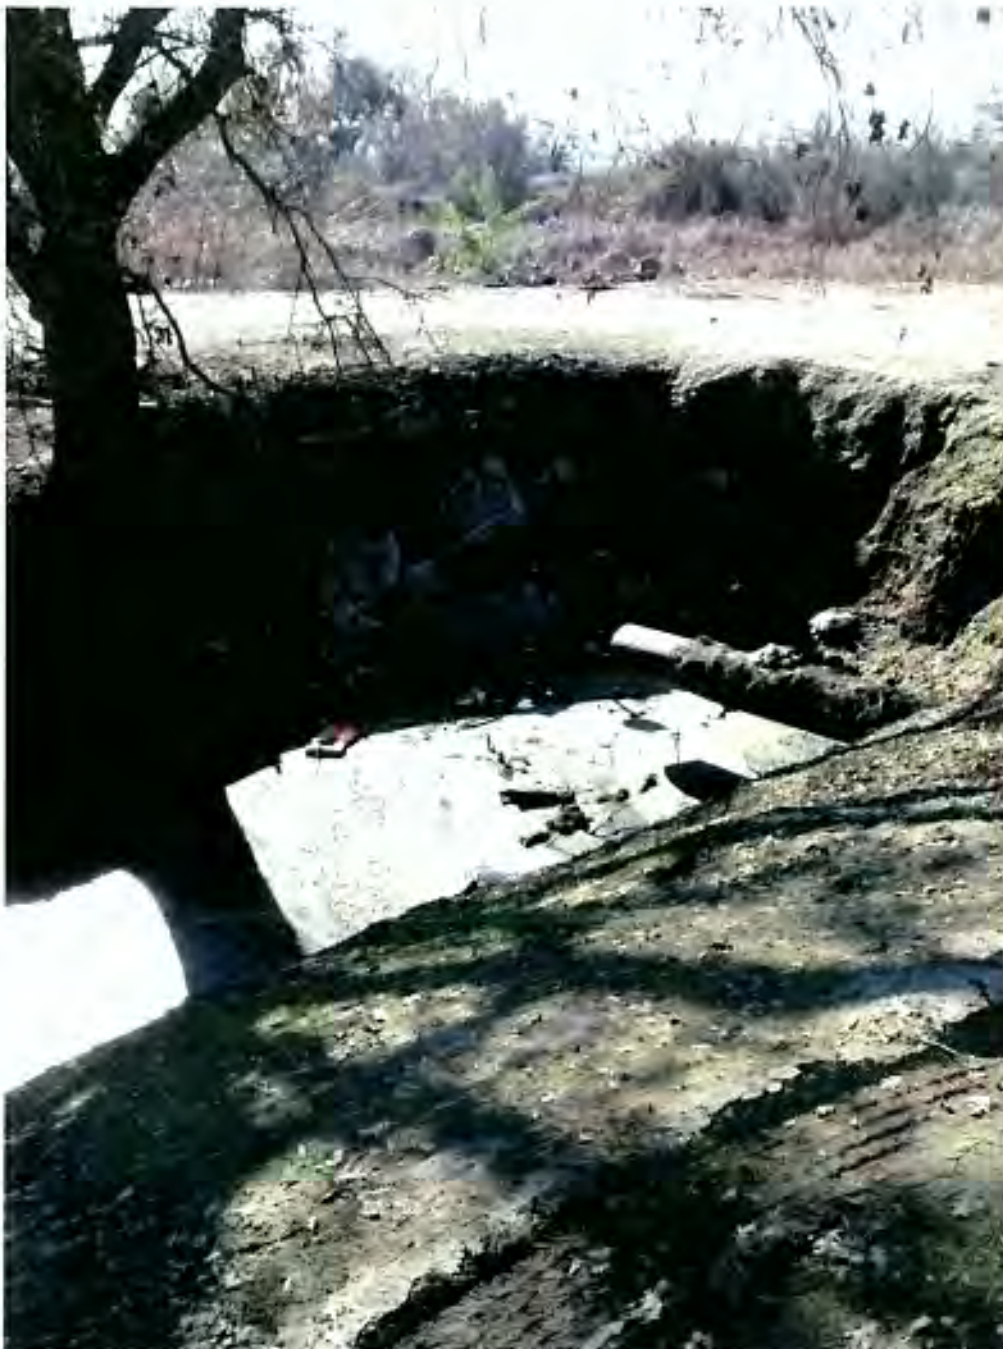
Photo 17

Description: View looking south-west at the end of the irrigation ditch that runs along the southern property boundary. Based on topographic maps from 1952, 1968 and 1976 provided by the consultant, the ditch appears to have been a stream which was previously manipulated and re-routed to its current location between 1952 and 1968, and connected to Walthall Slough. In addition, it appears as though a man-made barrier was constructed, which prevented the ditch from connecting to Walthall Slough at some time between 1968 and 196, and pumps were installed which pumped water from the ditch into the slough. During the site visit, no pumps were observed, and it does not appear as though water from the ditch is pumped into the slough. See January 14, 2012 Site Visit Photo Points drawing for location.

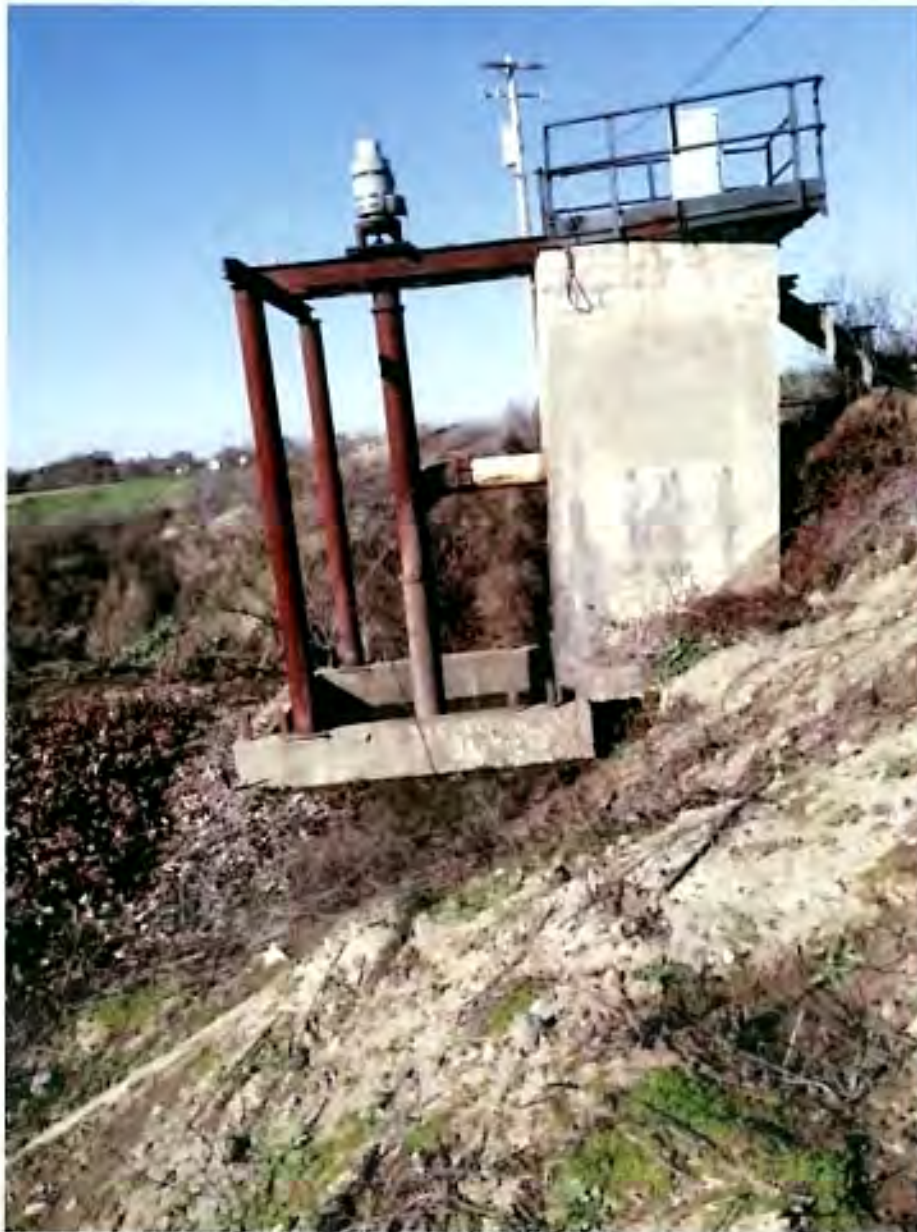
Photo 18

project site. Based on our January 14, 2013 site visit, ID-10 ends approximately 50-feet east of Walthall Slough, and no culverts or other surface or subsurface connection was found to Walthall Slough.

Description: View looking north-west at the pump along Walthall Slough. The pump delivers waters to ID1 through ID-9, ID-11 and ID-12.

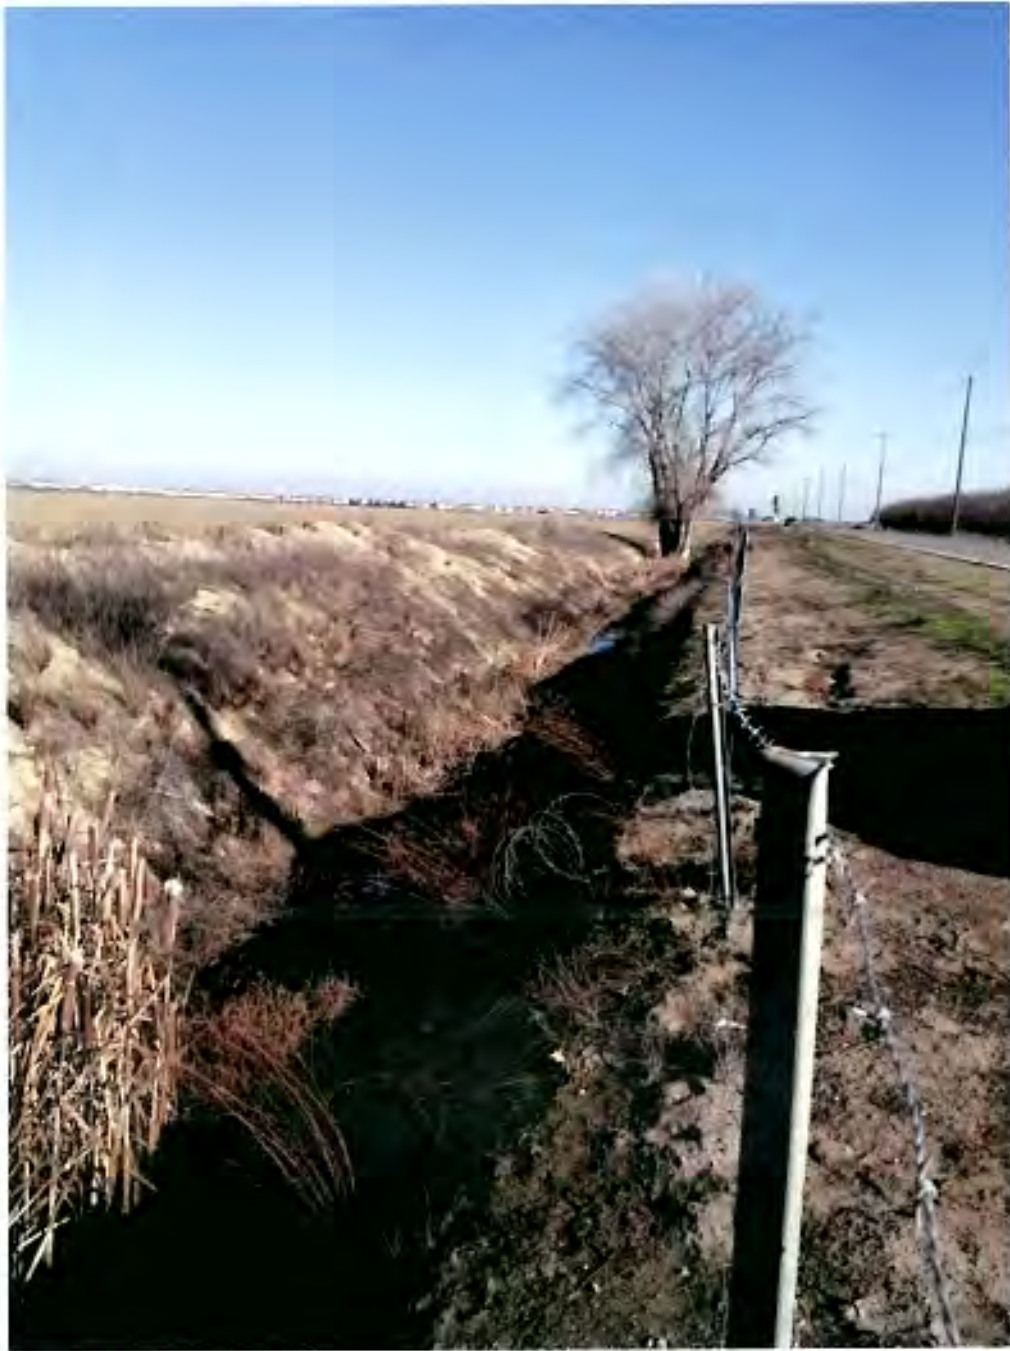
Photo 19

Description: View looking east from the north side of Woodward Avenue. To the south of Woodward Avenue is the irrigation ditch that runs along the northern boundary of the project site. There are no culverts or connections from the irrigation ditch on the south side of Woodward Avenue to the northern ditch. See January 14, 2012 Site Visit Photo Points drawing for location.
