Aquatic Resources Delineation
Additional Study Area
Bretton Woods
 City of Davis, Yolo County, California

**U.S. ARMY CORPS OF ENGINEERS
REGULATORY PROGRAM
APPROVED JURISDICTIONAL DETERMINATION FORM (INTERIM)
NAVIGABLE WATERS PROTECTION RULE**

ORM Number: [SPK-2019-00685](#).

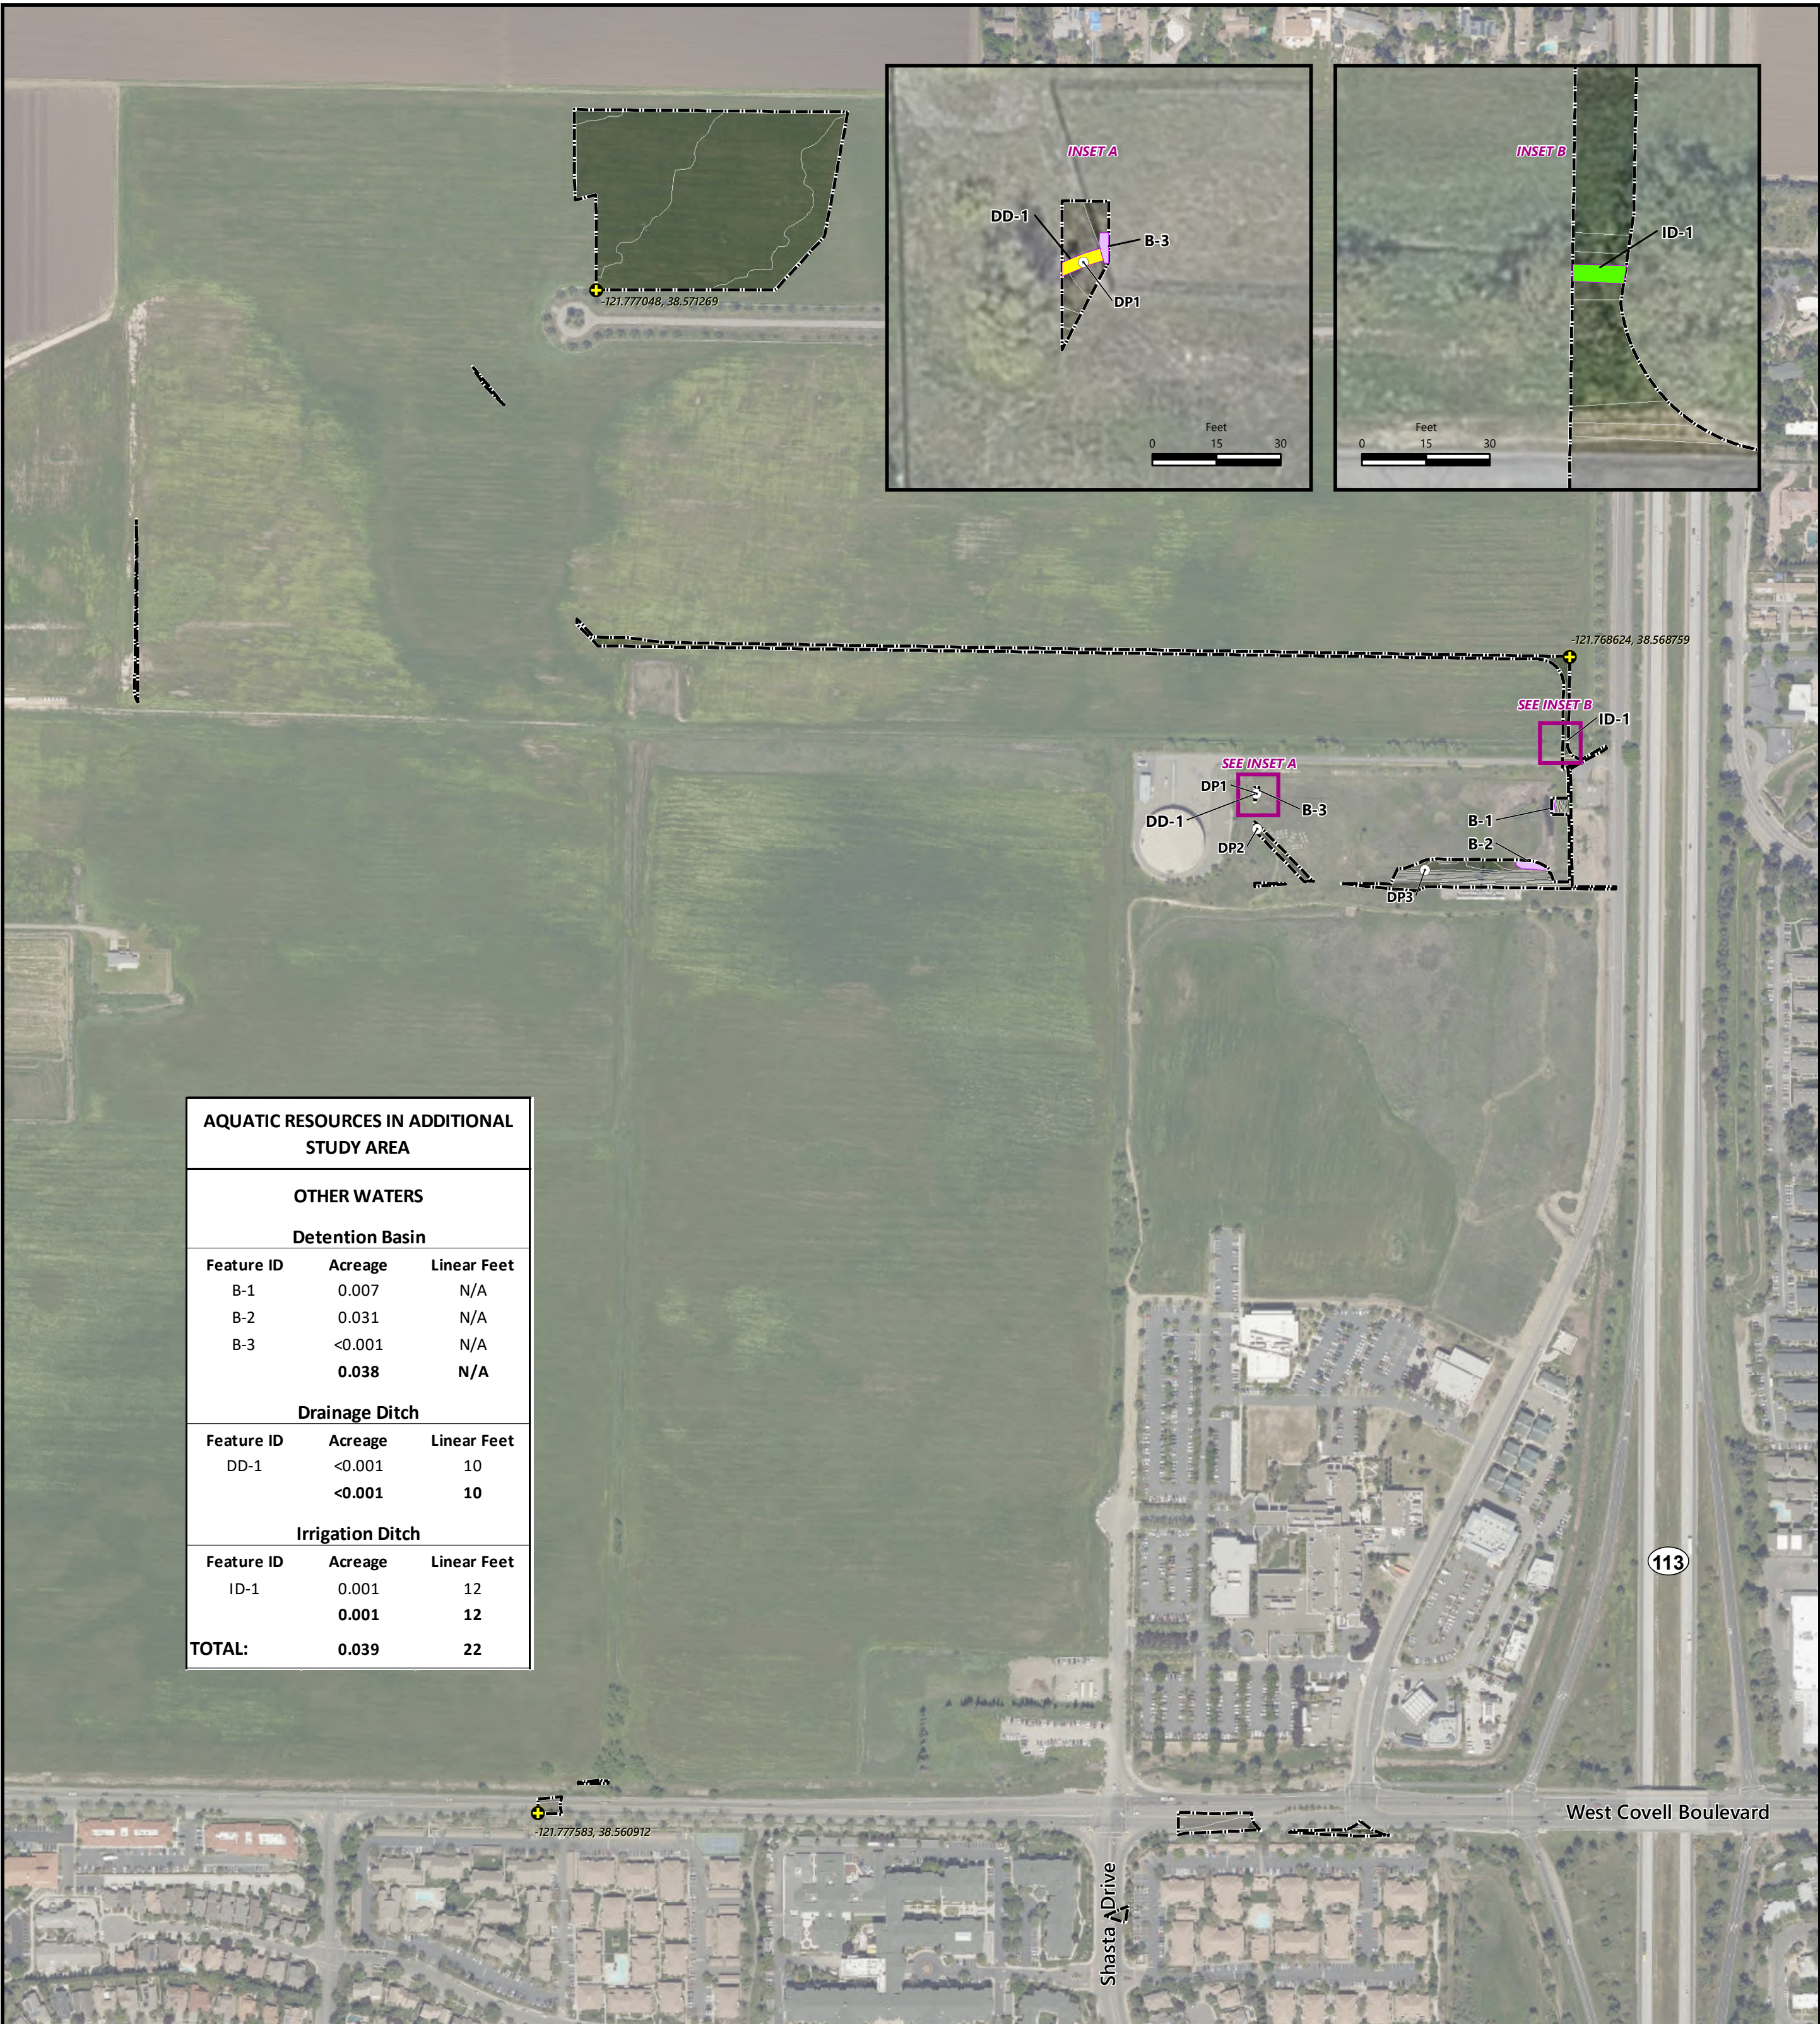
AQUATIC RESOURCES IN ADDITIONAL STUDY AREA		
OTHER WATERS		
Detention Basin		
Feature ID	Acreage	Linear Feet
B-1	0.007	N/A
B-2	0.031	N/A
B-3	<0.001	N/A
	0.038	N/A
Drainage Ditch		
Feature ID	Acreage	Linear Feet
DD-1	<0.001	10
	<0.001	10
Irrigation Ditch		
Feature ID	Acreage	Linear Feet
ID-1	0.001	12
	0.001	12
TOTAL:	0.039	22

Additional Study Area (0.039 acre)
Other Waters (0.039 acre)
 Drainage Ditch (<0.001 acre)
 Detention Basin (0.038 acre)
 Irrigation Ditch (0.001 acre)

Information submitted by, or on behalf of, the applicant/consultant: [Bretton Woods Aquatic Resources Delineation Map Addendum, prepared September 17, 2020 by Madrone Ecological Consulting](#); and [Aquatic Resources Delineation Report for West Davis Active Adult, prepared September 16, 2019 by Madrone Ecological Consulting](#).
