WEST SACRAMENTO General Reevaluation Report

**Draft Report
Documentation
Geotechnical
Appendix**

**WEST SACRAMENTO PROJECT, CALIFORNIA
GENERAL REEVALUATION REPORT**

**WEST SACRAMENTO PROJECT, CALIFORNIA
GENERAL REEVALUATION REPORT
Geotechnical Appendix**

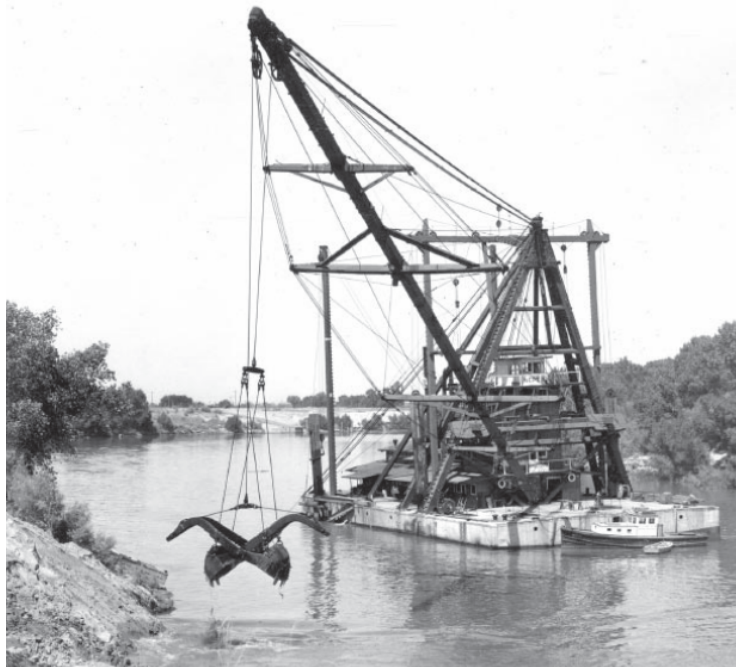
Figure 3-4: Dredge Neptune at RM 57.3 in 1942

The levees along the Sacramento River were constructed by local interests using clamshell dredges excavating material from the Sacramento River in the early 1900's. Figure 3-4 shows the Dredge Neptune placing material at RM 57.3 in 1942 during construction of the Sacramento Bank Protection Project. Figure 3-5 was taken around 1911 near Davis Road in West Sacramento and shows the recently constructed Sacramento River levee. This method of construction usually resulted in loose, sandy fill material that is deepest below the center of the levee. The current materials within the levee embankment are predominantly sands, silty sands, and cohesionless materials mainly silts and gravels. Numerous riverbank and levee waterside slope protection were constructed along the Sacramento west bank levee.

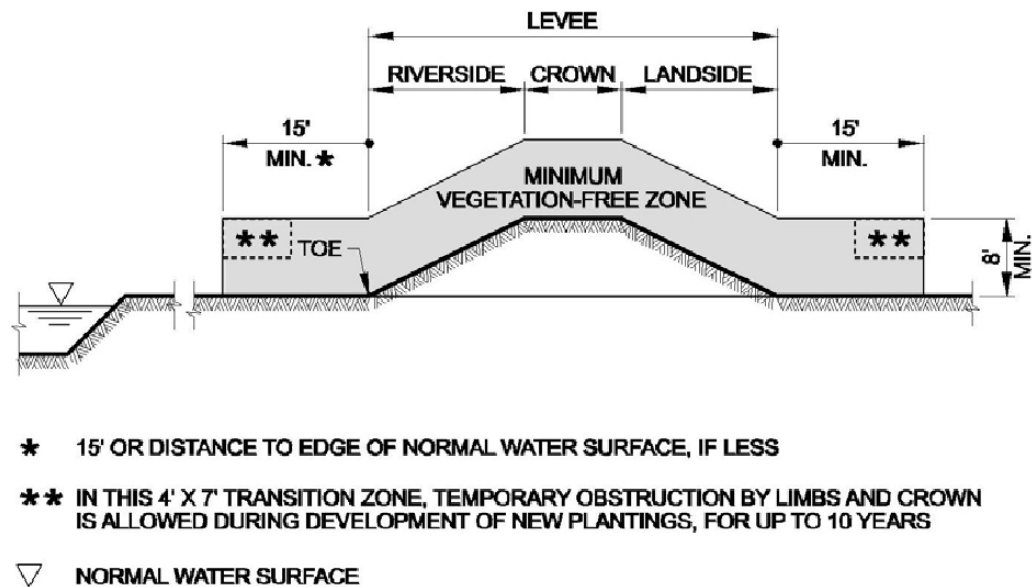
Figure 7-1: Vegetation-Free Zone of Basic Levee

Vegetation, encroachment, and access policy includes EM 1110-2-1913, SOP-003, and ETL 1110-2-571 *Guidelines for Landscaping and Vegetation Management at Levees, Floodwalls, Embankments Dams, and Appurtenant Structures*. The vegetation-free zone, as established by ETL 1110-2-571, is a three-dimensional corridor surrounding all levees, floodwalls, and critical appurtenant structures in a flood damage reduction system. The vegetation-free zone applies to all vegetation except grass. The minimum height of the corridor is 8 feet, measured vertically from any point on the ground. The minimum width of the corridor is the width of the flood-control structure (Levee toes or floodwall stem), plus 15 feet on each side, measured from the outer edge of the outermost critical structure. Figure 7-1 is a representation of the vegetation-free zone of a basic levee cross-section.

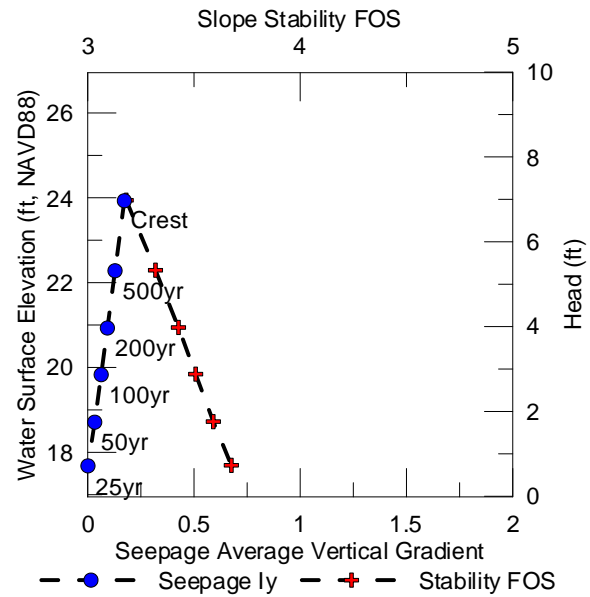
Figure 11-4: North Basin – Port North Levee – Sta. 117+37 - With Project Analyses Results

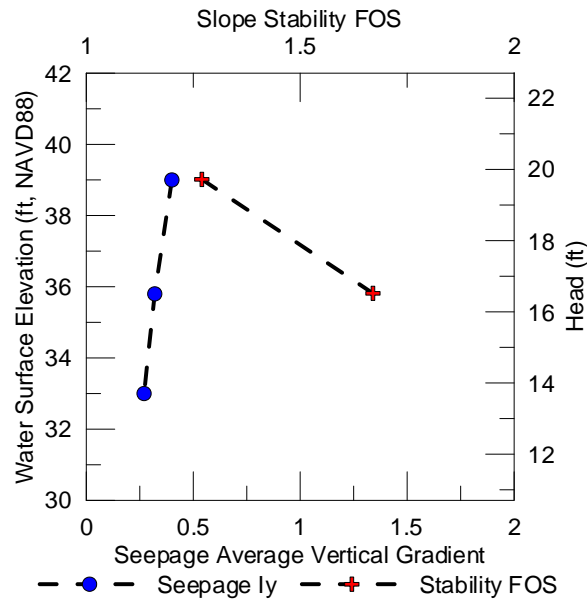
The without project conditions seepage analysis of the Sacramento Bypass South Levee Sta. 52+00 met criteria for all water surface elevations analyzed. Stability analyses showed the potential for landside slope instability with water surfaces near the crest of the embankment. Subsurface conditions and landside slopes are analogous to the analysis section at Sta. 32+00. Sacramento Bypass South Levee Sta. 52+00 was completed as part of the West Sacramento Levee System F3 Geotechnical Reevaluation Report – June 2011. The F3 report focused on locating deficiencies; as such, the report did not analyze mitigation measures. Figure 11-7 displays the without project conditions analyses results. Following review of subsurface conditions and past performance in the reach, the anticipated remedial improvement measure prescribed is a shallow cutoff wall constructed to elevation 5ft (NAVD 88).

Figure 11-7: North Basin – Sacramento Bypass South Levee – Sta. 52+00 - Without Project Analyses Results

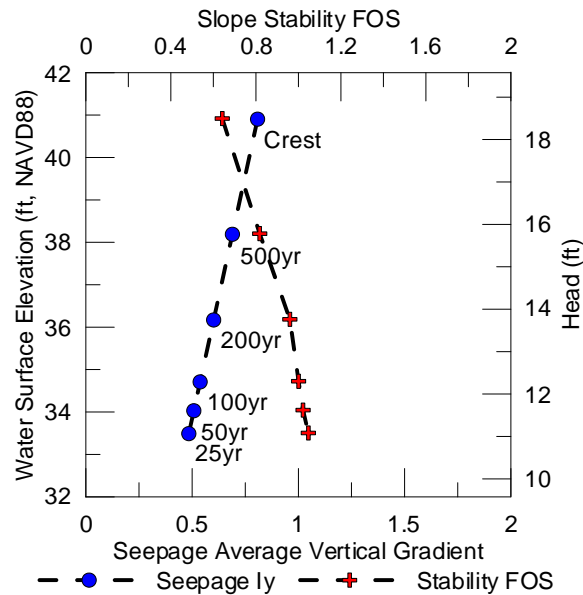
Figure 11-8: North Basin – Sacramento River West Levee – Sta. 96+00 - Without Project Analyses Results

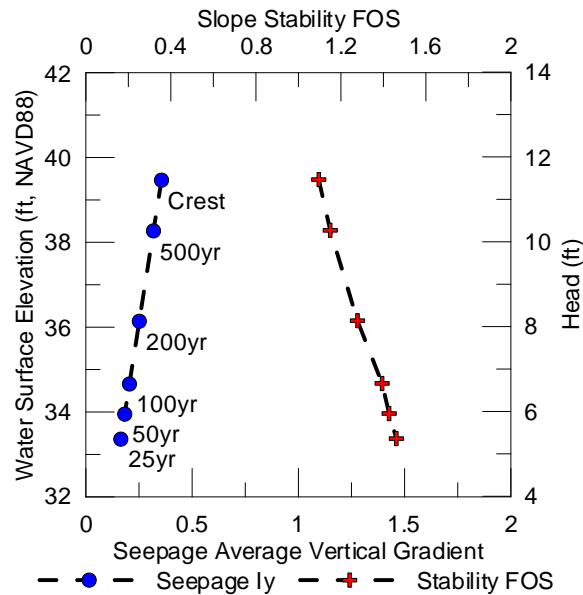
Figure 11-10: North Basin – Sacramento River West Levee – Sta. 190+00 - Without Project Analyses Results

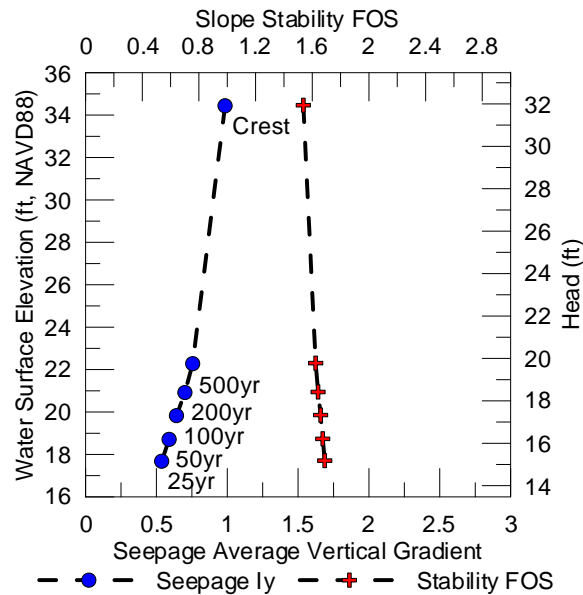
Figure 11-15: South Basin – Deep Water Ship Channel West Levee– Sta. 12+00 - Without Project Analyses Results

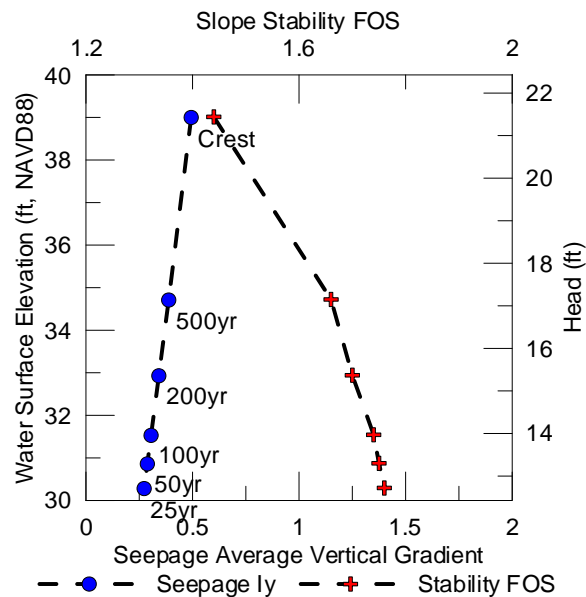
Figure 11-22: South Basin – Sacramento River West Levee – Sta. 80+00 - Without Project Analyses Results
