## **NOTICE OF AVAILABILITY**

### **Draft Environmental Assessment**

#### **Village of Hanoverton Sanitary Sewer System Project Columbiana County, OH**

### **Village of Hanoverton Sanitary Sewer System Project Hanoverton, Columbiana County, Ohio**

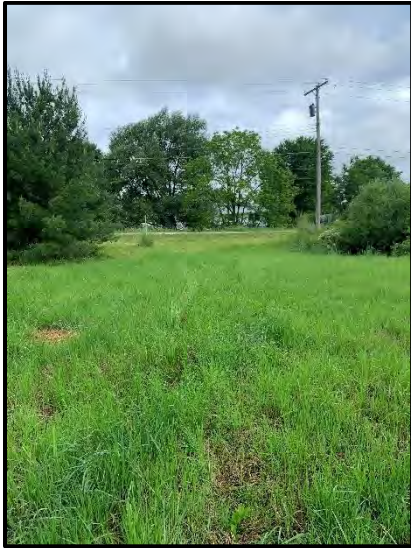
**Photo 1:** 06/08/2021 – Proposed Pump Station location, facing northwest.

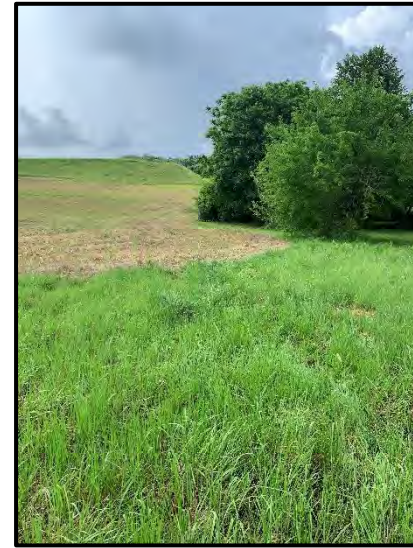
**Photo 2:** 06/08/2021 – Proposed Pump Station location, facing south.

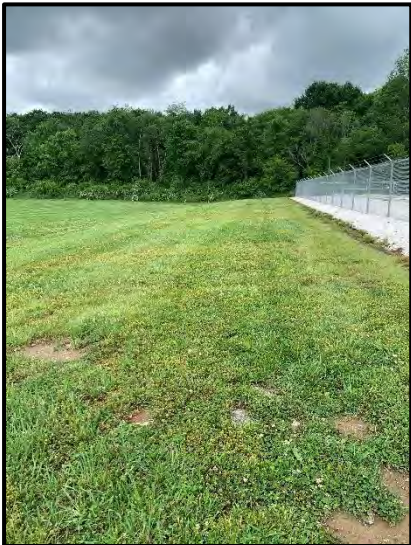
**Photo 3:** 06/08/2021 – south side of Kensington Wastewater Treatment Plant location, facing west.

The proposed sanitary sewer system project includes the construction of approximately 33,000 linear feet of 8-inch gravity sewer and 3,300 linear feet of 4-inch sanitary force main running in or along existing roads (primarily Lincoln Highway and 1<sup>st</sup> Street), and occasionally cutting through farmland to other existing roadways in the Village of Hanoverton (see Figure 2). A newly proposed pump station will be constructed to link the sewer system to the Kensington Wastewater Treatment Plant. The initial proposed location of the pump station was eliminated from evaluation due to property acquisition issues. The newly proposed pump station location is located along the Lincoln Highway on parcel #2701988.004 (Photographs 1 and 2). The proposed pump station is located between Dollar General and the neighboring property's driveway. The land is slightly sloping/flat land that is currently used for farming. The proposed pump station location is shown on Figure 1. The Kensington Wastewater Treatment Plant is located on State Route 30 just west of the Kensington Dairy Bar, as shown on Figure 1 (Photographs 3 and 4).

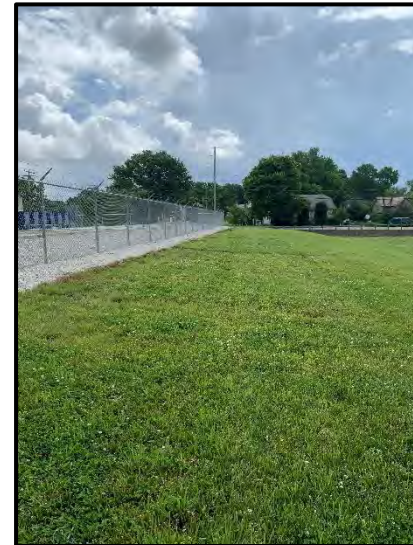
**Photo 4:** 06/08/2021 – south side of Kensington Wastewater Treatment Plan location, facing east.

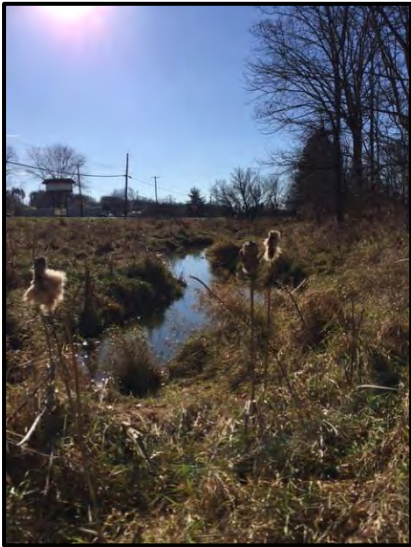
**Photo 5:** 11/18/2020 – WET-1SP, facing west.

A sampling station designated as WET-1SP (Photograph 5) was located on a flat area of the right down streambank of Sandy Creek in the area between Campbell Road and Canal Street

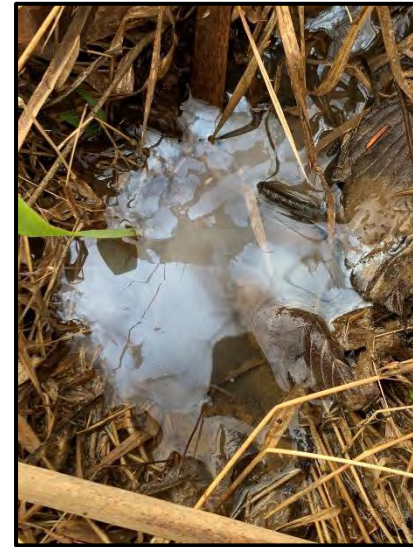
**Photo 6:** 11/24/2020 – WET-1, Iron present in surface water.

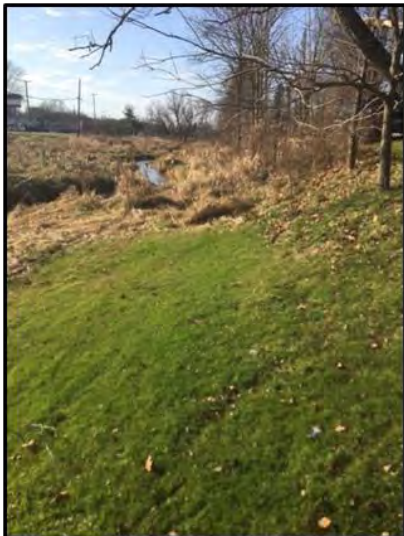
**Photo 7:** 11/18/2020 – WET-1/2UP, facing west.

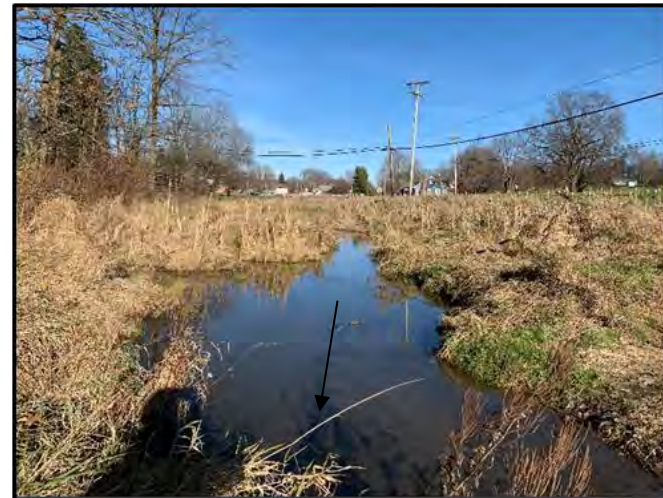
**Photo 8:** 11/18/2020 – WET-1, Sandy Creek (STREAM-2), and WET-2, facing east.

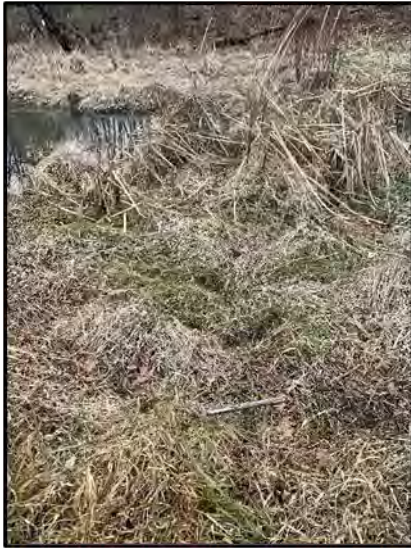
**Photo 9:** 11/24/2020 – WET-2SP, facing north.

WET-2SP lies on a flat area of the left downstream bank of Sandy Creek which lies at the bottom of the roadside slope of Canal Street. Stormwater runoff flows down this roadside slope off Canal Street to this flat area, along with being periodically inundated by Sandy Creek at times of flooding. The soil was saturated at the ground surface at the sampling point location with pockets of standing water. Primary hydrologic indicators included the presence of surface water, a high-water table, and saturation. Iron deposits were observed in standing water (Photograph 10). Secondary hydrologic indicators included the geomorphic position and the FAC-Neutral Test. WET-2SP met the wetland criteria for hydrology.

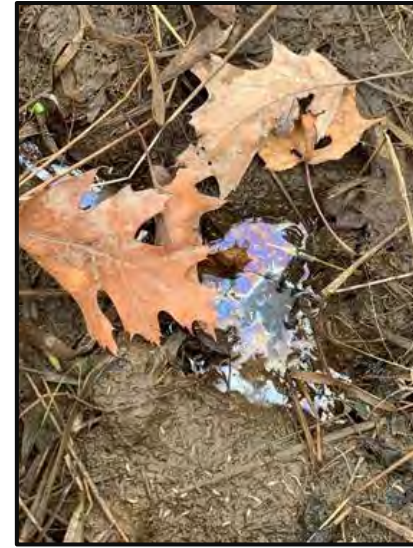
**Photo 10:** WET-2, Iron present in surface water.

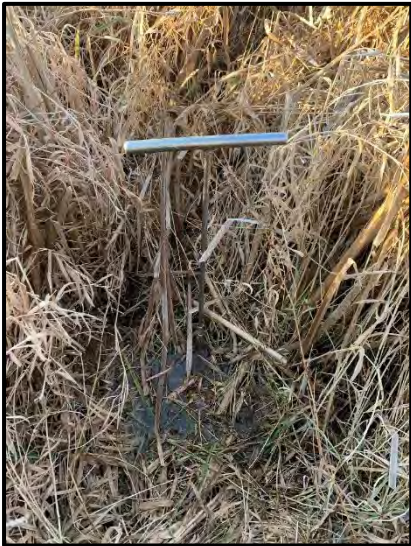
**Photo 11:** 11/24/2020 – WET-3SP.

A sampling station designated as WET-3SP (Photographs 11 and 12) was located at the edge of the roadside slope of Lincoln Highway at the edge of the proposed sewer line buffer (Figure 8).

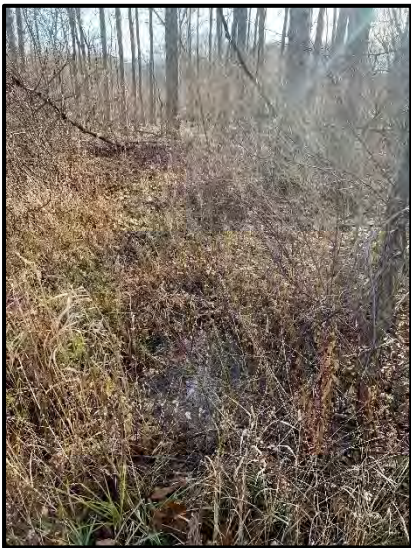
**Photo 14:** 11/24/2020 – WET-4SP, facing east.

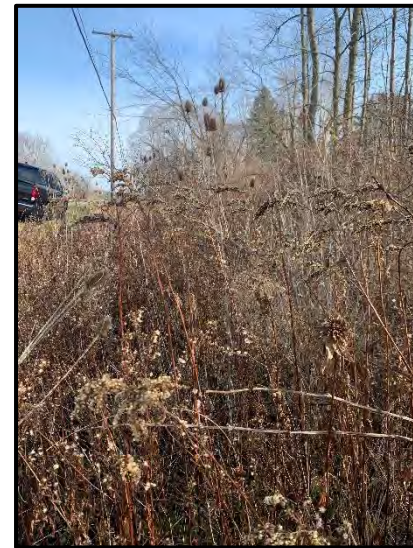
**Photo 15:** 11/24/2020 – Standing water observed near WET-4SP, facing south.

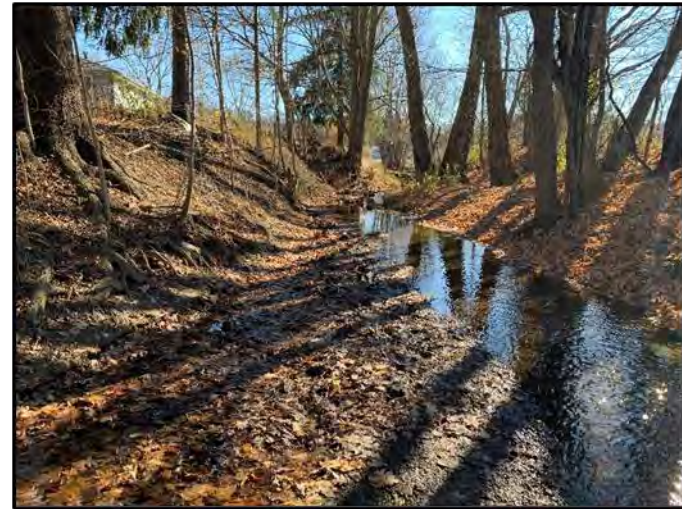
**Photo 21:** 06/08/2021 - Drainage channel adjacent to proposed pump station study area, facing east.

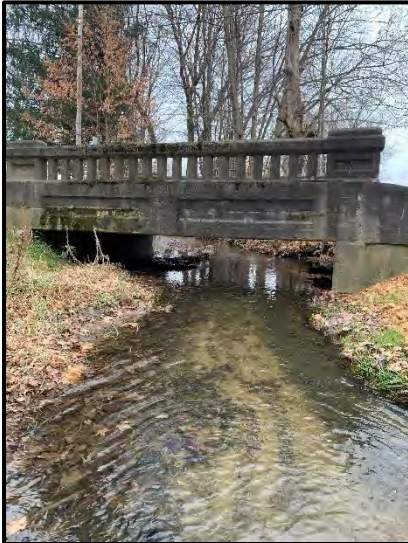
**Photo 23:** 11/24/2020 – STREAM-1, sample point location, facing north at Campbell Road.

A sampling station was designated as STREAM-1SP (Photographs 22 and 23) and was located near the proposed sewer line crossing the stream under a bridge on Campbell Road. This sample point was chosen as a representative section of the stream. A QHEI Field Sheet was completed for STREAM-1. STREAM-1 received a final score of 56.

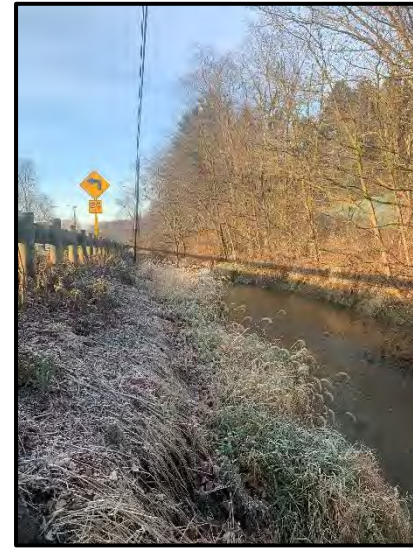
**Photo 26:** 11/24/2020 – STREAM-2 (Sandy Creek), flowing parallel to the Lincoln Highway at the edge of the study area, facing west.

During the site walk and based on the desktop analysis, a stream was identified running parallel to the Lincoln Highway at the edge of the study area, as shown in Figure 7, 8, 10, and 11 (Photograph 26). STREAM-2 is identified as Sandy Creek within the Tuscarawas (05040001) basin watershed. STREAM-2 crosses the proposed sewer line at three locations. This stream crosses the proposed sewer line in the area between Canal Street and Campbell Road and crosses underneath the bridge structure carrying Canal Street (Photographs 27 and 28). The stream crosses the proposed sewer line again under the bridge structure carrying 1<sup>st</sup> Street (Photographs 29 and 30). The stream had flowing water throughout the entire length of the project area at the time of the site visit. The evaluation findings for STREAM-2 are presented below.

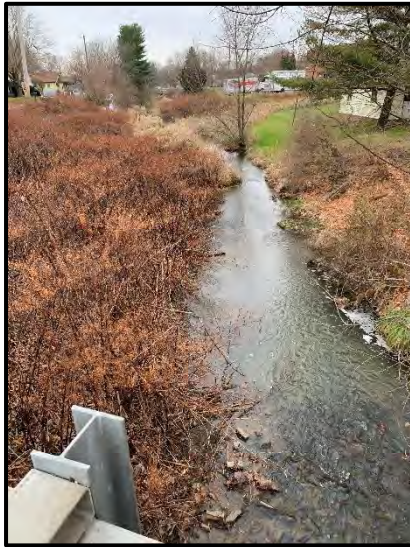
**Photo 29:** 11/24/2020 – STREAM-2SP location, crossing under bridge carrying 1<sup>st</sup> Street, facing west.

A sampling station was designated as STREAM-2SP (Photographs 29 and 30) and was located near the proposed sewer line crossing the stream under a bridge structure carrying 1<sup>st</sup> Street. This sample point was chosen as a representative section of the stream. A QHEI Field Sheet was completed for STREAM-2SP. STREAM-2SP received a final score of 54.

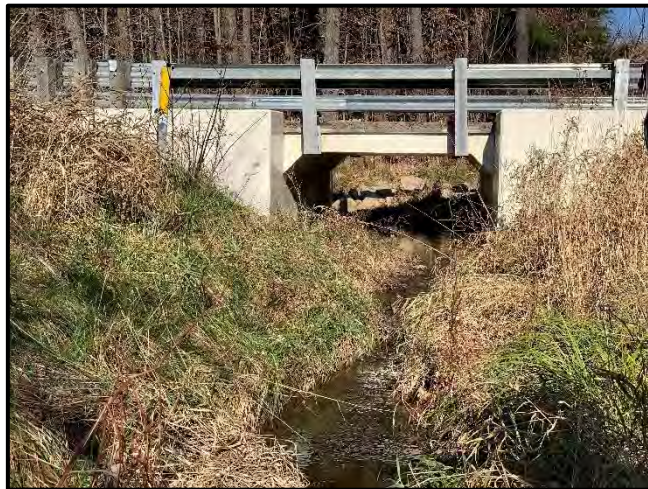
**Photo 31:** 11/20/2020 – STREAM-3SP location, facing north towards Cemetery Road.

A sampling station designated as STREAM-3SP (Photographs 31 and 32) crossed the study area under a bridge structure carrying Cemetery Road. This sample point was chosen as a representative section of the stream. A HHEI form was completed for STREAM-3SP. STREAM-3SP received a final score of 66.

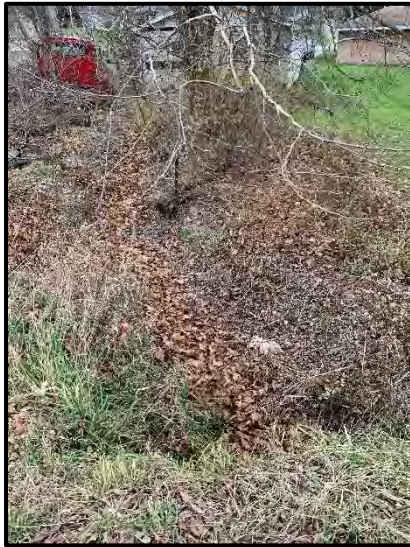
**Photo 33:** 11/20/2020 – STREAM-4SP location, facing north from Lincoln Highway.

A sampling station was designated as STREAM-4SP (Photographs 33 and 34) and located at the edge of the Lincoln Highway pavement. This sample point was chosen as a representative section of the stream. A HHEI form was completed for STREAM-4SP. STREAM-4SP received a final score of 34.

The stream flowed south into a concrete headwall. The stream channel was approximately 4.5 feet wide (top of bank to top of bank) and two feet deep (top of bank to toe of bank) with no flow at the time of evaluation. The substrate consisted of mostly cobble, gravel, and leaf debris. Both banks were steep with some erosion present. The stream was shaded by 90 percent open canopy. The location of this stream sampling station is shown as STREAM-4SP on Figure 12.

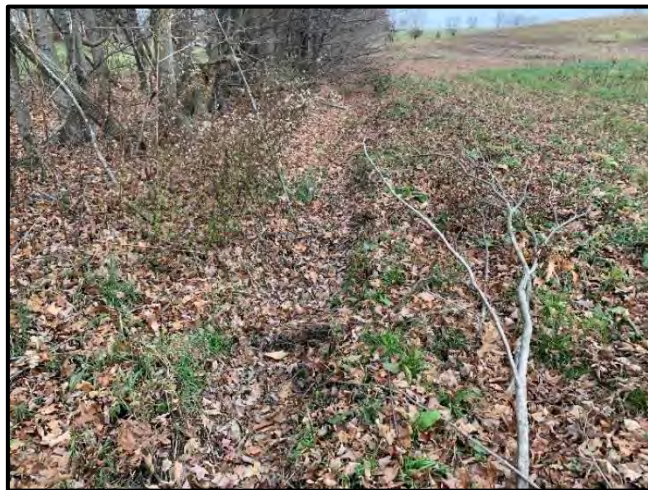
**Photo 35:** 11/20/2020 – STREAM-5, within sample location reach, facing north.

bed and bank was observed (Photographs 35 through 37). The channel appeared to end near the edge of the field and tree line. The channel flows south through the field at times of heavy precipitation and meets with a culvert that discharges into Sandy Creek within the Tuscarawas (05040001) basin watershed. The evaluation findings for the STREAM-5 are presented below.

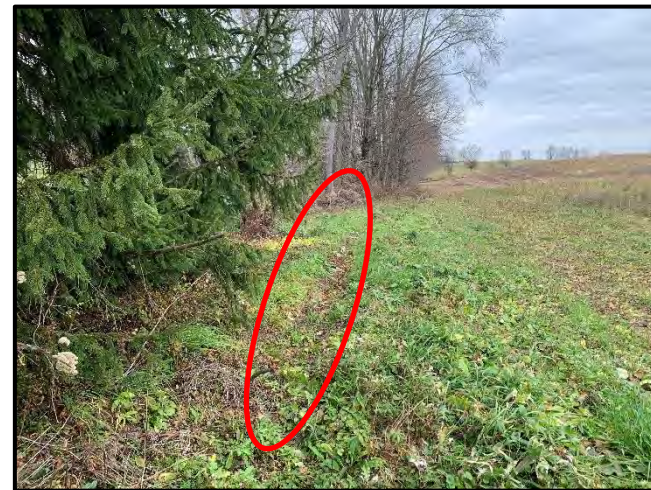
**Photo 36:** 11/20/2020 – STREAM-5SP location, facing north.

STREAM-5 flows south at the edge of the field, parallel to the tree line in a with minimal sinuosity. The stream channel at the sample point was approximately three feet wide (top of bank to top of bank) and 0.5 feet deep (top of bank to toe of bank) with no water flow at the time of observation. The predominant substrate types present consisted of silt and leaf pack/woody debris, with some gravel and sand present. Both banks were flat with the tree line parallel to the right bank and the field on the left bank. The stream was shaded by 90 to 100 percent open canopy. The location of this stream sampling station is shown as STREAM-5SP on Figure 13.

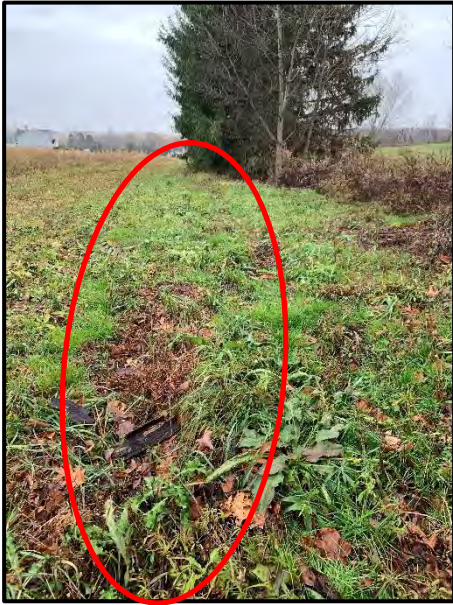
**Photo 37:** 11/25/2020 – STREAM-5, channel appears to end at the end of tree line, facing south.

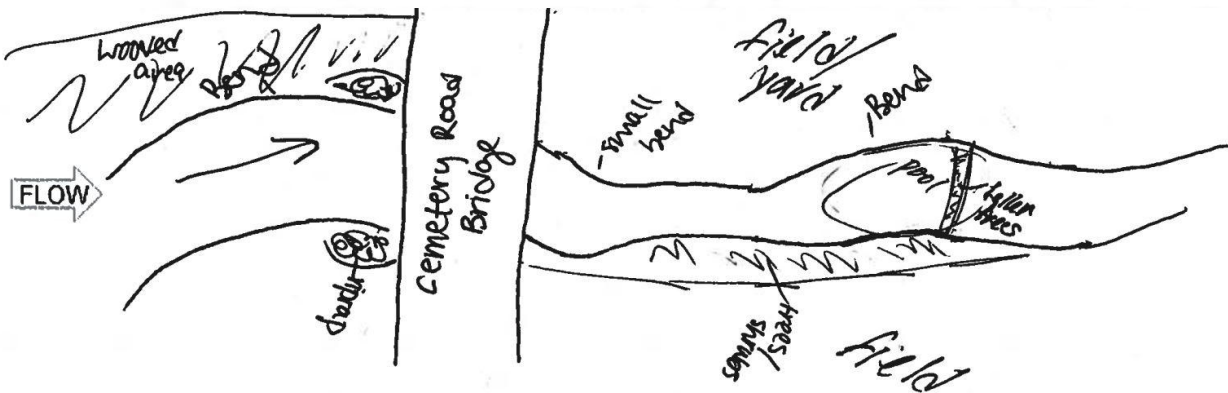
Stream-3 crosses under the bridge on Cemetery Road approximately 180 feet west from the intersection of Cemetery Road and 2nd Street.

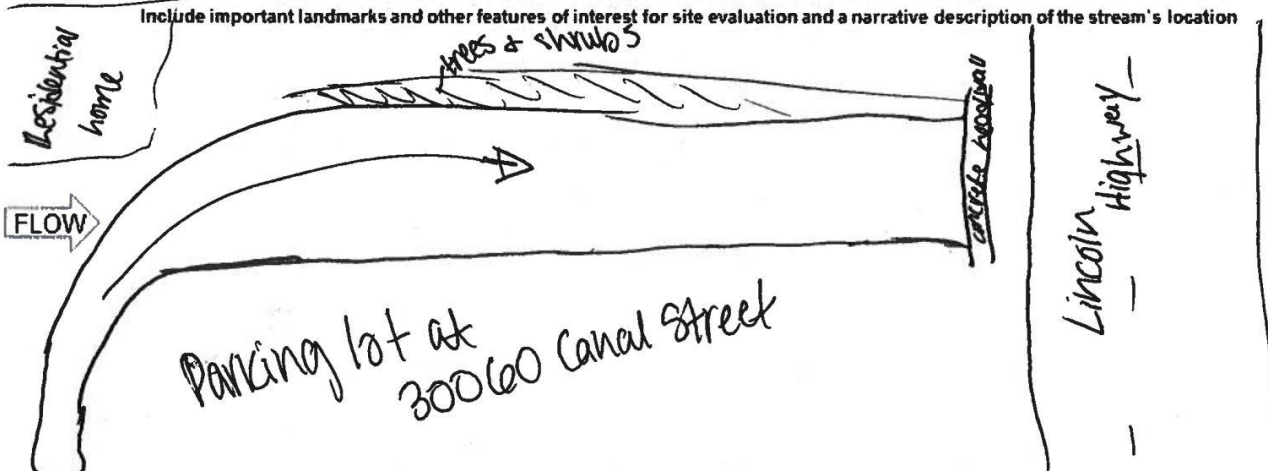
No water or flow at the time of evaluation. Stream-4 located adjacent to 30060 Canal Street- flows into concrete headwall at edge of pavement of Lincoln Highway.
