Murrells Inlet Special Area Management Plan

Contract M-3-959

Final Report from SCDNR

October 2005

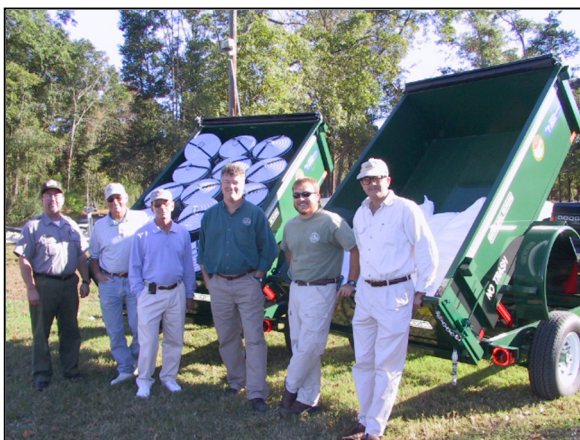
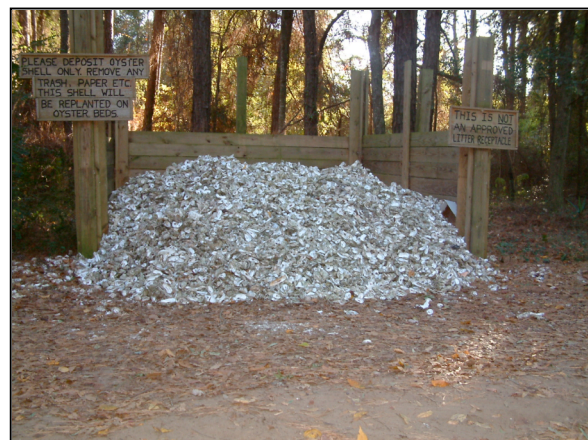
Figure 1. Murrell's Inlet 2007 volunteers receive dump trailers from SCDNR (left). Shell recycling drop-off center at Huntington Beach State Park (right).

SCDNR had previously established a shell drop-off station at Huntington Beach State Park, which proved to be the most productive drop-off site in the state. Expansion of the Murrells Inlet recycling program included the capability to pick up shells from nine participating local restaurants by using two hydraulic dump trailers as drop-off stations. SCDNR purchased the two trailers and transferred ownership to Murrells Inlet 2007, a nonprofit community revitalization group. One trailer was stationed at Cedar Hill landing and the other at the Garden City/Murrells Inlet Fire Station (both on Highway 17, Business, Murrells Inlet). Using the dump trailers, a Murrells Inlet 2007 volunteer collected discarded shells from restaurants participating in the shell recycling program. The restaurants are: The Admiral's Flagship, Capt. Dave's Dockside Restaurant, Bovine's/Divine Fish House, Drunken Jack's Restaurant and Lounge, Inlet Crab House, Seafare Seafood Restaurant, Russell's Seafood Grille, Dead Dog Saloon and Flo's Place. Fifteen 20 gallon Herculiner® coated galvanized containers were distributed to the participating restaurants for shell collection and loading into the hydraulic dump trailers. The restaurants also received window decals with the oyster recycle logo and "We Participate in SCDNR's Oyster Shell Recycling Program—You should too!" and the telephone number of Murrells Inlet 2007. Murrells Inlet certified shellfish dealers and seafood retail outlets were provided with 1,200 oyster bags with printed shell recycling logo and "Complete the Cycle—Recycle Your Shells". The recycling program was featured in a MI 2007 newsletter, in local newspapers and on local television. SCDNR has made a commitment to use shells collected by town volunteers for oyster restoration and enhancement projects in the Murrells Inlet estuary.

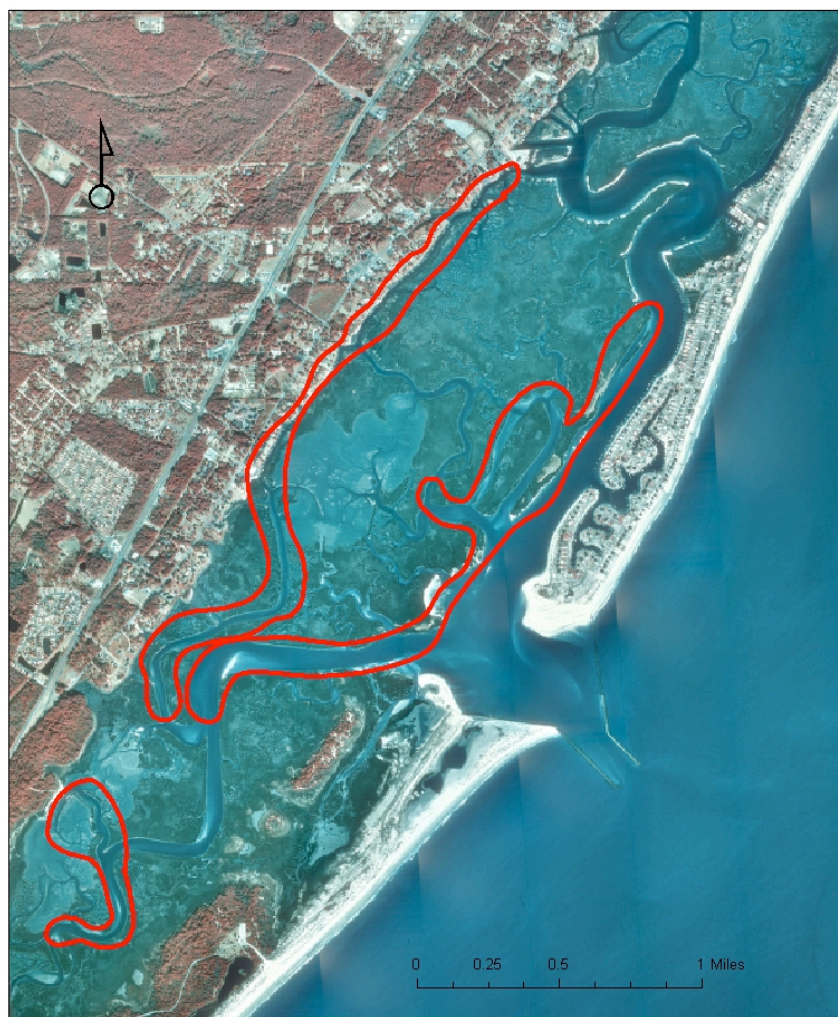
Figure 2. Survey areas in Murrell's Inlet.

In early 2004, waterways in the BROOKGREEN NE Quarter Quad were surveyed to evaluate location, size and general condition of oyster beds (Figure 2). Existing oyster beds were compared to those identified in the most recent survey conducted in 1984. A total of 249 oyster beds were identified, of which 145 were 'new' compared to the previous survey. Many of these new beds are probably the result of one oyster reef becoming fragmented into multiple smaller reefs. Some of the differences may also be due to increased accuracy/resolution available when using GPS survey equipment. Approximately half of the identified beds were surveyed with GPS equipment that is accurate to less than a meter to quantify location, size and shape of the beds. The remainder of the beds were qualitatively assessed using the strata system developed by OFM for the previous survey. Assessments were augmented with video footage of some banks as part of a ground-truthing effort related to mapping state oyster resources with remote sensing.

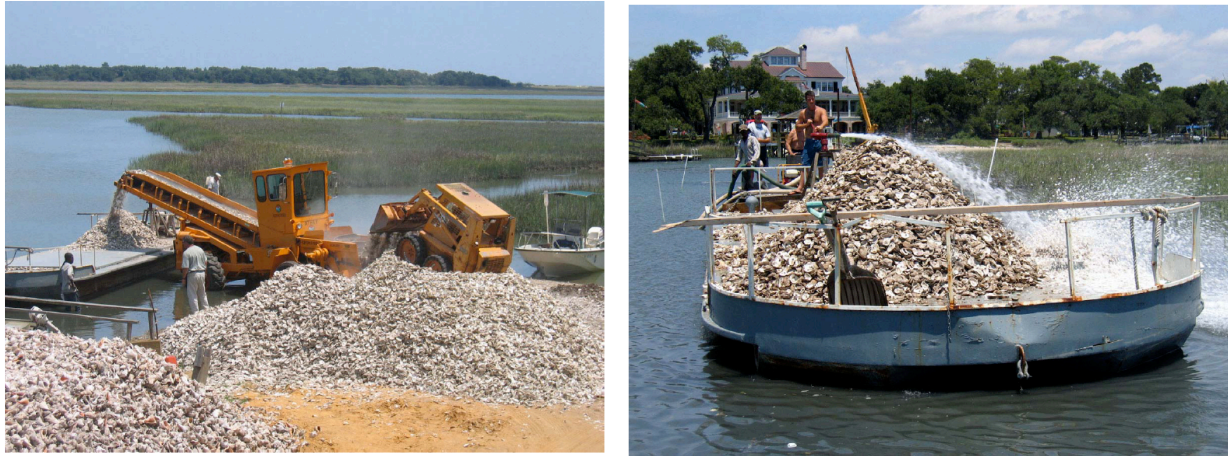
Figure 3. DNR equipment loads shell aboard a contractor's barge (left). High pressure water is used to blow the shells onto the shoreline (right).

Although updated survey information was not yet available, two areas of the Inlet were planted in late summer 2003 based on previous determinations of need. These included State Shellfish ground S-354 (Brookgreen), which is under administrative closure, and Public Shellfish Ground R-351 (Clam Bank Flats), which is classified as conditional by SCDHEC. In 2004, planting locations were based on survey results (see previous section) and logistical considerations. Planting sites were in Oaks Creek (S-354), Woodland Creek (S358), Parsonage Creek (undesignated SSG classified as Conditional) and Allston Creek (undesignated SSG classified as Restricted). In 2005, shell was planted at Drunken Jack Island (S357) and Woodland Creek (S358). These plantings were conducted by private contractor under SCDNR supervision with SCDNR equipment being used to move the shell from storage areas and load the barge.

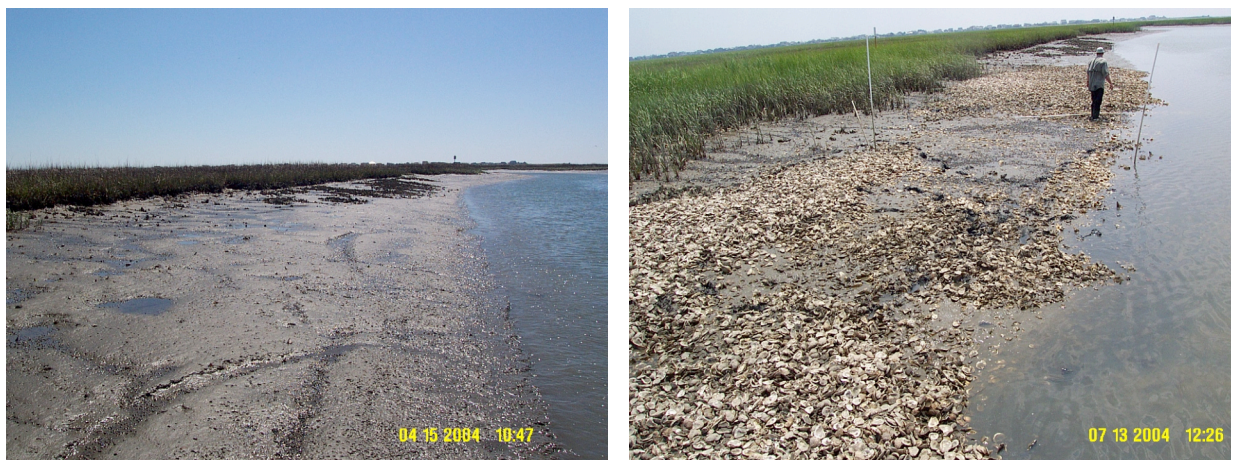
Figure 4. Shoreline in Parsonage Creek before and after shell planting.

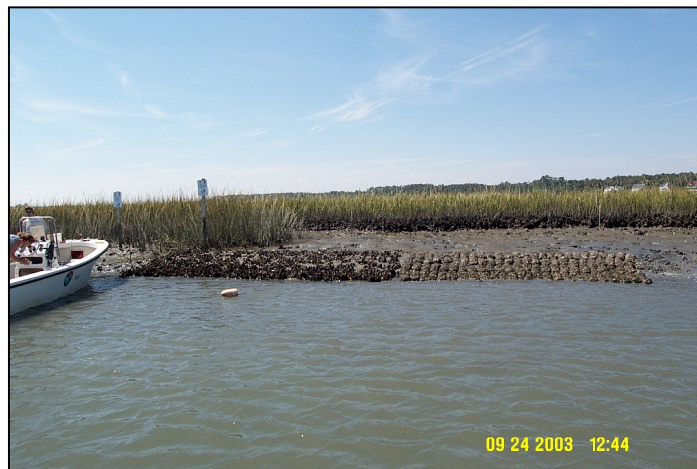
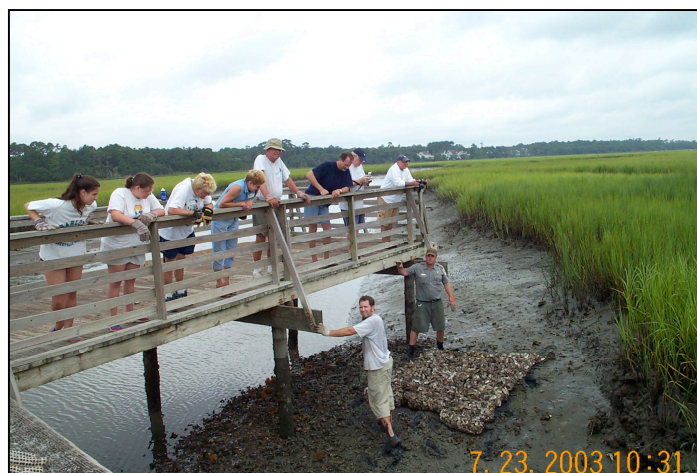
Figure 5. SCORE reefs in Oaks Creek (top) and at Huntington Beach State Park (bottom).

During July and August 2003, volunteers assisted DNR staff in constructing five small-scale oyster reefs in Murrells Inlet. SCORE reefs are constructed of mesh bags filled with oyster shells. A reef typically has 100 bags, each holding ³/₄ bushel of shell. DNR typically constructs three reefs at a site, allowing scientific replication. Approximately 30 volunteers filled shell bags at Huntington Beach State, including a group from Georgetown Marine Institute and many from Friends of Huntington Beach State Park. The bags were used to build three reefs in Oaks Creek and two reefs adjacent to the educational pier at Huntington Beach State Park (see Figure 5, right). At the State Park, uncontained shell was used to create two reference areas for comparison. Approximately 20 volunteers assisted with the reef construction in the park. In

Oaks Creek the three reefs were positioned adjacent to reefs constructed by the SCORE program in 2001 to provide more information on reef development over time and among years (Figure 5, left). The Oaks Creek project required transporting the bags in boats, which were provided by volunteers. Approximately ten volunteers with two boats assisted in the reef building in Oaks Creek.

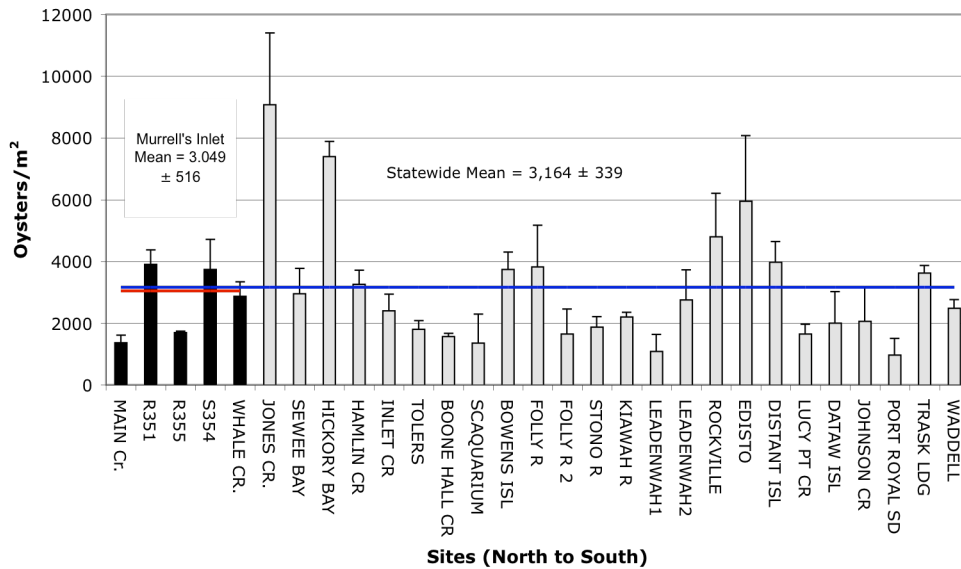
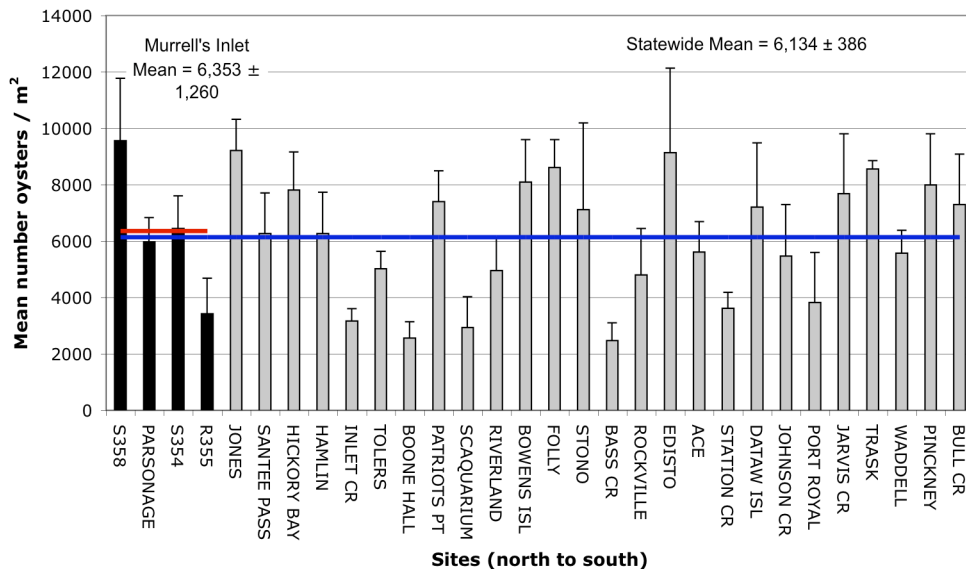
Figure 8. Statewide oyster recruitment for 2003-04 and 2004-05. Darker columns are Murrell's Inlet sites.

Oyster recruitment at a number of sites in Murrell's Inlet was compared with other sites statewide in 2003-04 and 2004-05. This recruitment analysis using shell trays helps SCDNR evaluate relative replenishment and/or restoration potential of oyster grounds to assist in management decisions. In 2003-04, the average recruitment at five Murrell's Inlet sites was 3,049 oysters/m² (289 oysters/ft²) compared with a statewide (31 sites) mean of 3,164 oysters/m² (300 oysters/ft²). Three Murrells Inlet sites had recruitment equal to or greater than the statewide average, but the other two sites (Main Creek and Oaks Creek R355) had lower than average recruitment (Figure 8, top). The 2004-05 statewide recruitment average was the highest we have observed since adopting the shell tray method in 1998. The mean recruitment from 30 sites statewide was 6,194 oysters/m² (586 oysters/ft²). The average recruitment at the four Murrells Inlet sites was slightly higher than the state average at 6,454 oysters/m² (611 oysters/ft²) but, as in the previous year, the recruitment at Oaks Creek R355 (Clambank Landing) was less than the statewide average (Figure 8, bottom). Overall, recruitment in Murrell's Inlet appears to be high enough to adequately populate newly planted shell.

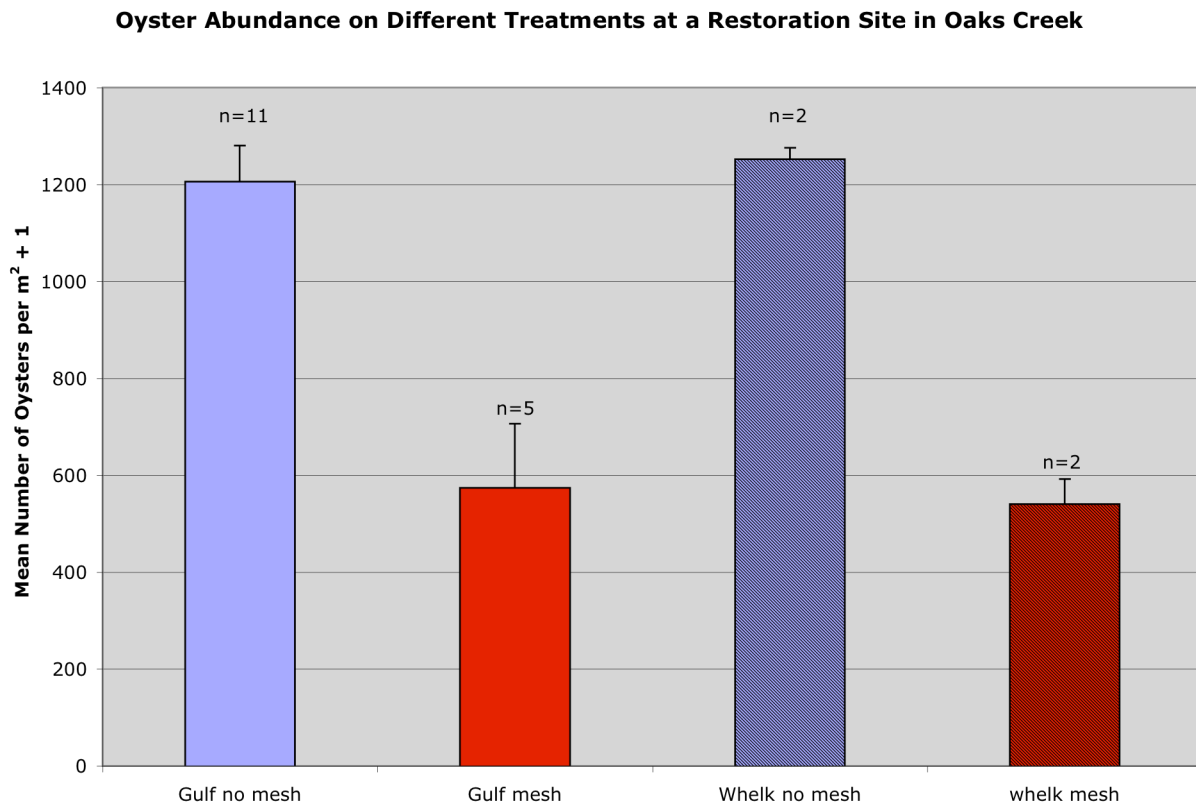
Figure 9. Oyster density at 2002 Oaks Creek large-scale restoration site when sampled in Fall 2004.

In November 2004 we sampled both large-scale reefs constructed in previous years in Oaks Creek. The large-scale site planted in 2002 in Oaks Creek included shell treatments (Gulf and Whelk) and mesh treatments (mesh and no mesh). In Fall 2004 the average oyster density in 20 samples was 987 oysters/m² (93 oysters/sq. ft.). The mean size of the oysters in all samples was 42.8 mm. When sampled, plots that had been designed to be planted with whelk shell had as much as 50% Gulf shell and vice versa. The abundance of oysters on unmeshed plots was twice as high as that on meshed plots. Average recruitment on unmeshed plots was 1,213/m² (115/sq. ft.) vs. only 564/m² (53/sq. ft.) on meshed plots (Figure 9). This is probably attributable to the fact that meshed areas, while effective at stabilizing shell, were associated with increased siltation. The mesh may be actually trapping sediment, or the reduction in shell movement may allow more silt to settle from the water column.

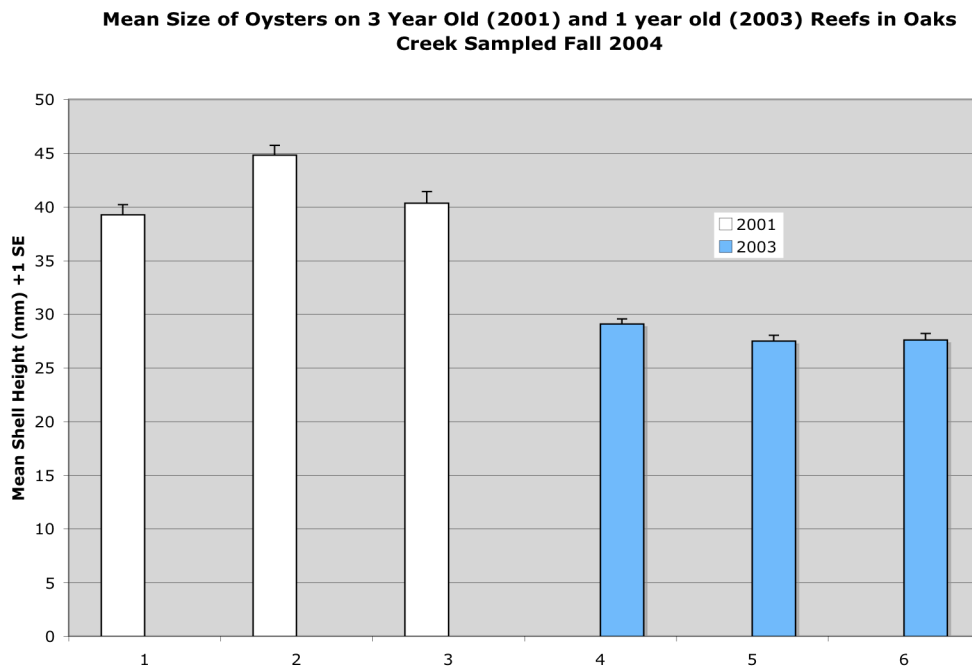
Figure 11. Mean size of oysters on 1 year old and three year old SCORE reefs at Murrell’s Inlet.

The mean size of oysters on the SCORE reefs was 41.5 mm (1.6”) and 28.0 mm (1.1”) on three year old and two year old reefs, respectively (Figure 11). This is the largest mean size observed on three year old reefs at five SCORE sites sampled Fall 2004 and the second largest mean size observed on 1 year old reefs (Table 2). The mean size on three year old reefs (41.5 mm = 1.6”) is similar to that on the adjacent large-scale two year old reefs (42.8 mm = 1.7”). We have observed at other sites that the mean size on two year old reefs is similar to that on older reefs. We interpret this to indicate that the older reefs are continuing to recruit smaller oysters as well as retaining the larger size classes. This is confirmed by evaluation of the size frequency distribution on the 1 year old and 3 year old reefs, which indicates good survival as evidenced by the larger size classes on the older reefs (Figure 12). There are substantially more oysters in the larger size classes on the three year old (2001) reefs than on the one year old (2003) reefs. There is demonstrable evidence of multiple year classes on the older reefs, a major criterion for sustainability.
