HYDRAULIC CONCERNS 2021 AND 2022

Jon Hendrickson

Regional Technical Specialist
Mississippi Valley Division

February 2022

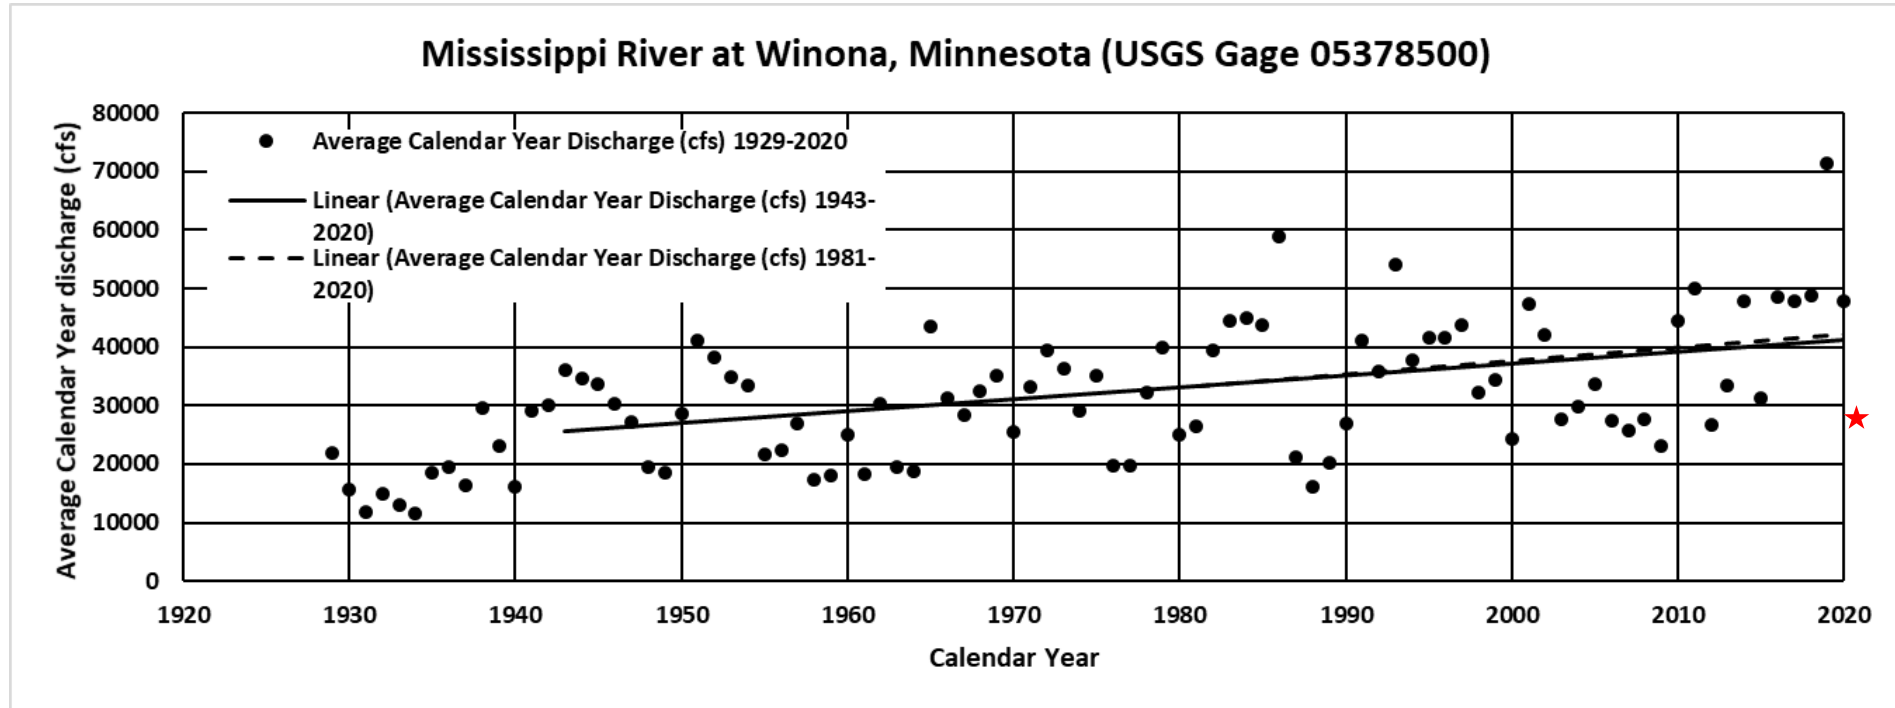
MISSISSIPPI RIVER

Average Calendar Year Discharge at Winona

1943 to 1980 = 28,950 cfs

1981 to 2020 = 37,820 cfs (30 % increase)

2016, 2017, 2018, 2019, 2020 = 48,700, 47,960, 48,900, 71,520, 47,850 cfs

2010 to 2020 is wettest decade on record

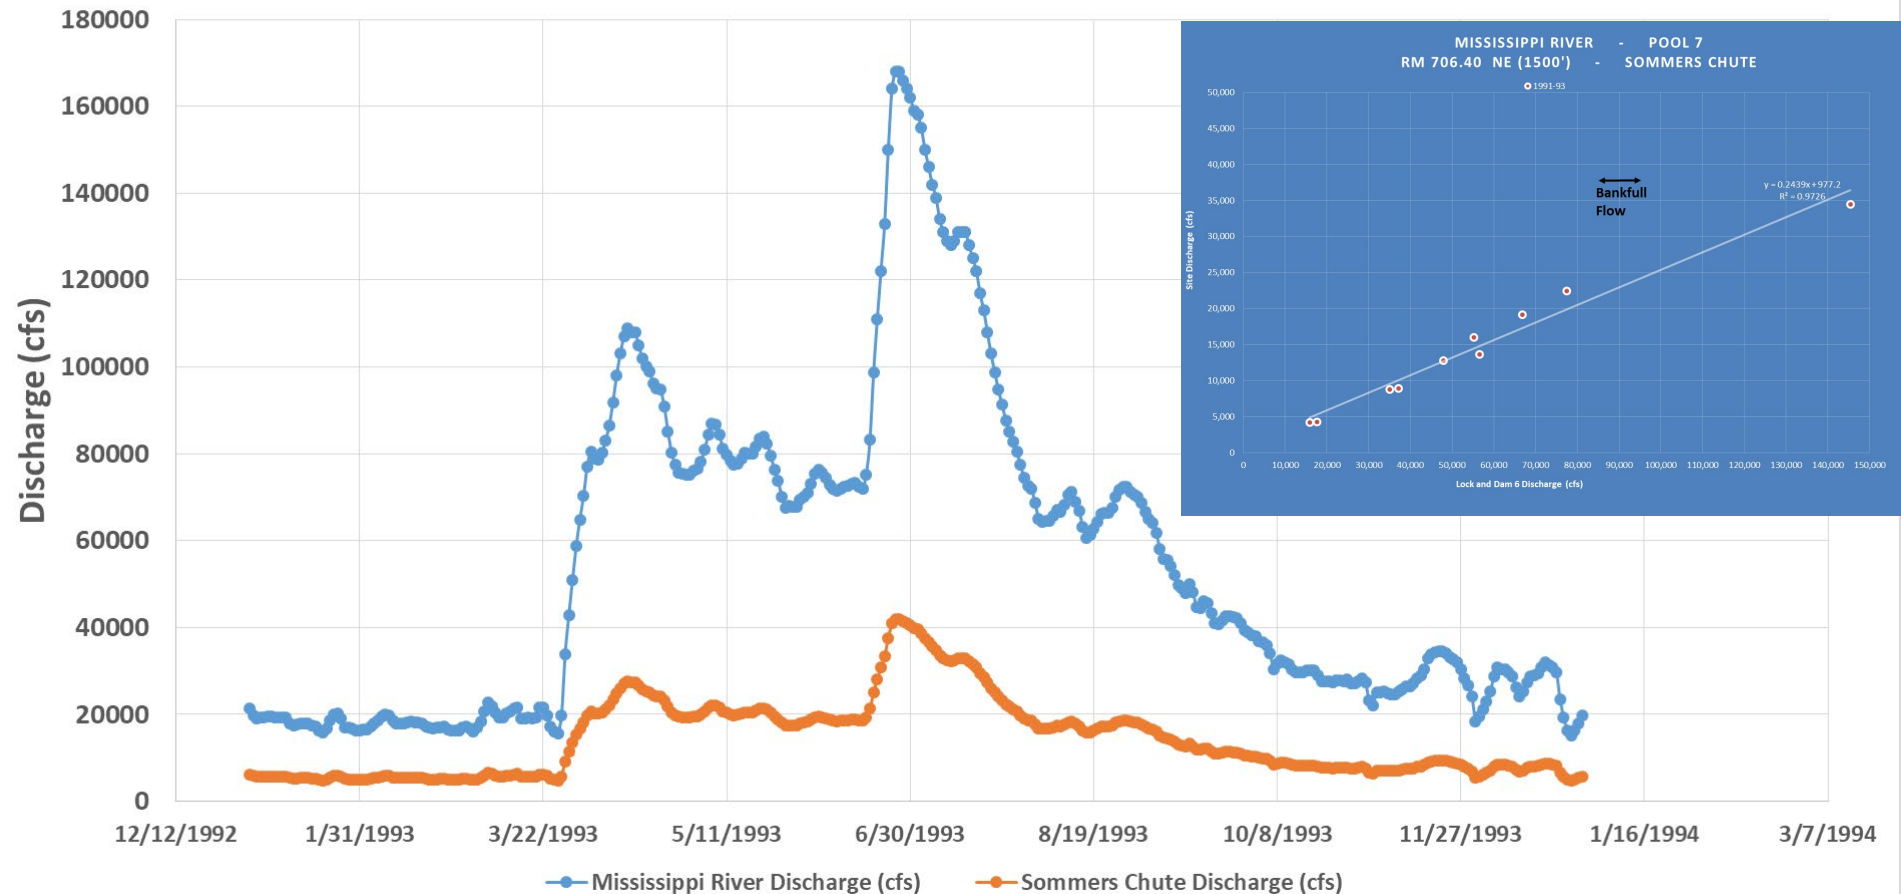
Estimates of Daily Water Exchange

Discharge (cfs), Mississippi River and Sommers Chute, 1993

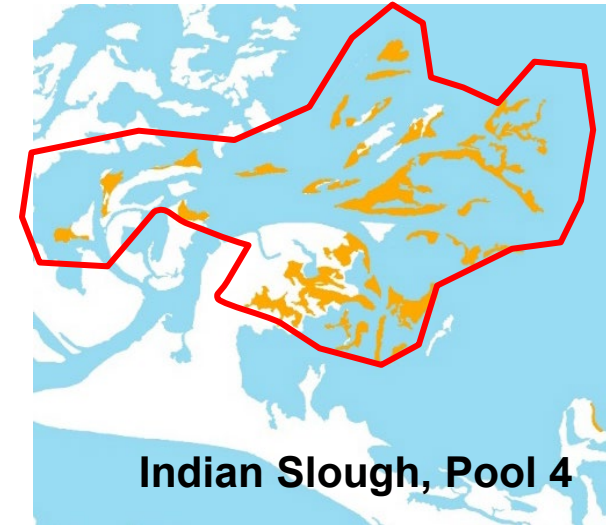
Indian Slough, Pool 4

- Secondary channel measurements at several sites indicate that flow to backwaters decreases as sediment deltas expand.
- Pool 7 is Probably Most Significant Example to Date
 - Outdraft
 - Shift in Dredging
 - Greater sand loads to Pool 8??
- Delta expansion is occurring in many backwaters
