# Bridger Foothills Entrapment and Shelter Deployment

Facilitated Learning Analysis

**September 5<sup>th</sup>, 2020**

Montana Department of Natural Resources and Conservation  
USDA Forest Service, Region 1/ Custer-Gallatin National Forest

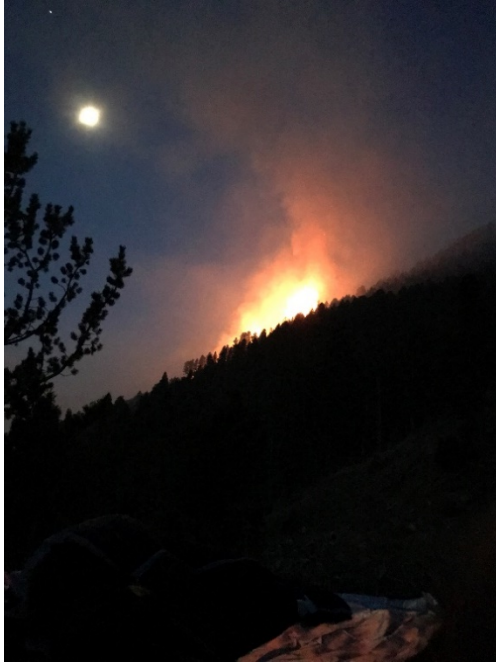
*Figure 5: A photo, taken at approximately 0605 on Saturday morning, of the trees torching above the Helitack Crew's campsite.*

The Helitack Crew woke up Saturday morning at 0600 to the sound of trees torching. These trees, which they could view from their campsite, were likely part of a slop-over outside the handline that the Hotshot Crew had been digging and burning off all night and into the early morning. Given the approximately 1-acre slop-over, the priority for Division A on Saturday morning was to send the Hotshot Crew back up the handline to contain the slop and continue down the ridge towards the other ground resources working below.

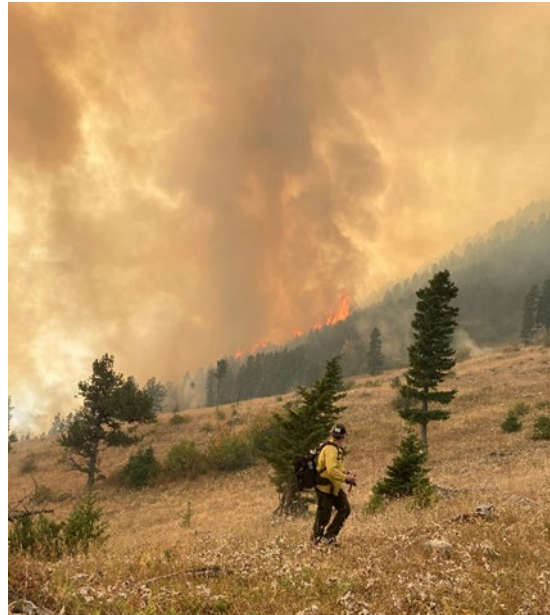
*Figure 9: View of fire activity from the north end of the opening above the campsite, taken as the Helitack Crew moved back towards their helispot and first called for extraction.*

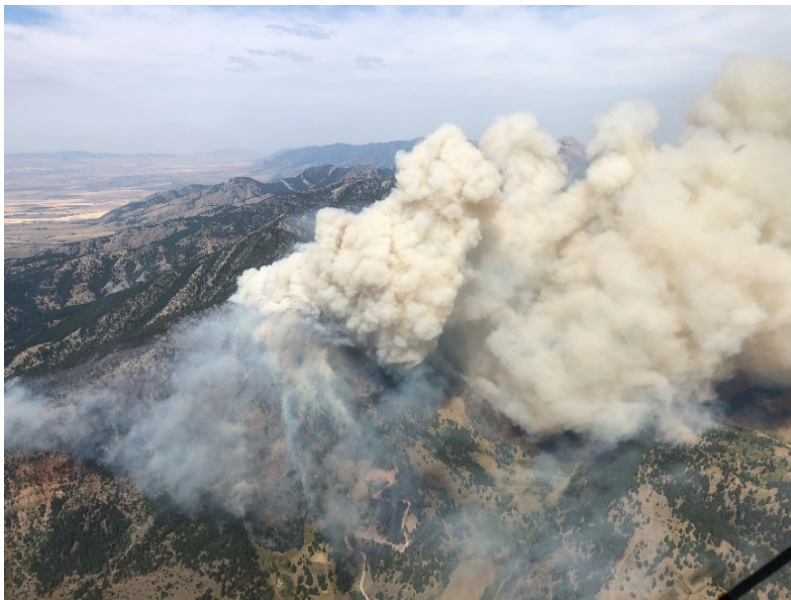
*Figure 11: Picture taken from the air attack platform at 1326. The image captures fire activity leading up to the shelter deployment.*

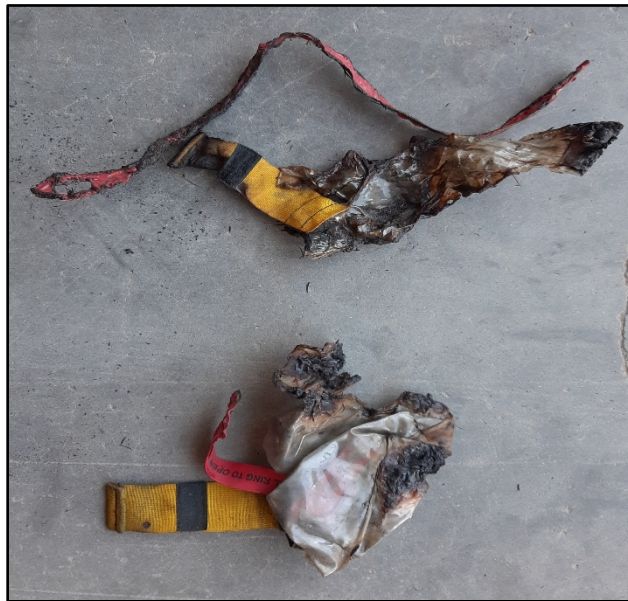
- Firefighter information: FF1 was 71 inches (5 foot 11 inches) tall and weighed 185 pounds.
- Fire shelter information: The regular-sized fire shelter was manufactured according to Forest Service Specification 5100-606C in October of 2016.
- Post-deployment fire shelter inspection observations:
  - Polyvinyl chloride (PVC) bag(s): The fire consumed both fire shelter PVC bags—PVC bags, pull-tab strips, and nylon pull straps. See figure 4.

*Figure 4: Both polyvinyl chloride (PVC) bags, red pull-tab strips, and yellow nylon pull straps.*

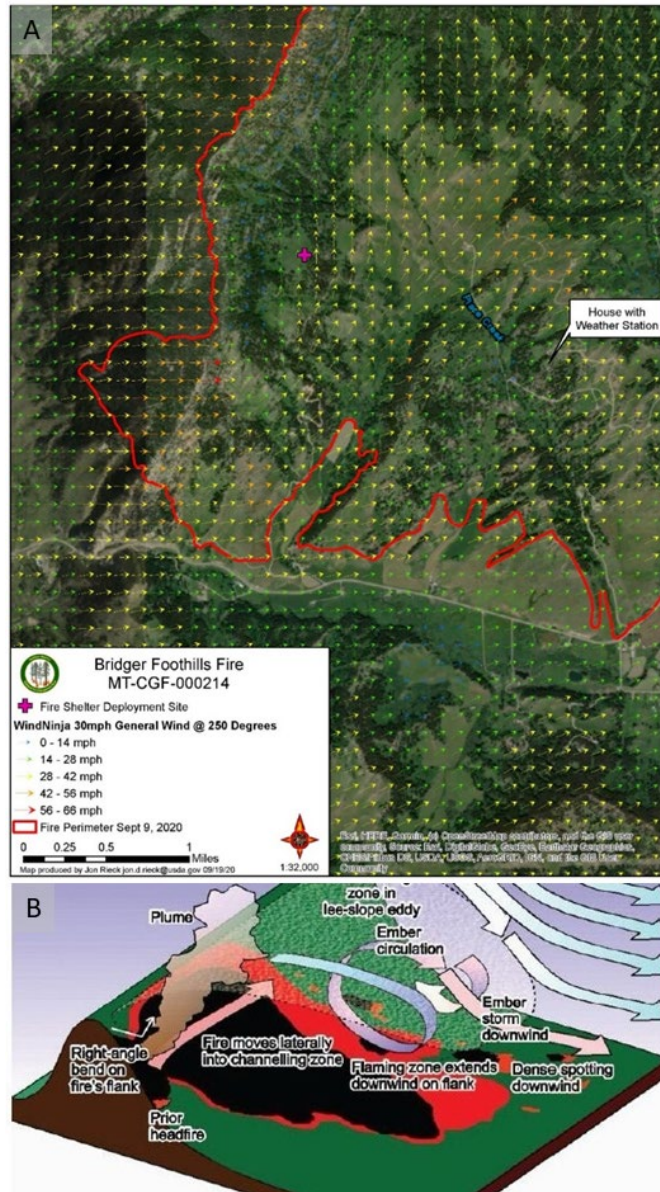
Model outputs from Wind Ninja indicate an expected wind at that weather station to be 14-28 mph from the southwest with stronger winds adjacent to the site. On-site observations of needle freeze on Douglas-fir trees indicates a slope effect, turning surface winds to approximately 168 degrees.

Figure 1A: Results of the Wind Ninja model using a 30-mph wind from 250 degrees and 1B: conceptual diagram of slope effect on wind direction.

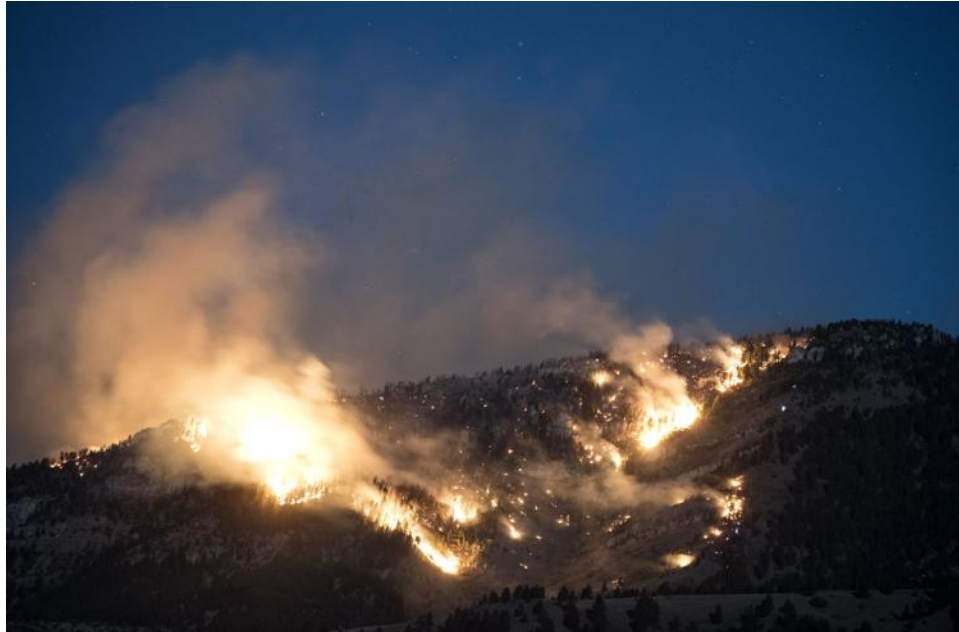
Photos show that the fire was established down to about the 5,900 feet elevation level on the morning of the 5<sup>th</sup>, on the east side of the ridge. Fire behavior was active throughout the previous night.

*Figure 2: Fire activity on the Bridger Foothills Fire for the night of September 4<sup>th</sup>. Photo credit: Rachel Leathe, Bozeman Daily Chronicle.*
