Informational Summary Report of Serious or Near Serious Injuries, Illnesses and Accidents

GREEN SHEET

Firefighter Burn Over

Silverado Incident

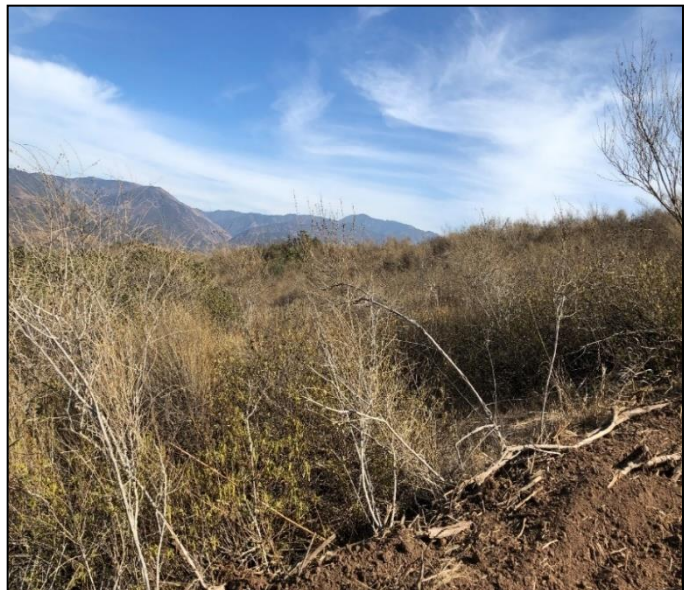
- The live fuel moisture samples were taken on October 13, 2020, at the Black Star Canyon site that is 1.6 miles away to the East Northeast of the accident site at 1,240' elevation.
 - Values for Chamise were at 60%, with critical levels below 60. Those fuels reached critical on October 13, 2020.
 - The live fuel moisture values for sage were at 48%, with critical levels below 100%. Those fuels reached and continued to drop below those levels on July 15, 2020.

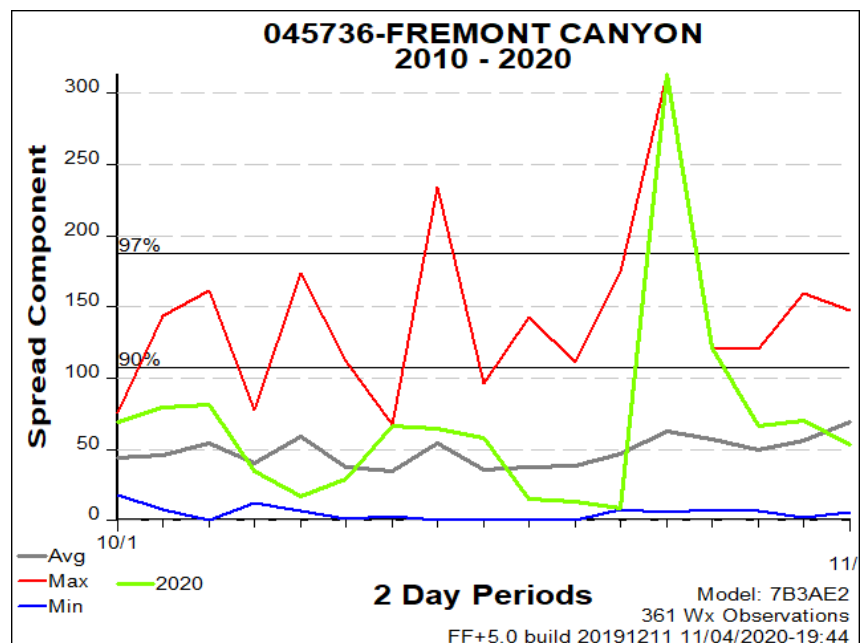
- Spread Component is a rating of the forward rate of spread at the head of the fire in feet per minute. The Spread Component for the area was well above the 97th percentile at 313, and created historical levels for the 10 year period from October 1st to November 1st. The previous historical level for 2010-2019 was only 117. This high value is the main factor in the high rates of spread and long-distance spotting that occurred during the incident.

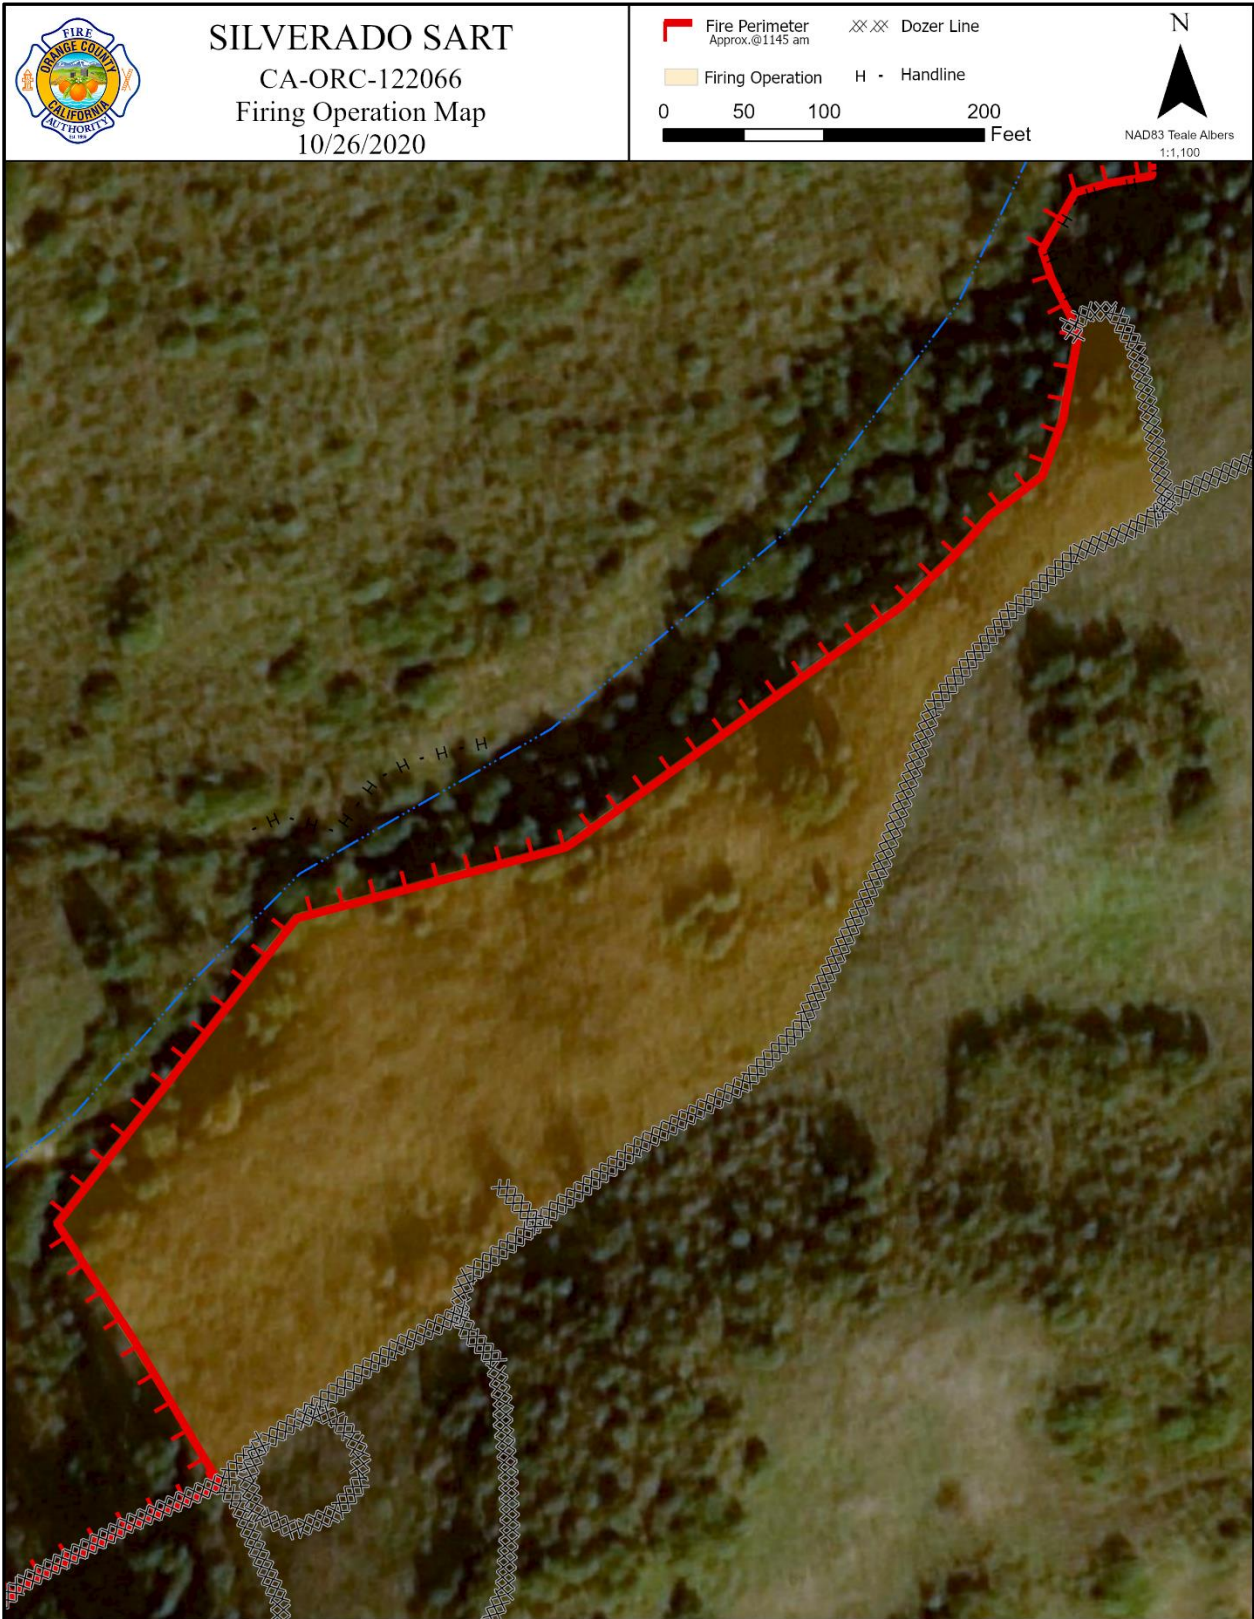
*HCFF Personnel Protective Equipment (PPE) after burn over. *PPE was exposed to extreme heat from direct flame impingement for an unknown duration **
