**GALVESTON'S BULWARK
AGAINST THE SEA**

history of the Galveston seawall

**Public Affairs Officer
Corps of Engineers
P. O. Box 1229
Galveston, Texas 77553**

HISTORY OF THE GALVESTON SEAWALL

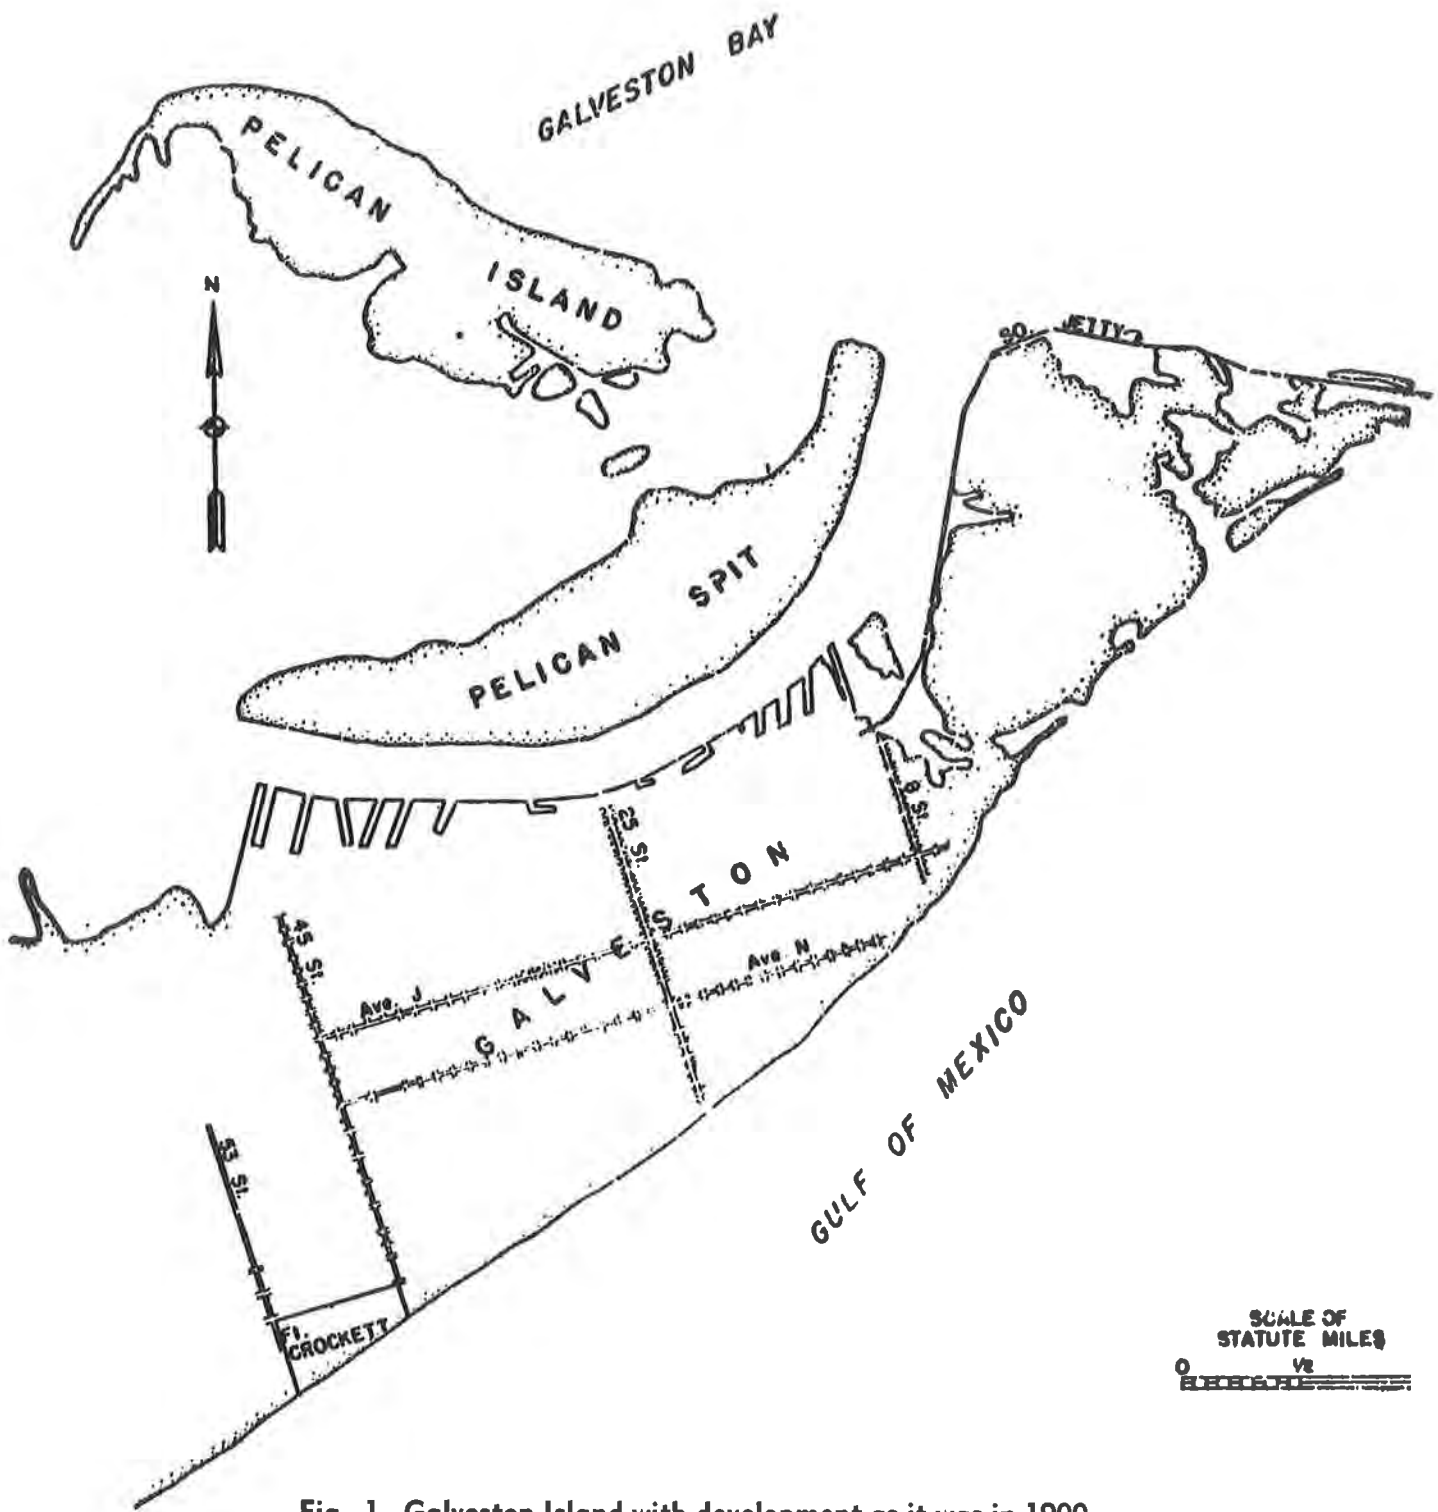
Fig. 1. Galveston Island with development as it was in 1900.

Galveston Island, one of the long narrow barrier beaches that fringe the Gulf Coast of Texas, is a low, sandy formation about 28 miles long and from ½ to 3 miles wide. In its natural state the Gulf shore was bordered by an area of sand dunes rising to heights of 12 to 15 feet above the natural surface of the island. The availability of deep water along the bay side of the island led to the early development of the city of Galveston on the east end of the island. In its early days the city was protected from hurricane tides by the sand dunes along the Gulf front. The rapid development of the city in the latter part of the 19th century, especially its increasing importance as a summer resort, led to the removal of sand dunes along the beach front for fill and to permit easy access to the beach. Without the dunes the city was unprotected from the fury of the hurricanes. The danger to the city was realized by a number of persons, and several plans for storm protection had been developed; however, because of financing difficulties and general public apathy, none of these plans was carried out. (See Figure 1.)

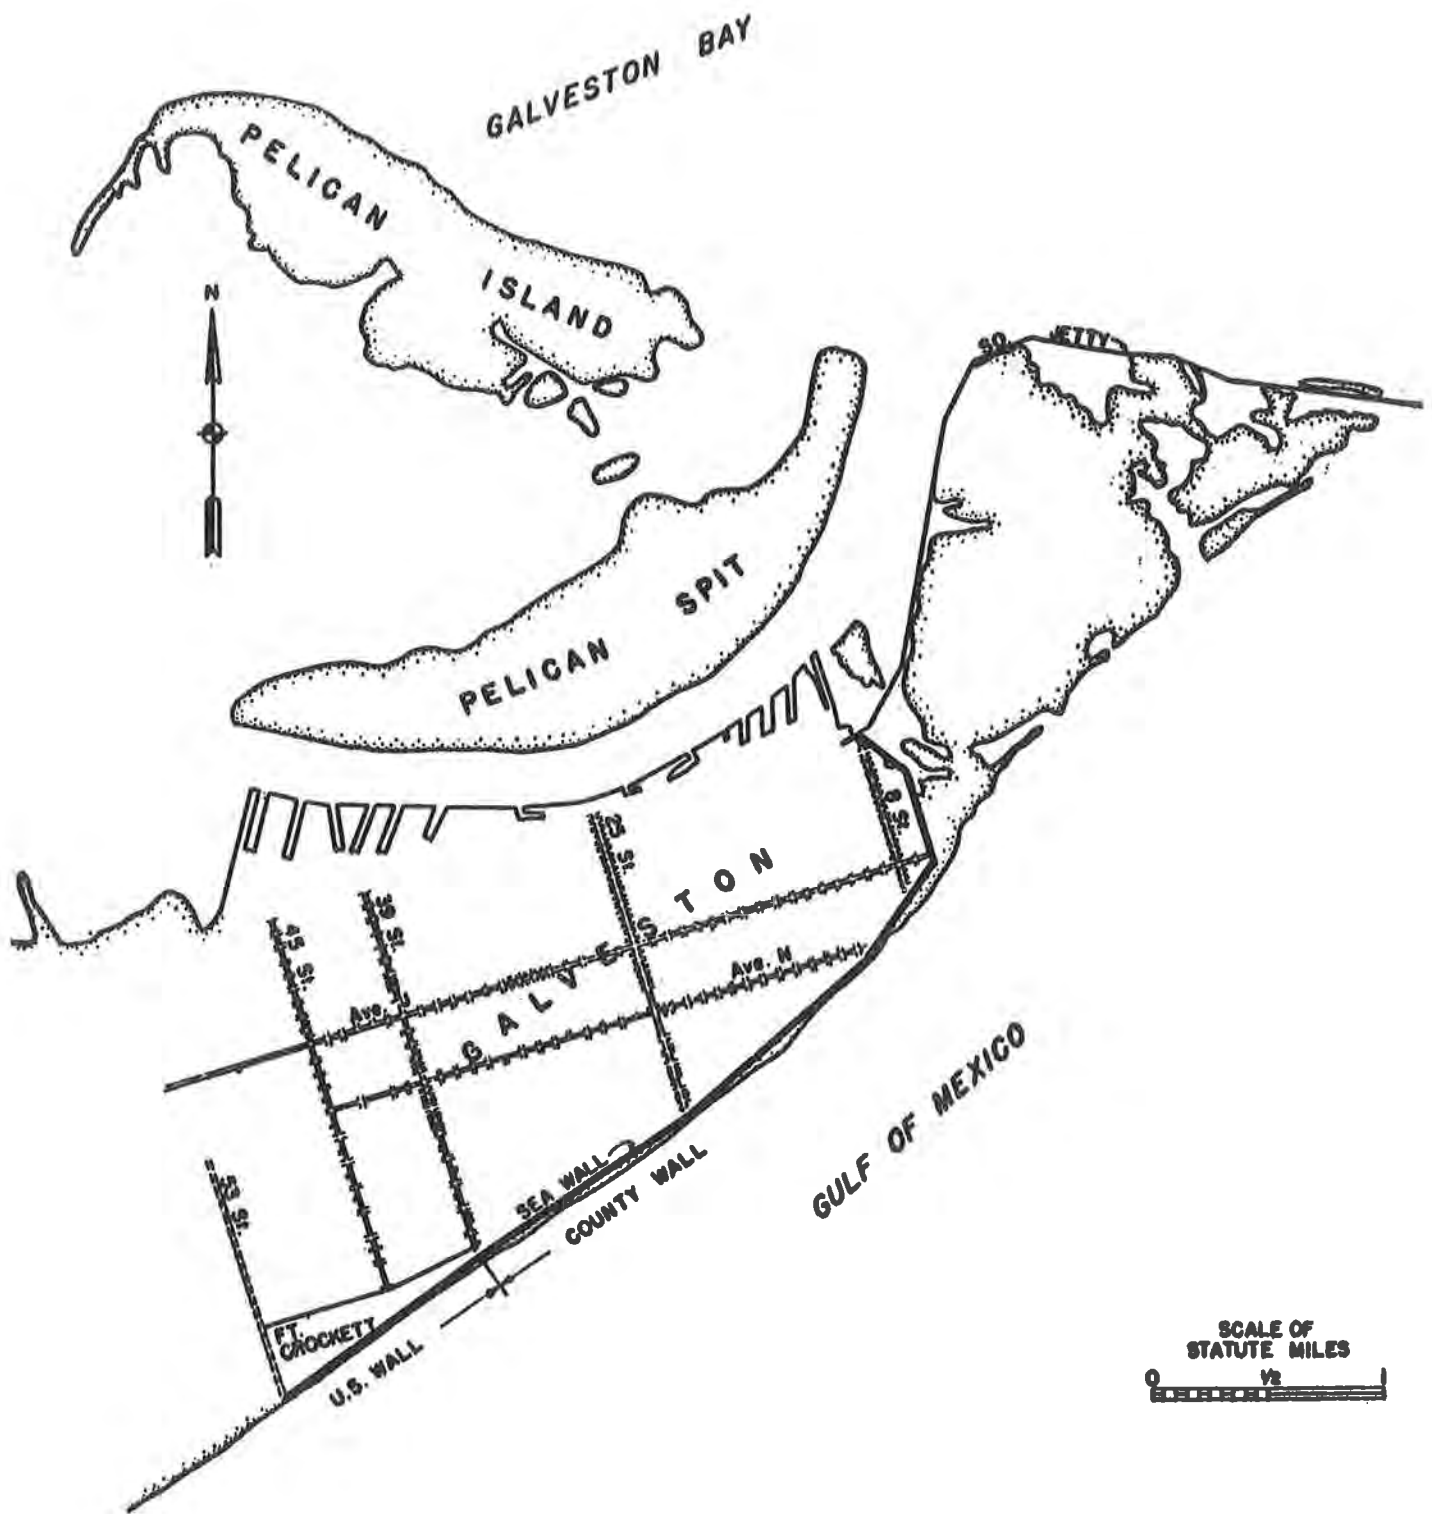
Fig. 2. Location of seawall as recommended by Robert Board in 1902.

- a. A solid concrete wall, over 3 miles long, connecting with the south jetty near 8th Street; thence to 6th Street and Avenue D; and thence on 6th Street across the island to the beach and down the beach as far as 39th Street. The top of this wall to be 17 feet above mean low water.⁽¹⁾ The location of this seawall would be landward of the highwater line generally at about the 3-foot contour. (See Fig. 2)

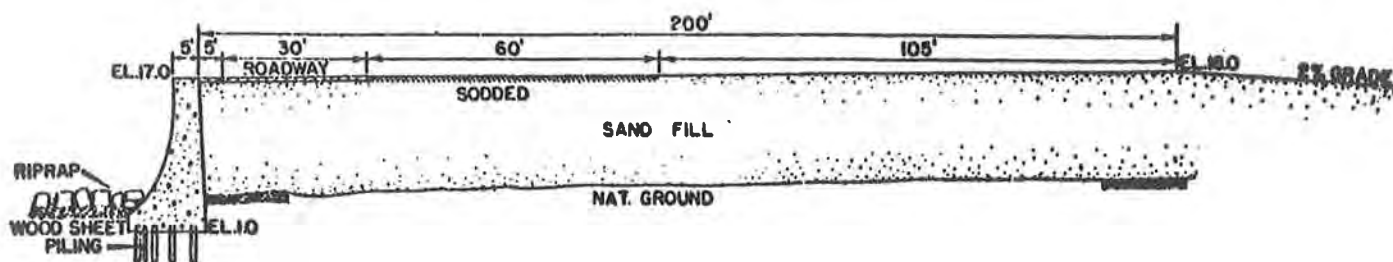
Fig. 3-a. 1902—Embankment structure proposed by Robert Board.

c. The making of an embankment on top of this fill adjacent to the wall, and rising to a height of 18 feet above mean low water at a distance of 200 feet from the wall, thence sloping down on a grade of 1 in 50 to the surface of the fill. The top of this embankment for 35 feet from the seawall to be protected by a brick pavement and 60 feet farther by Bermuda grass. (See Figure 3-a.)

The design of the seawall provided for a concrete gravity section 16 feet wide on the base at elevation 1 foot above mean low water and 5 feet wide on top at elevation 17 feet above mean low water. The sea face of the concrete seawall to be curved so that its upper portion will be vertical, to give the wave an upward direction and prevent, to a great extent, its running up and over the embankment behind the wall. The wall would be founded on piles and protected from undermining by sheet piling and a layer of riprap 27 feet wide and 3 feet thick extending outward from the toe of the sea face of the wall. The riprap to be deposited so that when the work is

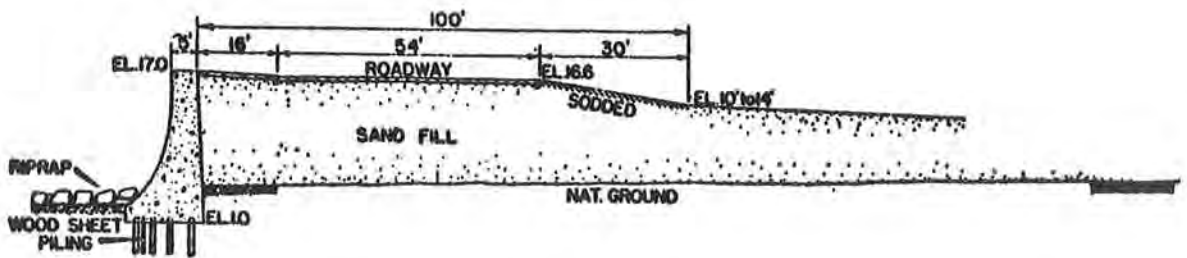
Fig. 3-b. 1904—Seawall as constructed.

The cost of the seawall was estimated at a total of \$1,295,000 for the 17,593 feet of seawall. This portion of the seawall was constructed by Galveston County, beginning in October 1902 and completed in July 1904 at an actual cost of \$1,581,673.30. The structure was built generally in accordance with the plans of General Robert, except that the embankment behind the concrete section was built only 100 feet wide and to a maximum elevation of 16.6 feet. (See Figure 3-b.)

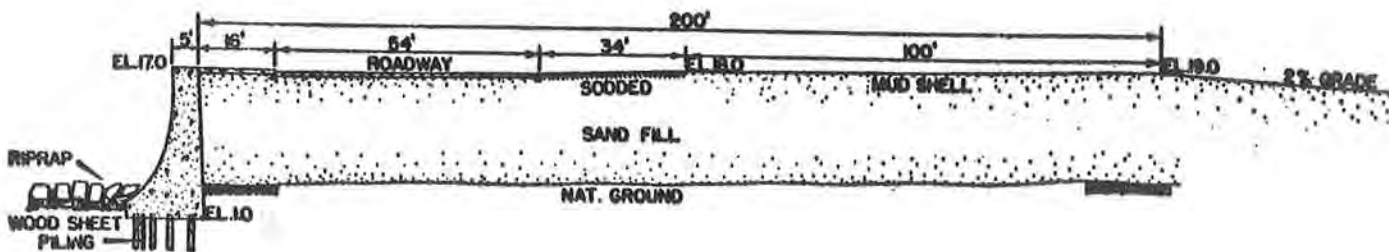
Fig. 3-c. 1909—Seawall repair and modification following storm.

The toe of the wall was repaired by placing sand and riprap to bring the riprap up to grade. As a result of the damage to the embankment caused by this storm it was decided to repair the embankment behind the wall and extend the fill to a crest elevation of 18 feet at a distance of 200 feet from the face of the concrete section as originally proposed. (See Figure 3-c.)

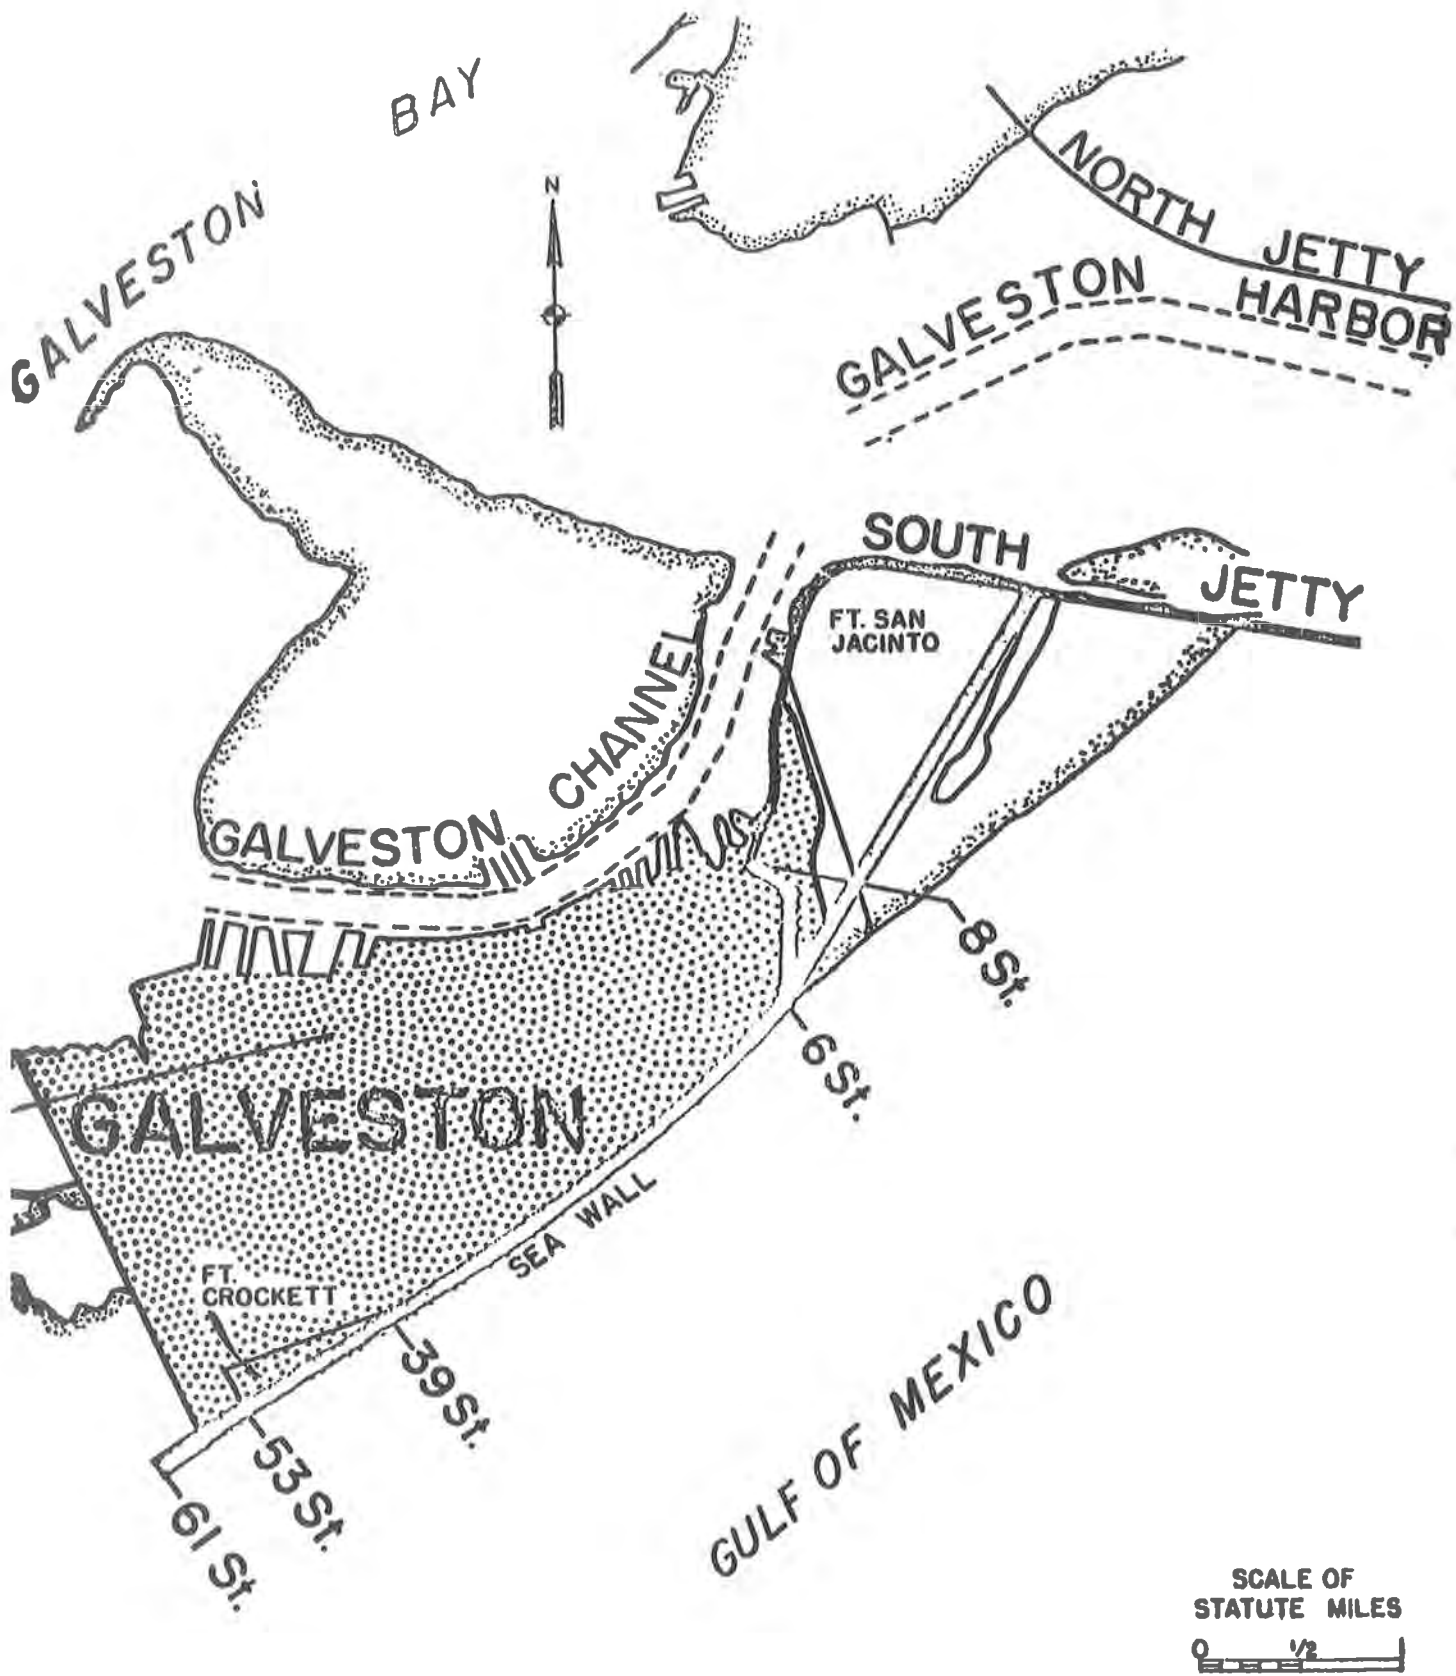
Fig. 4. 1913—Seawall extension from 6th Street to Fort San Jacinto proposed.

In 1913 a report was prepared at the request of Congress by a special board of engineers for rivers and harbors, which considered the question of extending the seawall eastward from 6th Street to Fort San Jacinto in the east end flats. This report pointed out the danger of storm erosion cutting a channel across the island in this area, which would breach the jetty and result in extensive shoaling in the Galveston channel along the bay side of the island. The board considered this danger sufficient to warrant preventive measures and recommended that the seawall be extended across the east end flats to protect the harbor from blockage by storms and to permit expansion of the harbor facilities. The recommended extension from 6th Street to the first battery at Fort San Jacinto had a total length of 10,300 feet, of which 3,300 feet would be built by local interests, city or county, and 7,000 feet on the Fort San Jacinto Reservation would be built by the United States. (See Figure 4) The design of the seawall extension was the same as the completed seawall with the embankment behind the wall 200 feet wide from the edge of the wall to the crest of the fill.

On July 27, 1916, Congress authorized the east extension of the seawall from 6th Street to Fort San Jacinto as recommended by the board of engineers in 1913. (See Figure 4). Work on this extension was begun on June 20, 1918. The work was very much delayed by wartime labor shortages and lack of materials because of embargoes on railroad cars. The extension was about half completed, having reached the edge of an old borrow pit about 300 feet wide and 2-1/2 feet deep, from which about 3,000,000 cubic yards of material had been removed for the Galveston grade raising, when the severe hurricane of September 13-14, 1919, occurred. The borrow pit had been closed with a wood sheet pile bulkhead and the work of constructing the seawall across the area was in progress when the storm occurred. This storm passed about 180 miles south of Galveston but it caused a tide of 9.0 feet above mean low tide and winds of about 60 miles an hour at Galveston.

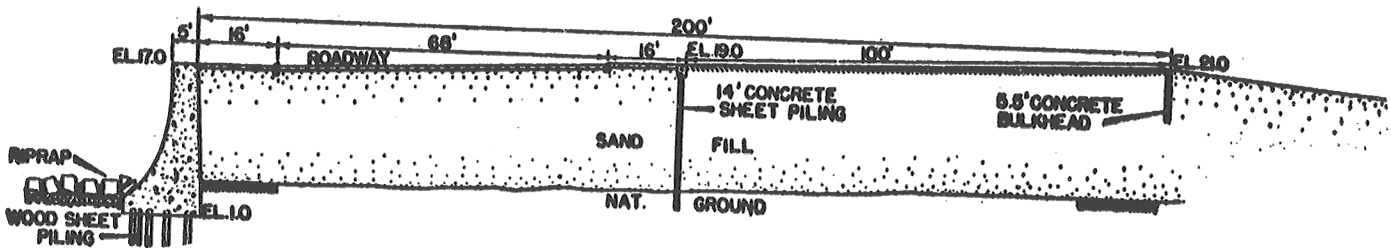
Fig. 3-d. 1915—Improvements to seawall following storm.

Because of the extensive damage to the seawall, the county requested General Robert to review the problem and report on a plan to furnish further protection against hurricanes. His recommendations were that the paving on top of the embankment be extended to a width of 100 feet; that a reinforced concrete sheet pile bulkhead be placed along the land side of the pavement, with a top elevation of 18 feet; and that the embankment rise in another 100 feet to an elevation of 21 feet at 200 feet from the wall.

This work was done immediately and, in addition, a small concrete bulkhead, 1 foot thick and 5 feet high, was constructed at the crest of the embankment. The sand fill beyond the paving was protected by sodding or by a cover of shell. (See Figure 3-d)

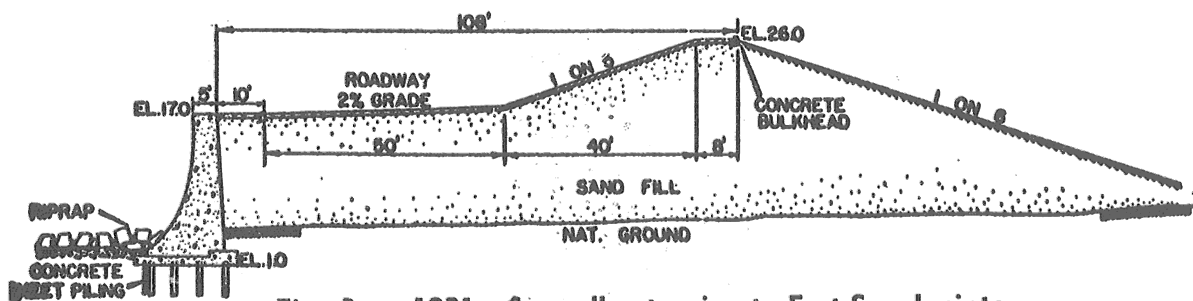
Fig. 3-e. 1921—Seawall extension to Fort San Jacinto.

A somewhat different design was used for the embankment behind the seawall across the San Jacinto Reservation. Here the embankment behind the wall has a 10-foot walk and 50-foot roadway that slope up on a 2 per cent slope and then the embankment rises on a 20 per cent slope for 40 feet to a crest of the fill at elevation 26 feet above mean low water. The crest is 8 feet wide and there is a concrete cut-off wall along its landside that extends one foot above the top of the fill. Behind the cut-off wall the fill has a 1 on 6 slope to the natural ground at a distance of about 250 feet from the face of the concrete wall. The front slope and crest of the embankment are paved. This embankment is designed to prevent any overtopping of the fill by storm waves. (See Figure 3-e)

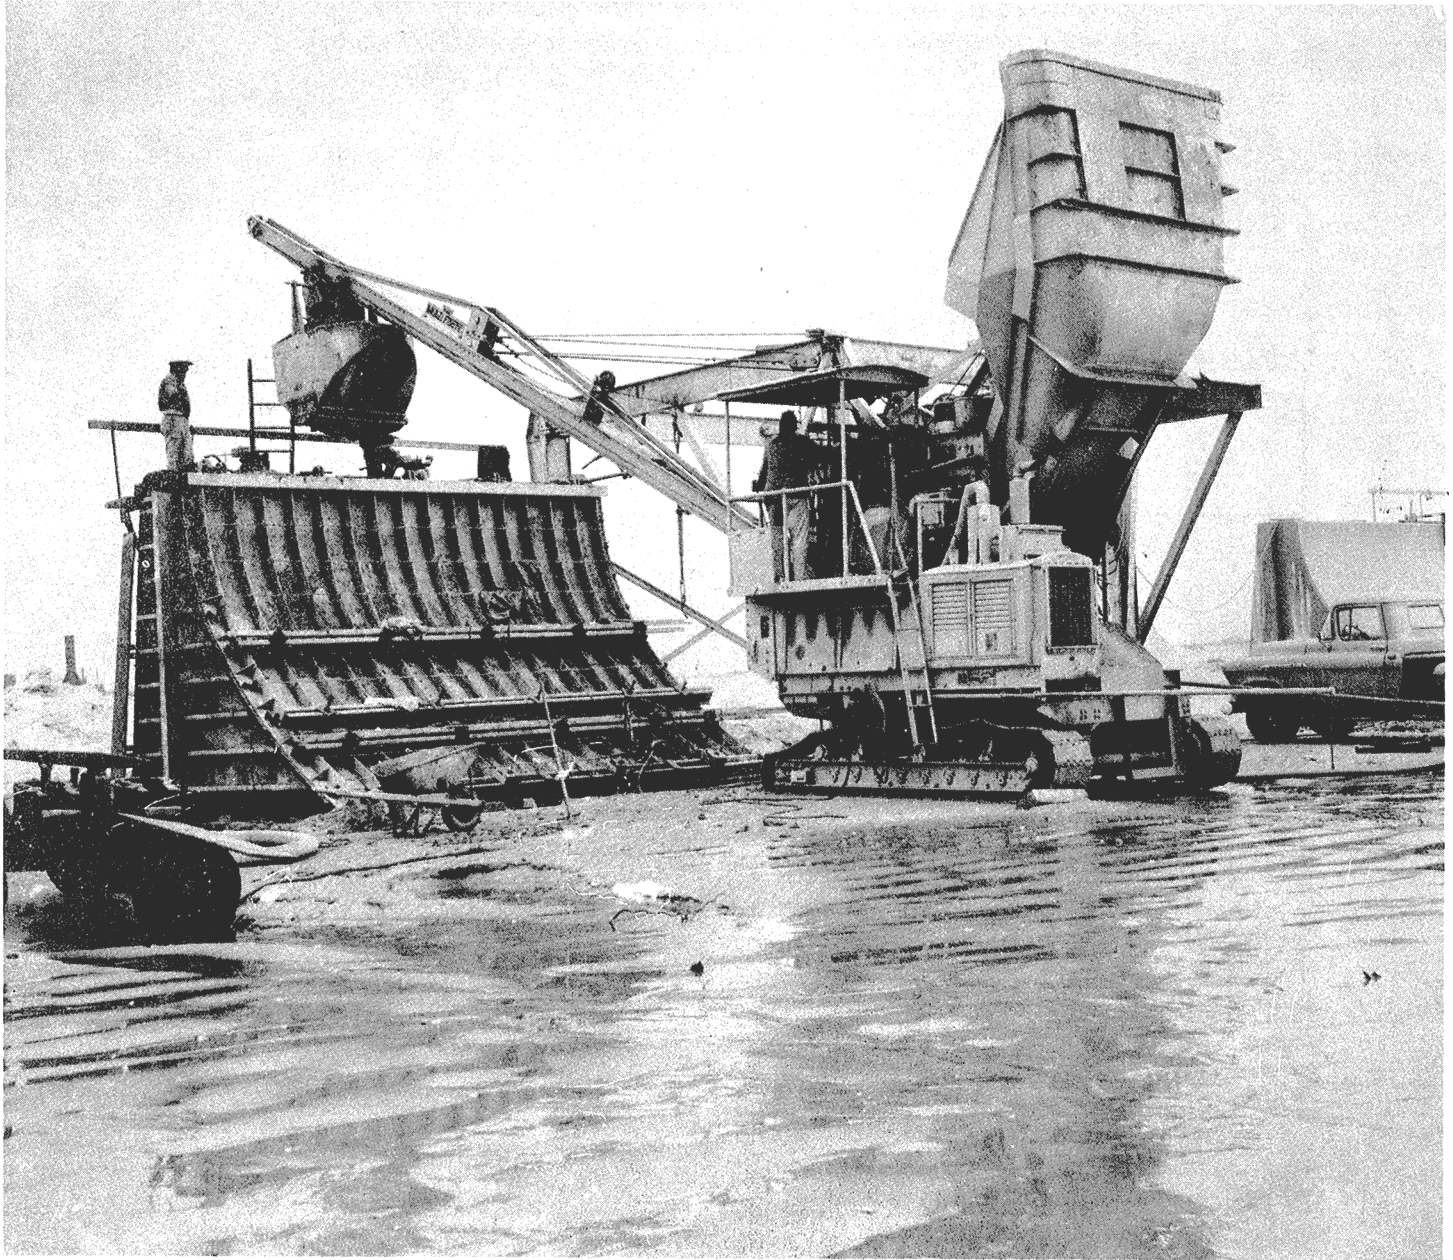
Concrete pouring during 1959 seawall extension.

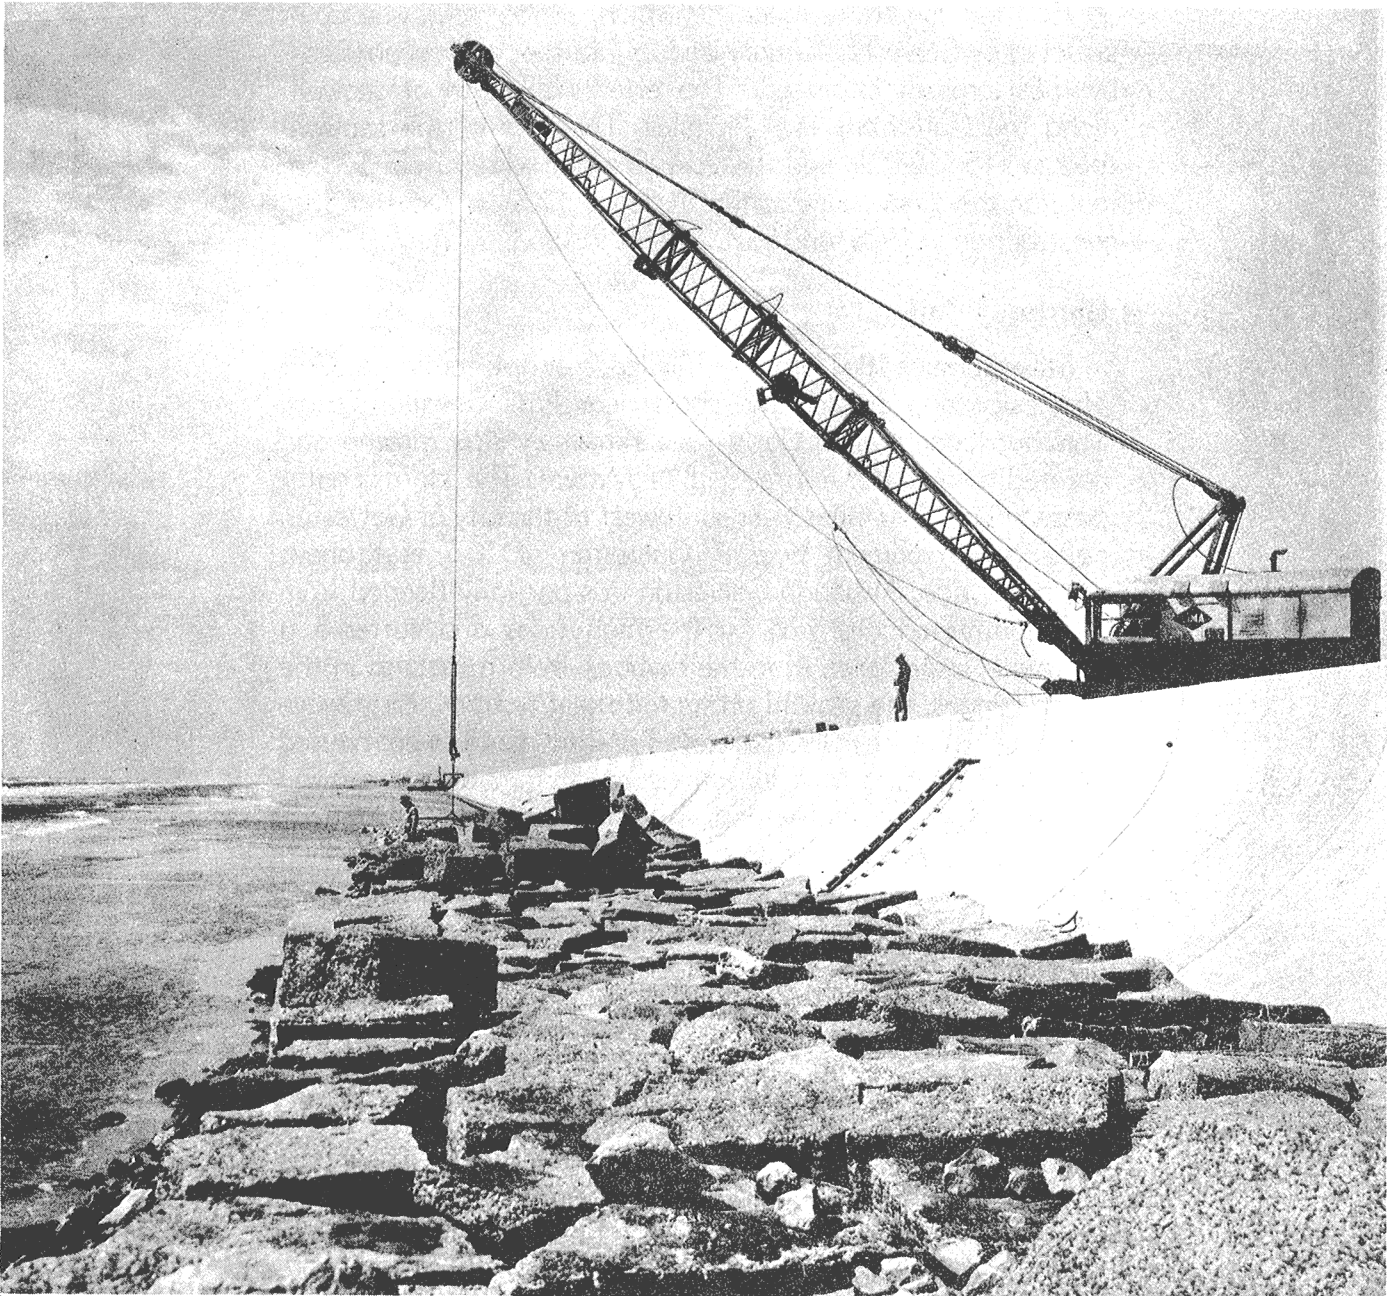
Riprap is placed at toe of seawall extension.

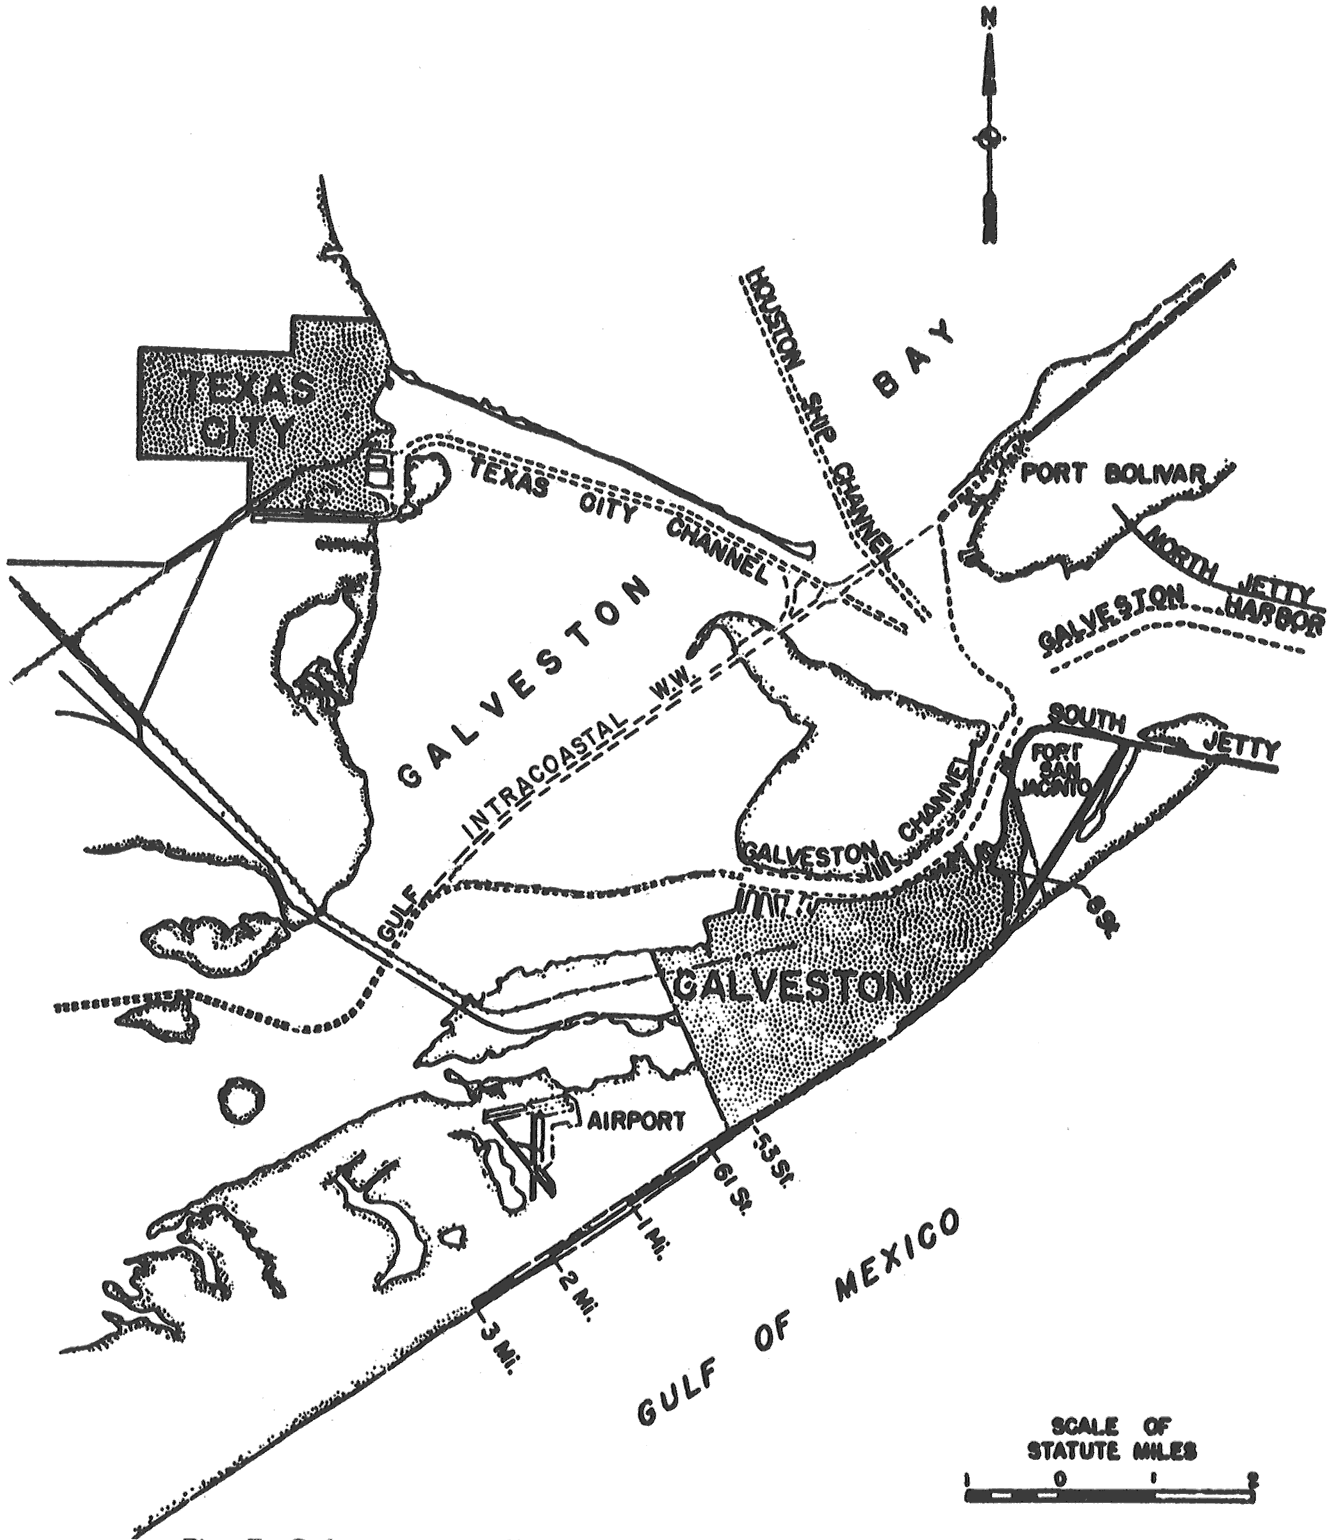
Fig. 7. Galveston seawall stretches almost 10 miles in length from South Jetty.

Today, Galveston's bulwark against the sea extends for nearly 10 miles across the Island City (Figure 7), protecting life and property against destructive forces of tide and wave that accompany tropical hurricanes. The seawall and the groins also provide a facility that is widely used by fishermen and sight-seers and adds materially to Galveston's attractiveness as a vacation area.
