**APPROVED JURISDICTIONAL DETERMINATION FORM  
U.S. Army Corps of Engineers**

**B. DISTRICT OFFICE, FILE NAME, AND NUMBER:** Sacramento District, SPK-2008-00023-UO-JD2

Procter & Gamble Box Elder County, Utah site

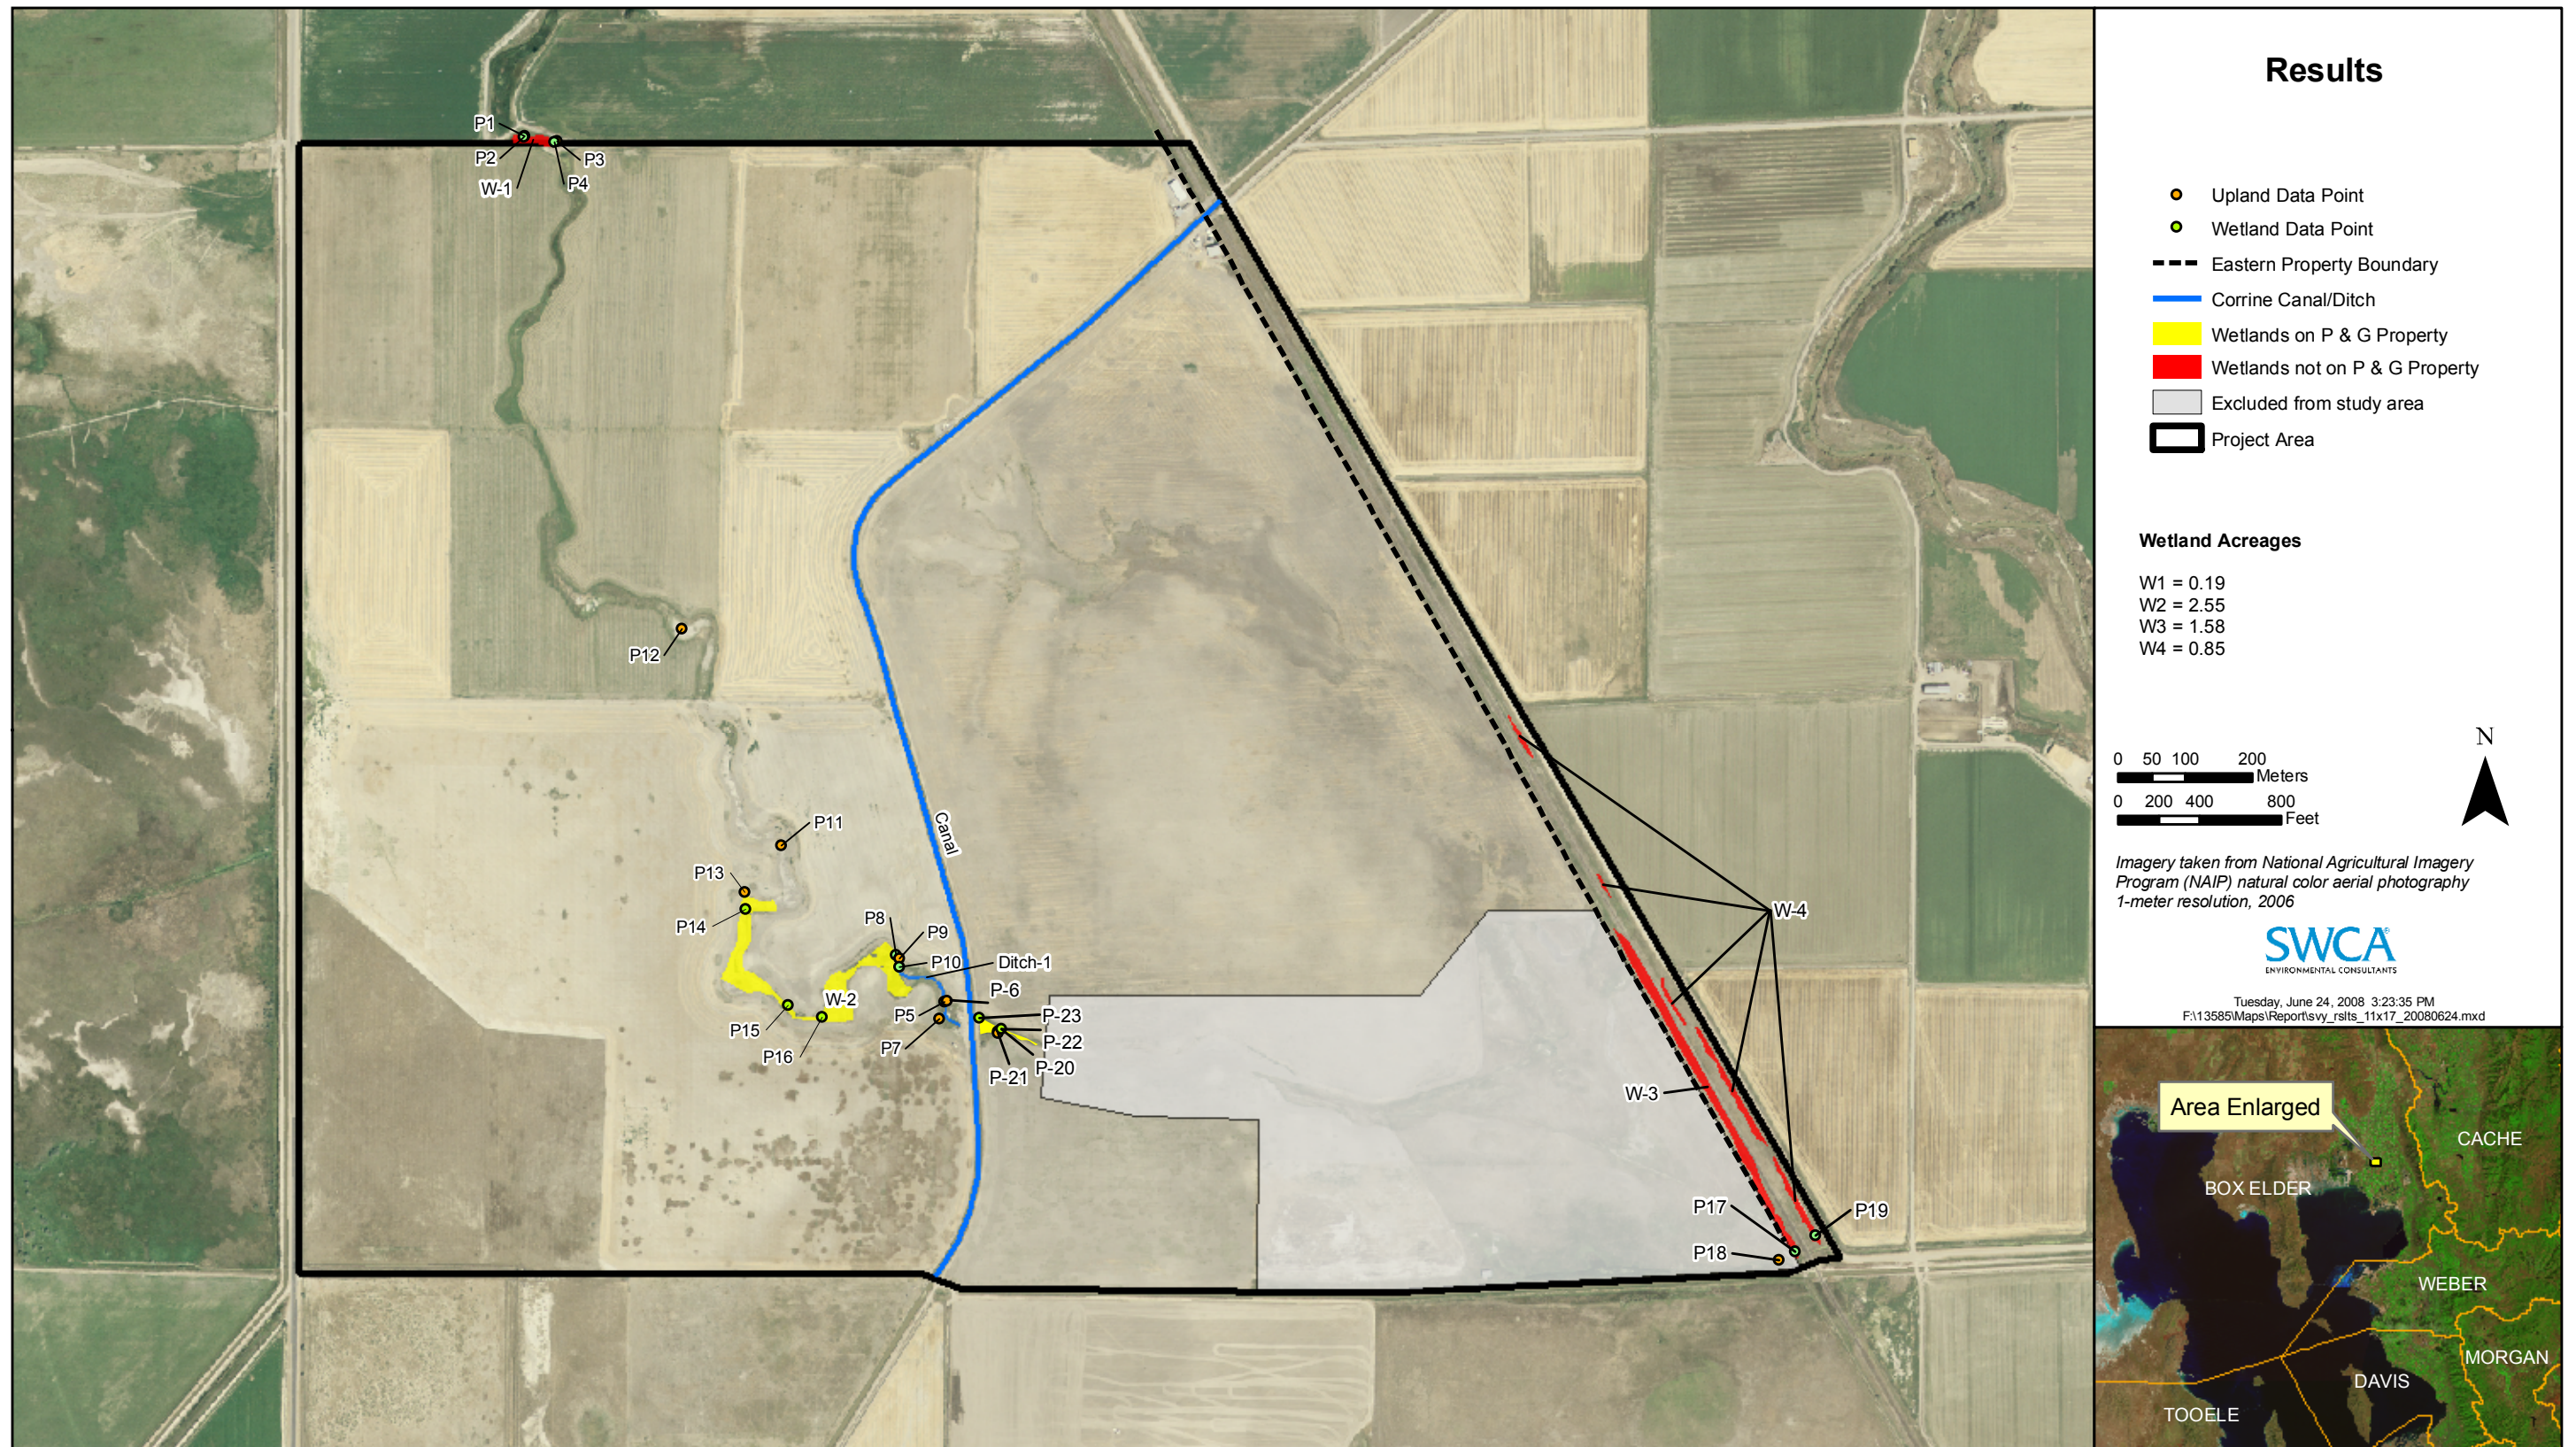
Figure 5. Wetland delineation results.

Potentially jurisdictional waters and/or wetlands were assessed within the review area and determined to be not jurisdictional. Explain: Three wetland areas (W-1, W-2 and W-5) and one ditch (Ditch-1) were determined to be isolated with no hydrologic connection to navigable waters (See attached delineation map). Wetland W-1 is 0.19 acre, located in the northern border of the property and lacks any ditch or pipe that would connect it to another downstream water body. W-2 is a 2.55-acre Salicornia dominated wetland that flows directly into D-1, a 457-foot long ditch. D-1 connects and flows into W-5, an emergent marsh, via a culvert underneath the Corinne Canal. At this location the Corinne Canal is elevated 6-10 feet above D-1 and may leak water into D-1/W-5; D-1 or W-5 do not contribute water to the canal. The wetland and ditch appear to be within a historic stream channel. Although the remnants of the channel are still visible on recent aerial photography, the channel has been highly disturbed from agricultural practices. Some sections of the channel have been completely plowed over and no longer slope downstream. Information obtained through a dye test conducted by the applicant's agent in late March and early April of 2008 indicate that W-2, D-1, and W-5 are within a closed basin with no outlet. There are manhole access points for an underground tile drain system within the survey area. The tile drain system does connect directly with a ditch along the southern boundary, however these manholes are located topographically higher than the wetlands and there was no visual evidence that water from the wetlands enters the drain system from these points. Since there is known possible connection between these features and a downstream tributary, they have been determined to be isolated and non-jurisdictional.

Description
<p>Three wetland areas (W-1, W-2 and W-5) and one ditch (Ditch-1) were determined to be isolated with no hydrologic connection to navigable waters (See attached delineation map). Wetland W-1 is 0.19 acre, located in the northern border of the property and lacks any ditch or pipe that would connect it to another downstream water body. W-2 is a 2.55-acre Salicornia dominated wetland that flows directly into D-1, a 457-foot long ditch. D-1 connects and flows into W-5, an emergent marsh, via a culvert underneath the Corinne Canal. At this location the Corinne Canal is elevated 6-10 feet above D-1 and may leak water into D-1/W-5; D-1 or W-5 do not contribute water to the canal. The wetland and ditch appear to be within a historic stream channel. Although the remnants of the channel are still visible on recent aerial photography, the channel has been highly disturbed from agricultural practices. Some sections of the channel have been completely plowed over and no longer slope downstream. Information obtained through a dye test conducted by the applicant's agent in late March and early April of 2008 indicate that W-2, D-1, and W-5 are within a closed basin with no outlet. There are manhole access points for an underground tile drain system within the survey area. The tile drain system does connect directly with a ditch along the southern boundary, however these manholes are located topographically higher than the wetlands and there was no visual evidence that water from the wetlands enters the drain system from these points. Since there is known possible connection between these features and a downstream tributary, they have been determined to be isolated and non-jurisdictional.</p>

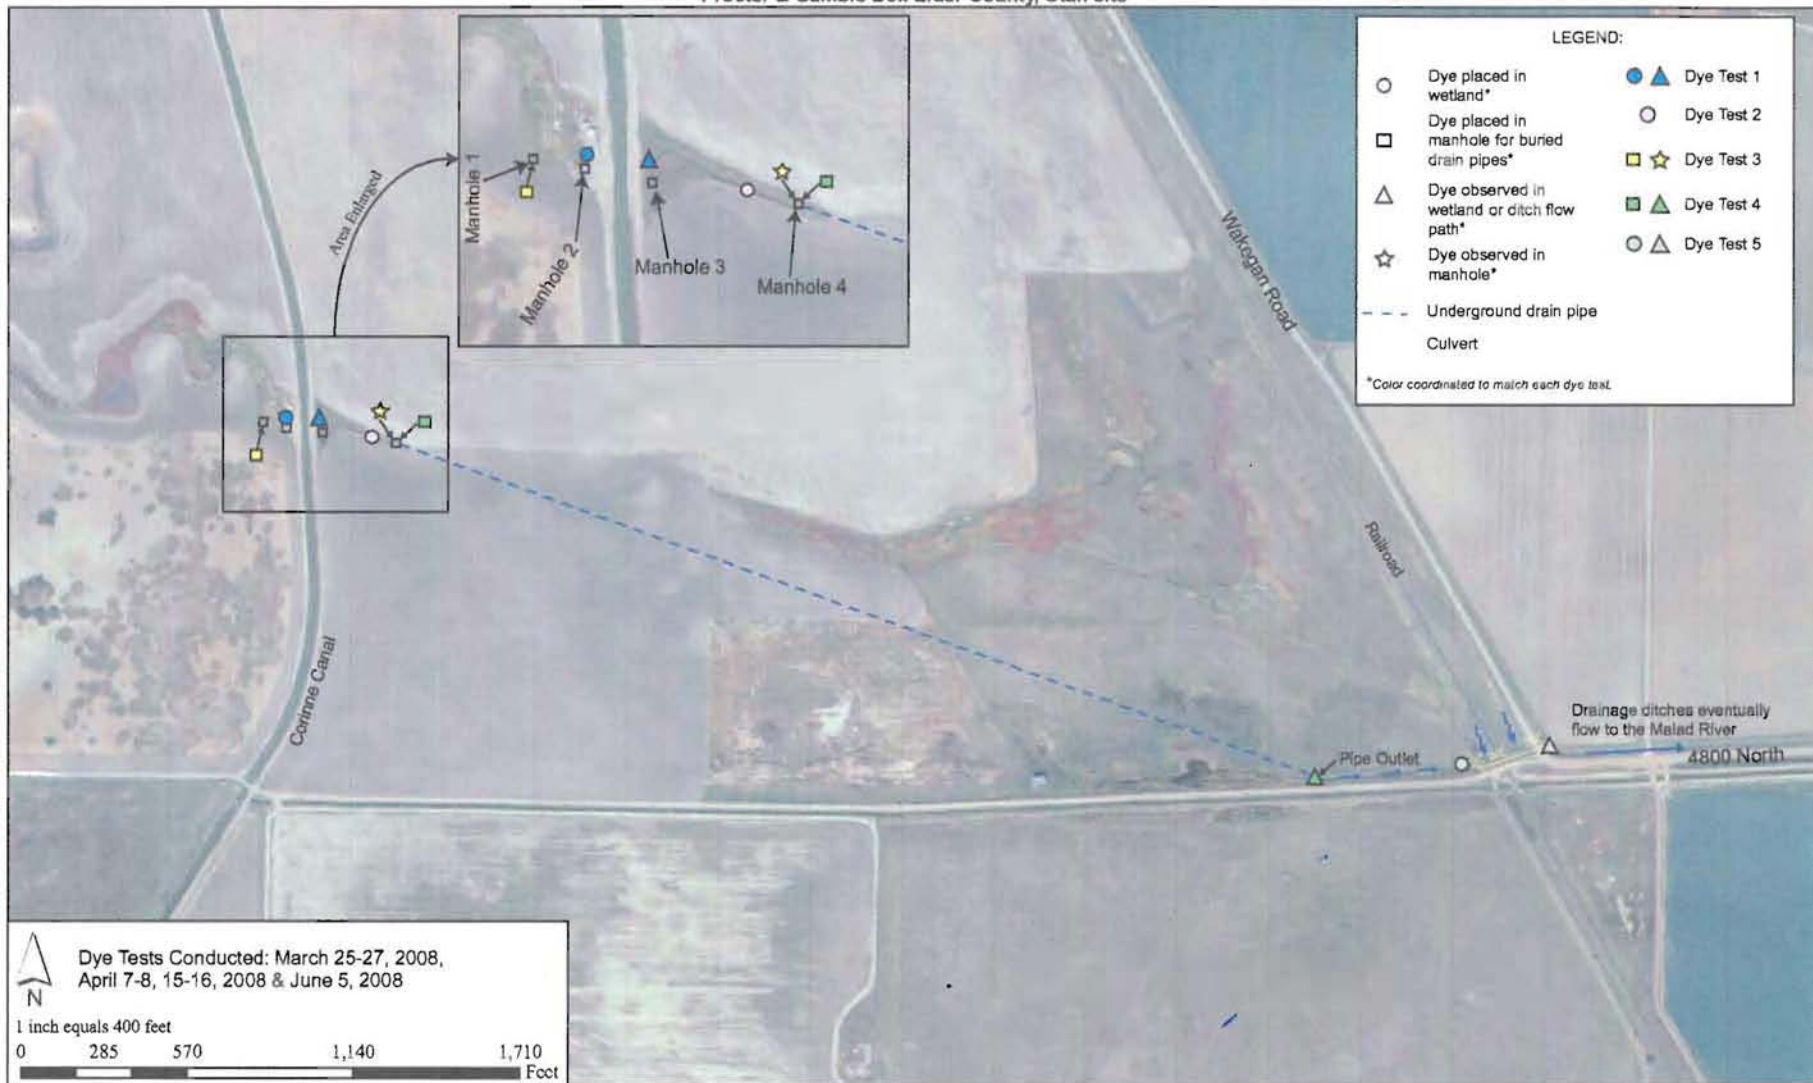
Figure 1. Dye Test Location Map. Individual Dye Test placements are shown.

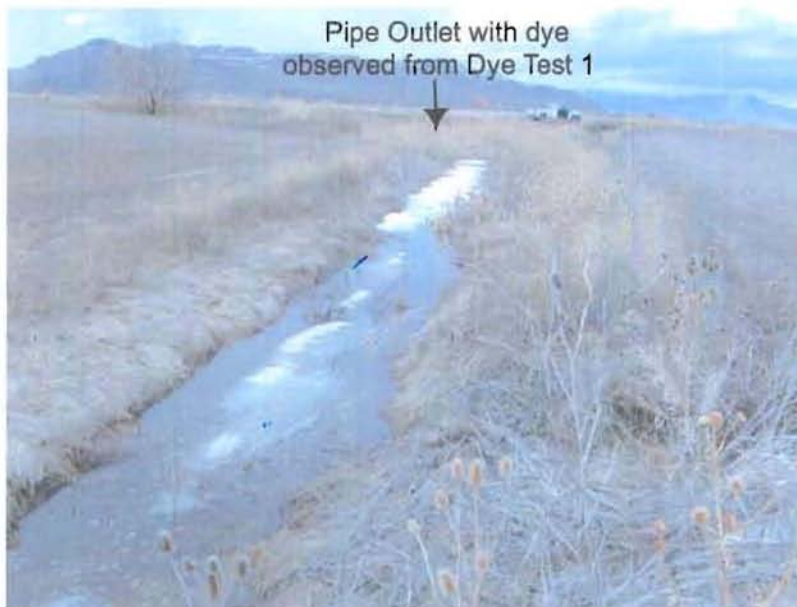
Photo 11. Looking west at the wetland east of the Corinne Canal, before Dye Test 2 took place. Taken on March 25, 2008.

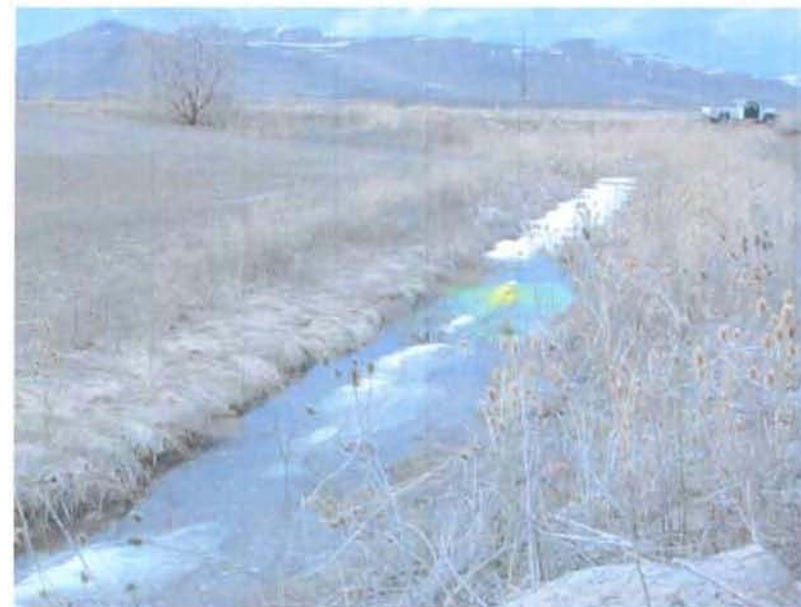
Photo 12. Looking west at the wetland east of the Corinne Canal, after dye was placed for Dye Test 2. Taken March 25, 2008.

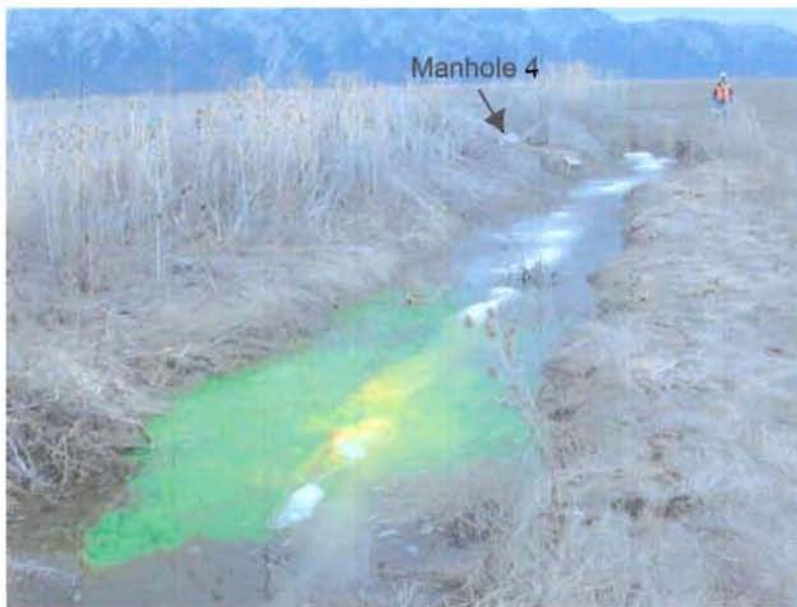
Photo 13. Looking southeast at the wetland east of the Corinne Canal, after dye was placed for Dye Test 2. Taken March 25, 2008.

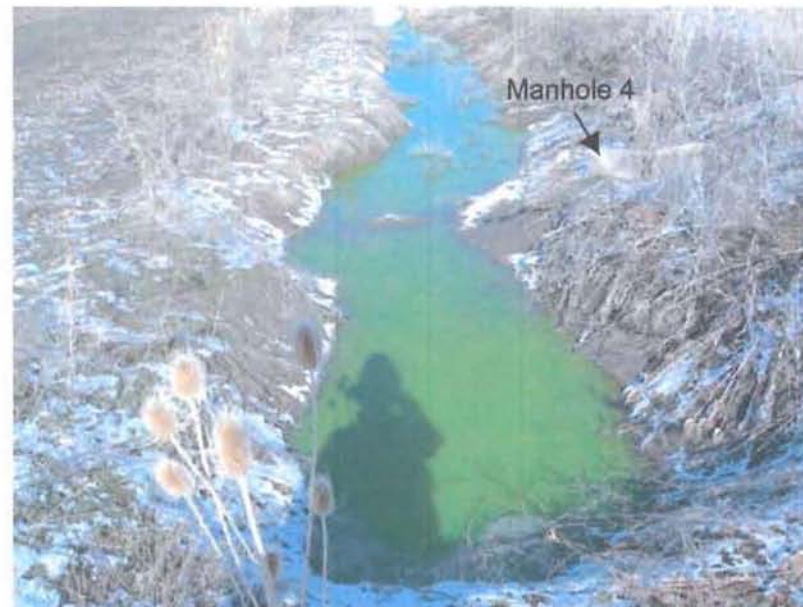
Photo 14. Looking west at the wetland east of the Corinne Canal, on March 27, 2008 at Dye Test 2. No dye was observed in Manhole 4.
