WATERSHED- BASED PLAN

Craven Creek, Grove Creek, Big
Creek, and Hurricane Creek of
the Saluda River, South Carolina

SUBMITTED BY:
Upstate Forever

September 30, 2013

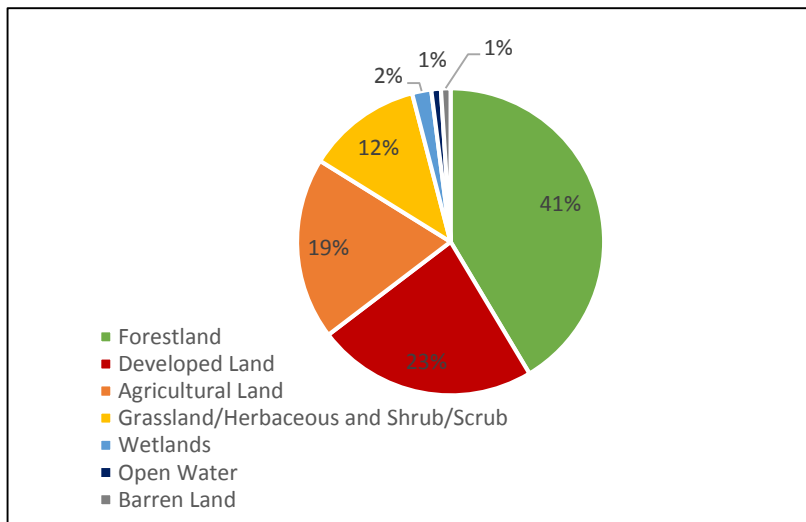
Figure 3: Overall Land Use Percentages

Sourced from the 2006 National Land Cover Dataset (NLCD), land cover in the focus area (Figure 3) has been divided into eleven categories, as shown in Table 2. Together, the two dominant undeveloped land covers – forest and agricultural land – make up over fifty percent of the land cover in the subwatershed⁸. Developed land accounts for 24% of the subwatersheds’ land cover, but is concentrated on the Greenville County, or eastern side, of the Saluda River. The Anderson County, western side of the Saluda River, is characterized by concentrations of agriculture and forest lands primarily. Forest land is the predominant land cover type, covering 41% of the subwatershed area.
