CECW-EG  Engineer Manual 1110-2-2002	Department of the Army U.S. Army Corps of Engineers Washington, DC 20314-1000	EM 1110-2-2002  30 June 1995
	Engineering and Design  EVALUATION AND REPAIR OF CONCRETE STRUCTURES	
	<b>Distribution Restriction Statement</b> Approved for public release; distribution is unlimited.

**Engineering and Design**  
**EVALUATION AND REPAIR OF CONCRETE STRUCTURES**

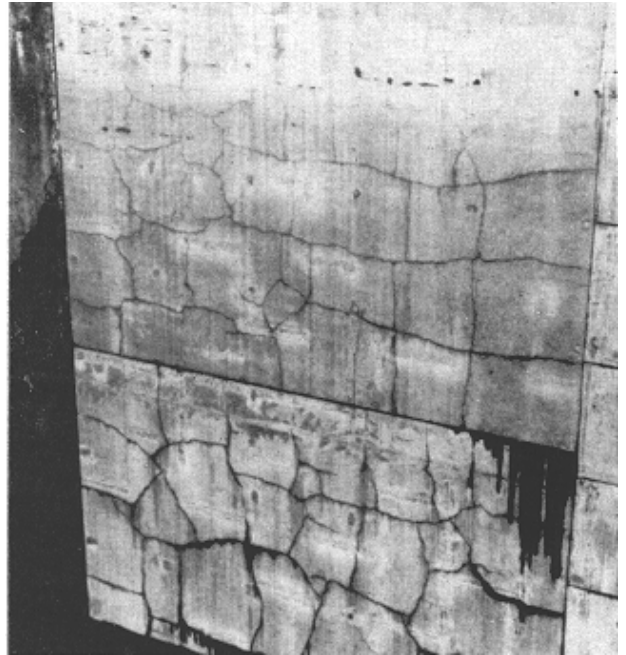
**Figure 2-5. Pattern cracking caused by restrained volume changes**

(a) Surface appearance of cracks. The surface appearance of cracks can give the first indication of the cause of cracking. Pattern cracks (Figures 2-5 through 2-7) are rather short cracks, usually uniformly distributed and interconnected, that run in all directions. Pattern cracking indicates restraint of contraction of the surface layer by the backing or inner concrete or possibly an

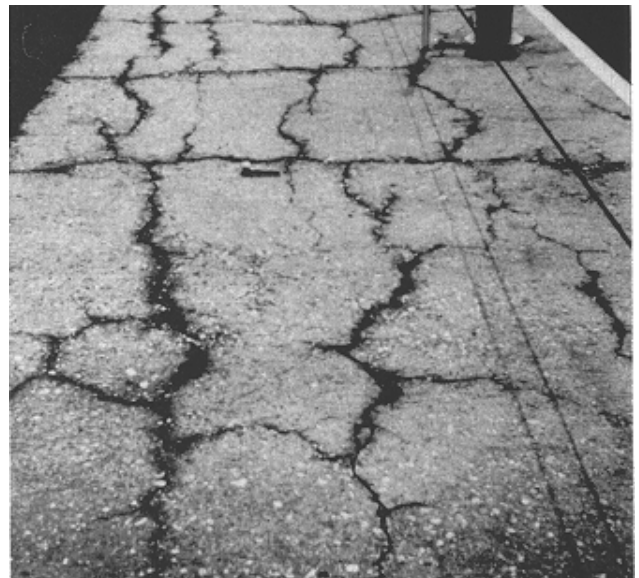
**Figure 2-6. Pattern cracking resulting from alkali-silica reaction**

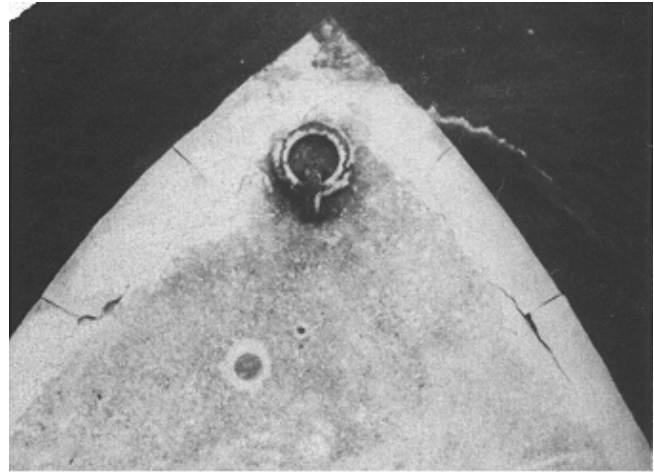
Figure 2-9. Isolated cracks as a result of restraint in the direction perpendicular to the crack

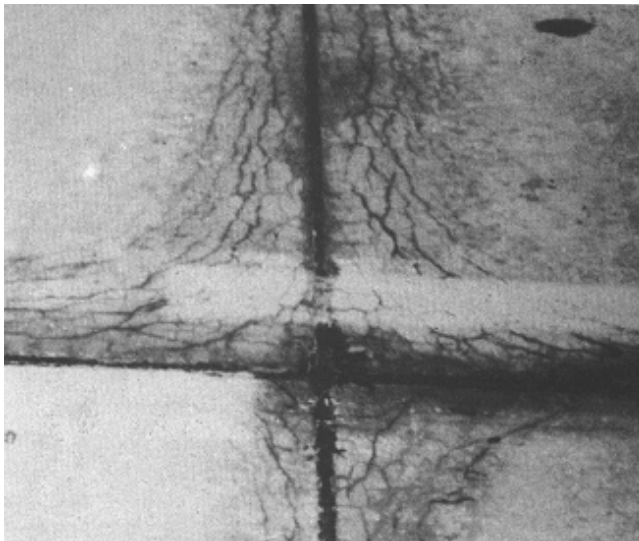
Figure 2-8. D-cracking in a concrete pavement

increase of volume in the interior of the concrete. Other terms used to describe pattern cracks are map cracks, crazing, and checking (see Glossary, Appendix B, for definitions). Another type of pattern crack is D-cracking. Figure 2-8 shows typical D-cracking in a concrete pavement. D-cracking usually starts in the lower part of a concrete slab adjacent to joints, where moisture accumulates, and progresses away from the corners of the slab. Individual cracks (Figures 2-9 through 2-11) run in definite directions and may be multiple cracks in parallel at definite intervals. Individual cracks indicate tension in the direction perpendicular to the cracking. Individual cracks are also frequently referred to as isolated cracks. Several terms may be used to describe the direction that an individual or isolated crack runs. These terms include diagonal, longitudinal, transverse, vertical, and horizontal.

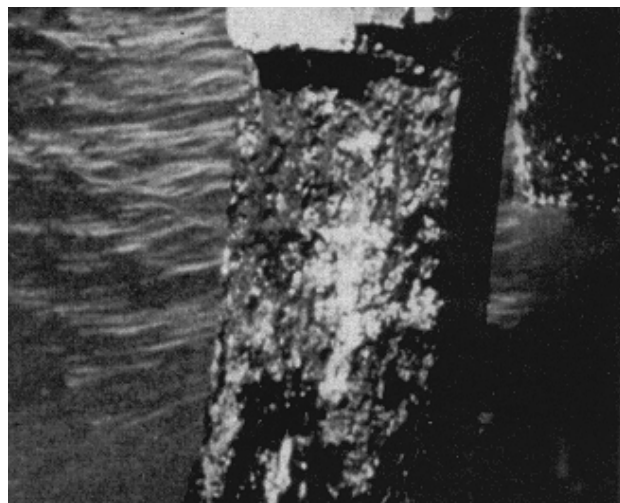
**Figure 2-13. Disintegration of concrete caused by exposure to acidic water**

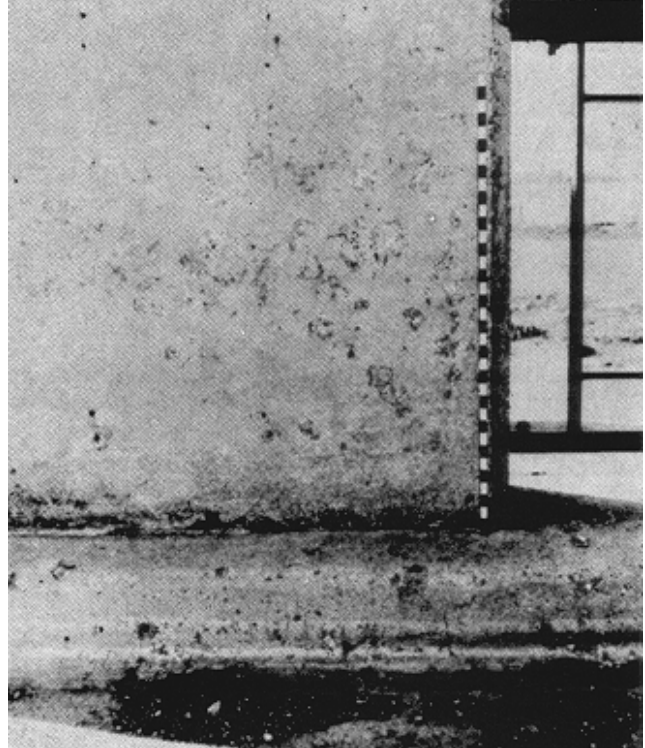
Figure 2-16. Light scaling

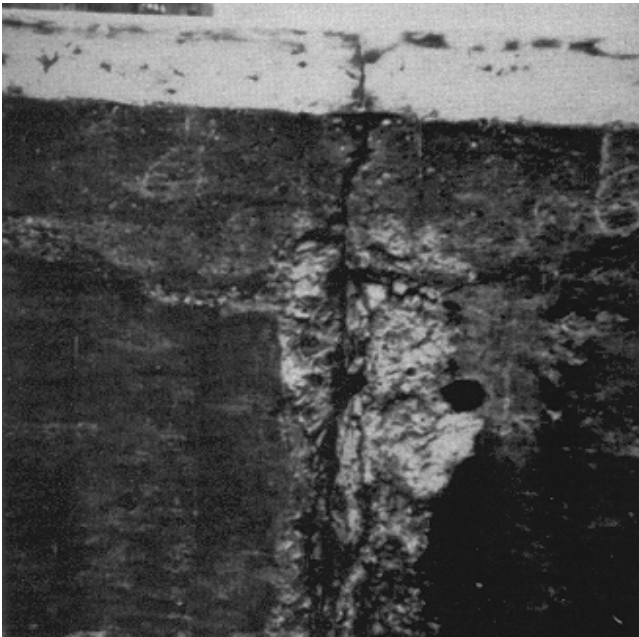
Figure 2-15. Disintegration at a monolith joint as a result of repeated cycles of freezing and thawing and barge impact

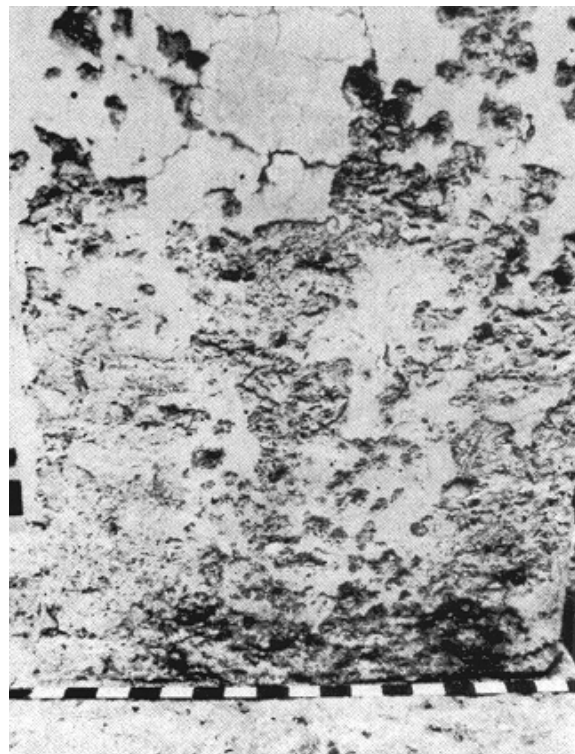
Figure 2-17. Medium scaling

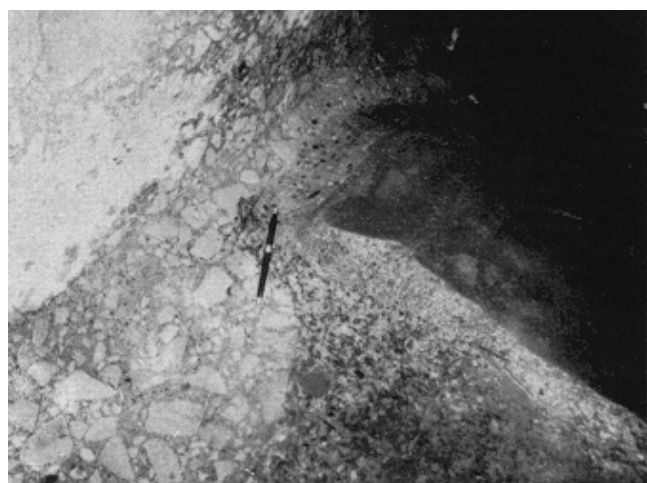
Figure 2-20. Smooth, worn, abraded concrete surface caused by abrasion of waterborne debris

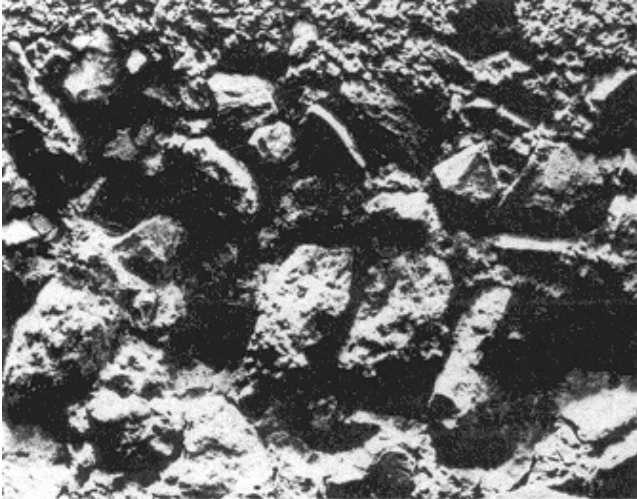
**Figure 2-21. Rough, pitted concrete surface caused by cavitation**

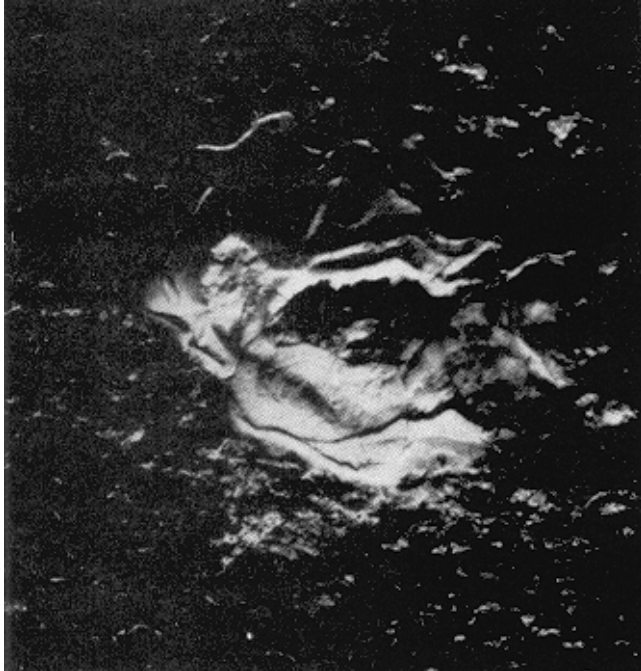
Figure 2-25. Exudation

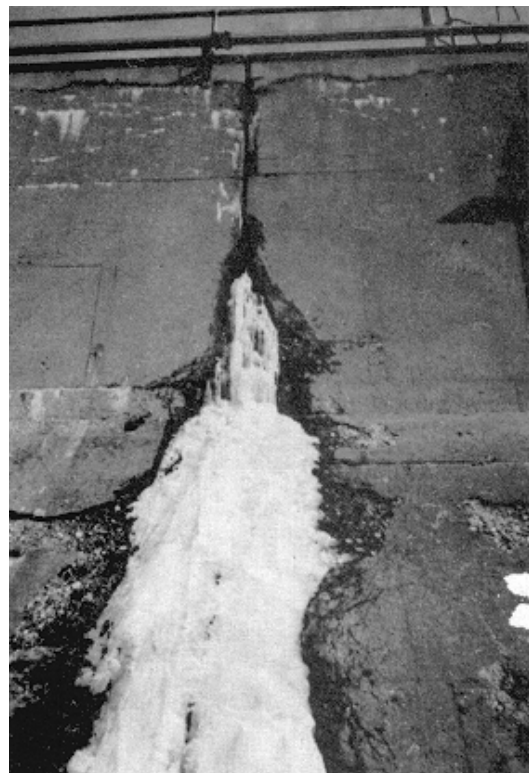
Figure 2-28. Water seepage through joint

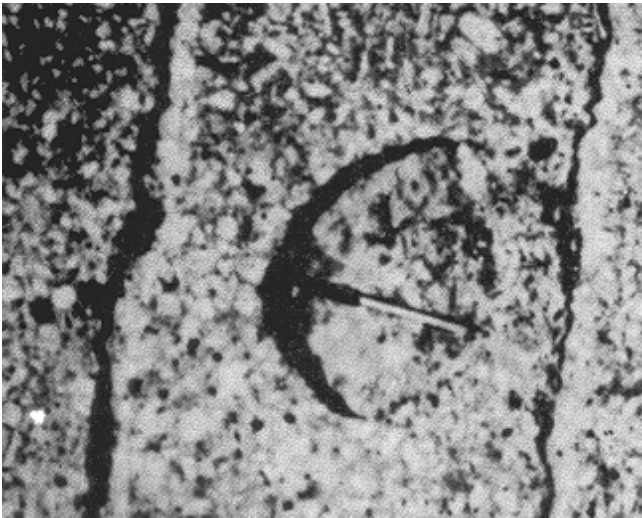
Figure 2-29. Small spall

(a) Small spall. Not greater than 20 mm (0.8 in.) in depth nor greater than 150 mm (6 in.) in any dimension (Figure 2-29).

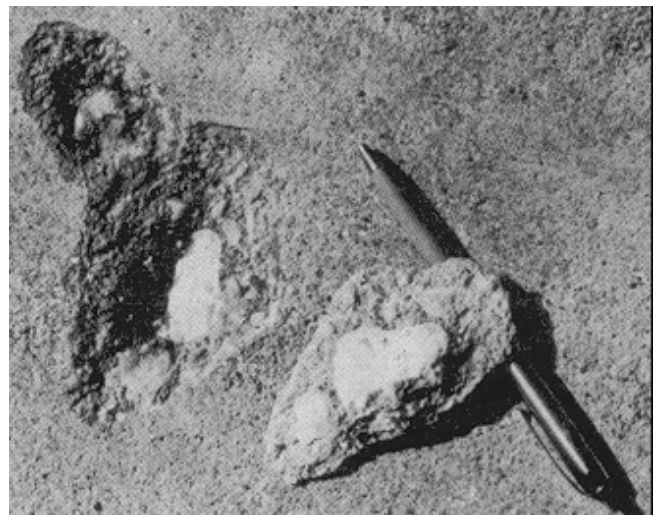
Figure 2-31. Popout

in saturated coarse aggregate particles near the surface freezes, expands, and pushes off the top of the aggregate particle and the superjacent layer of mortar, leaving shallow pits. Chert particles of low specific gravity, limestone containing clay, and shaly materials are well known for this behavior. Popouts are easily recognizable by the shape of the pit remaining in the surface and by a portion

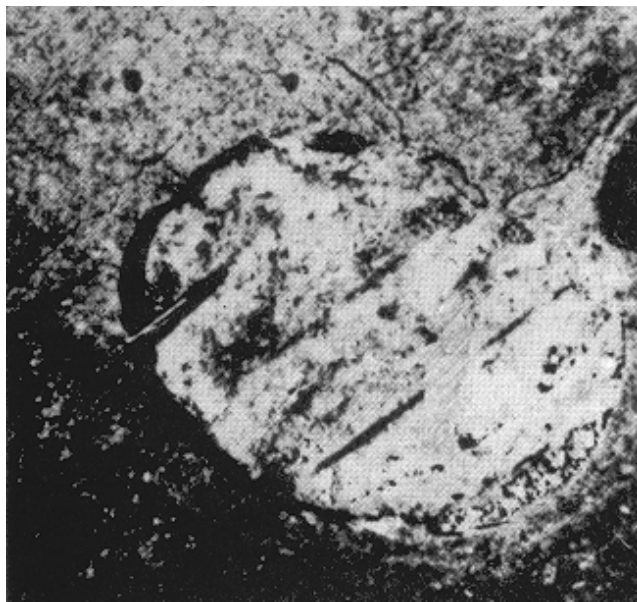
Figure 2-30. Large spall

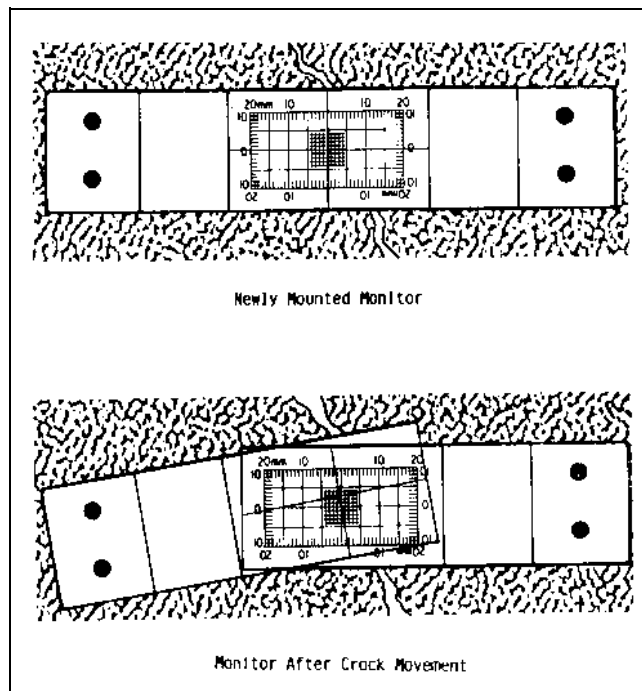
Figure 2-33. Crack monitor

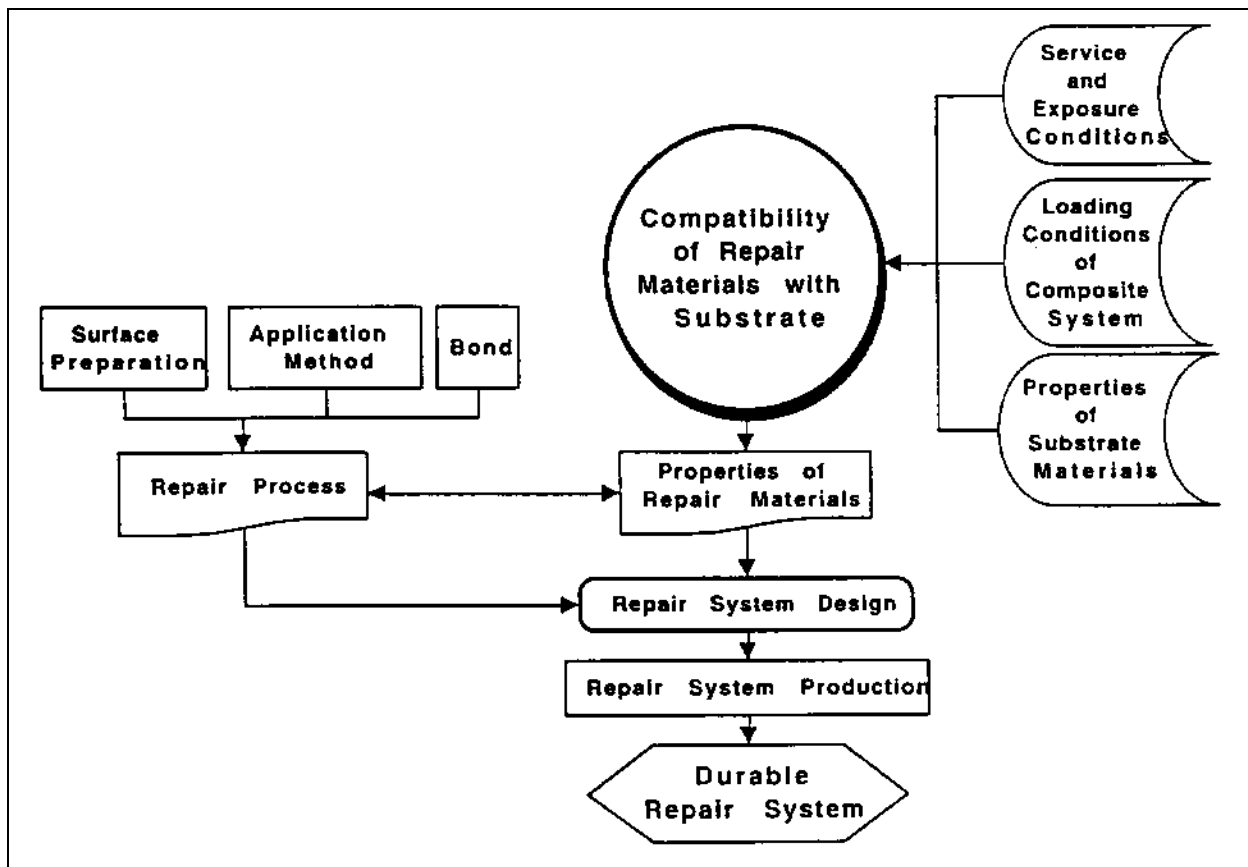
Figure 4-1. Factors affecting the durability of concrete repair systems (Emmons and Vaysburd 1995)

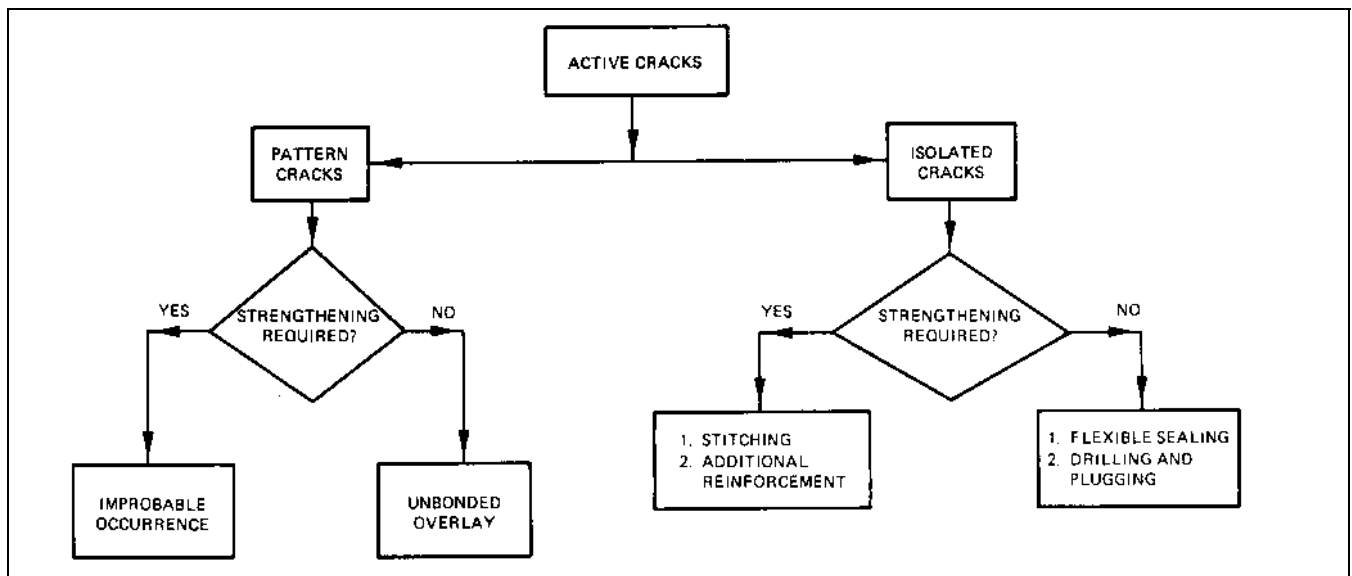
Figure 4-3. Selection of repair method for active cracks (after Johnson 1965)

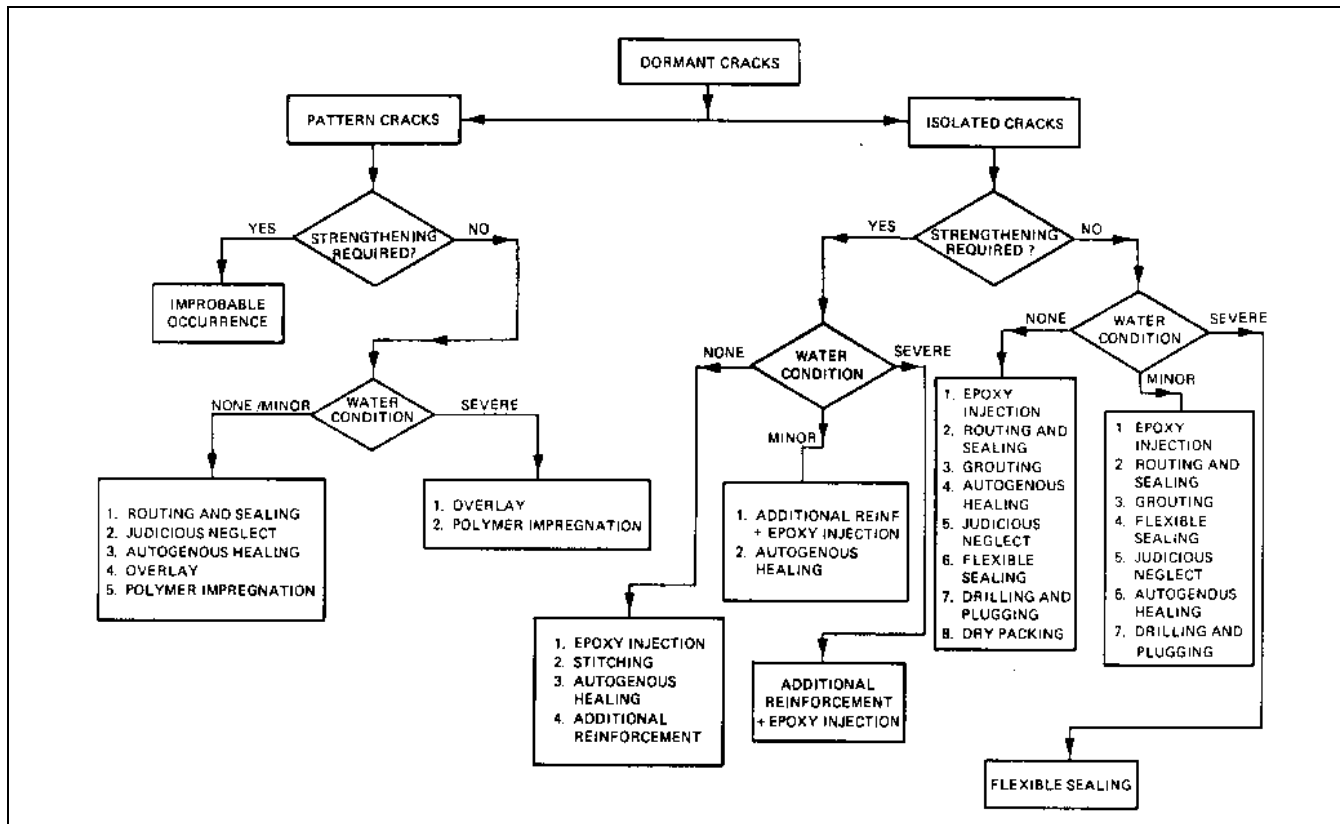
Figure 4-4. Selection of repair method for dormant cracks (after Johnson 1965)

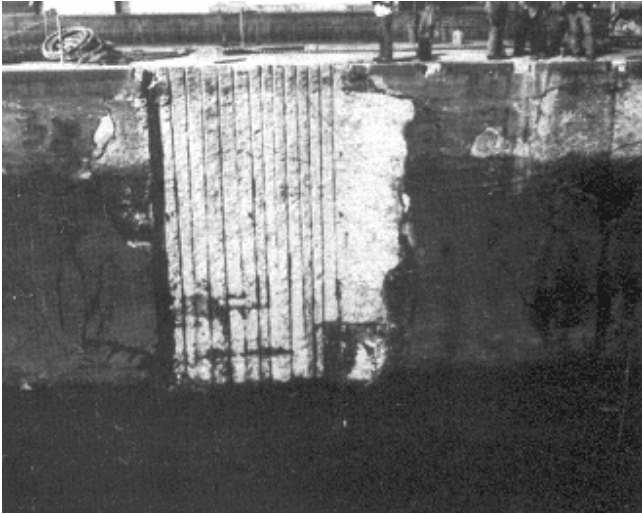
**Figure 5-1. Surface removal of deteriorated concrete by explosive blasting**

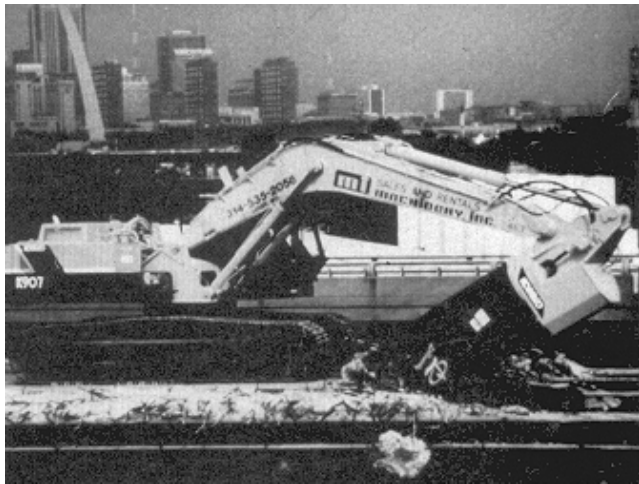
**Figure 5-2. Boom-mounted concrete crusher**

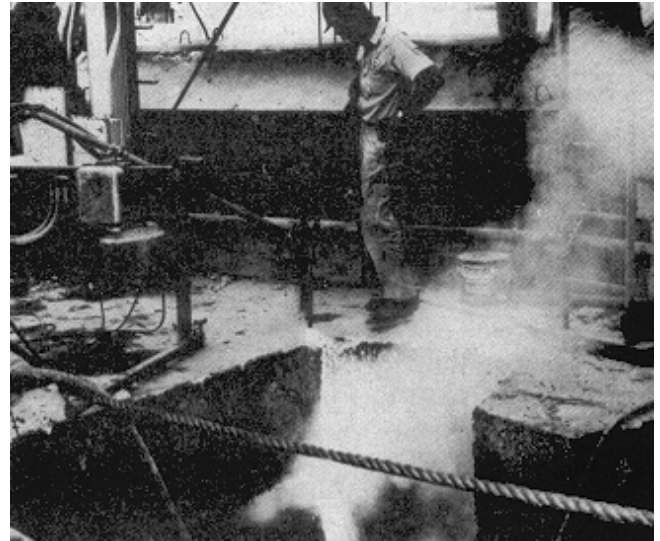
**Figure 5-5. Powder torch**

(5) *Thermal cutting.* Thermal-cutting methods are applicable for making cutouts through heavily reinforced decks, beams, walls, and other reinforced members where site conditions allow efficient flow of molten concrete from cuts. Flame tools (Figure 5-5) are typically employed for cutting depths of 600 mm (24 in.) or less, and lances (Figure 5-6), for greater depths. Thermal cutting tools are of limited commercial availability and are costly to use. The concrete that remains has a layer of thermal damage with more extensive damage occurring around steel reinforcement. Personnel must be protected from heat and hot flying rock produced by the cutting operation. Additional safety precautions are required because of the hazards associated with the storage, handling, and use of compressed and flammable gases. The

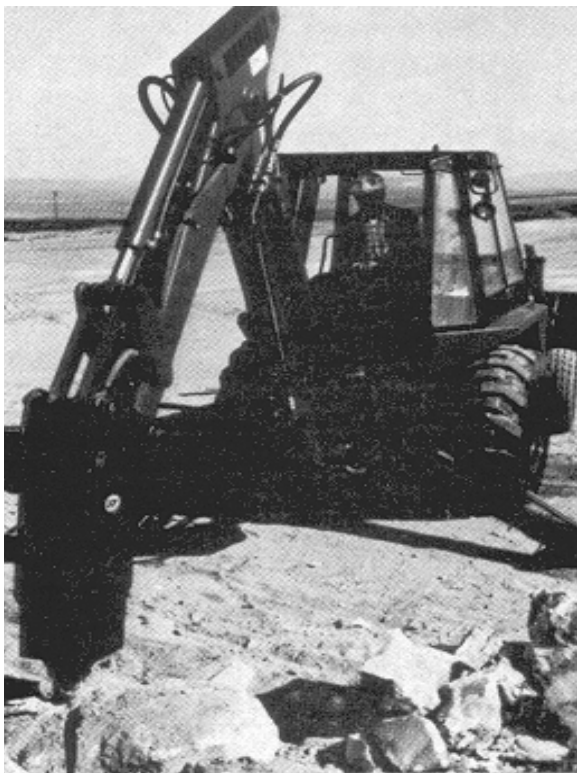
**Figure 5-7. Boom-mounted breaker**

(1) Boom-mounted breakers. Boom-mounted impact breakers are applicable for both full- and partial-depth removals where production rates required are greater than can be economically achieved by the use of hand-held breakers. The boom-mounted breakers are somewhat similar to the hand-held breakers except that they are considerably more massive. The tool is normally attached to the hydraulically operated arm of a backhoe or excavator (Figure 5-7) and can be operated by compressed air or hydraulic pressure. The reach of the hydraulic arm enables the tool to be used on walls at a considerable distance above or below the level of the machine. Boom-mounted breakers are a highly productive means of removing concrete. However, the blow energy delivered to the concrete should be limited to protect the structure being repaired and surrounding structures from damage resulting from the high cyclic energy generated. Saw cuts

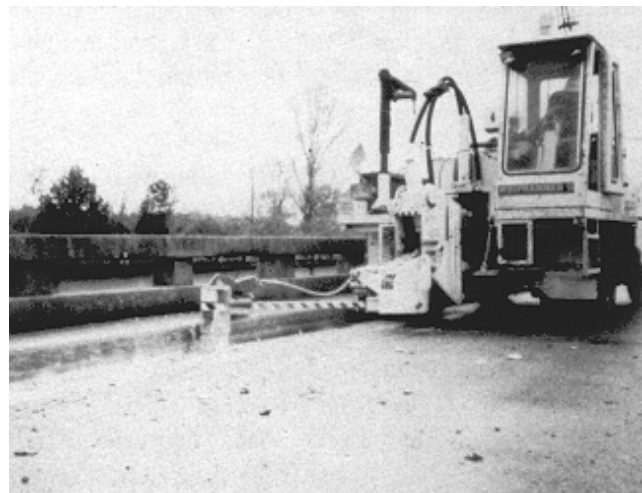
**Figure 5-8. Spring-action hammer (mechanical sledgehammer)**

(2) Spring-action hammers. Spring-action hammers (sometimes referred to as mechanical sledgehammers) are boom-mounted tools that are applicable for breaking concrete pavements, decks, walls, and other thin members where production rates required are greater than can be economically achieved with the use of hand-held breakers. Hammers are more applicable for total demolition of a concrete member than for removal to rehabilitate or repair. The arm of the hammer is hydraulically powered, and the impact head is spring powered. The spring is compressed by the downward movement of the arm of the backhoe or excavator and its energy released just prior to impact. There are truck units available that make it easier to move between projects. The operation of the hammer and advancement of the truck during removal are controlled from a cab at the rear of truck (Figure 5-8). The blow energy delivered to the concrete should be limited to protect the structure being repaired and surrounding structures from damage caused by the high cyclic energy generated. Saw cuts should be employed at removal boundaries to reduce the occurrence of feathered edges. The concrete that remains may be damaged (microcracking) along with the exposed reinforcing steel.

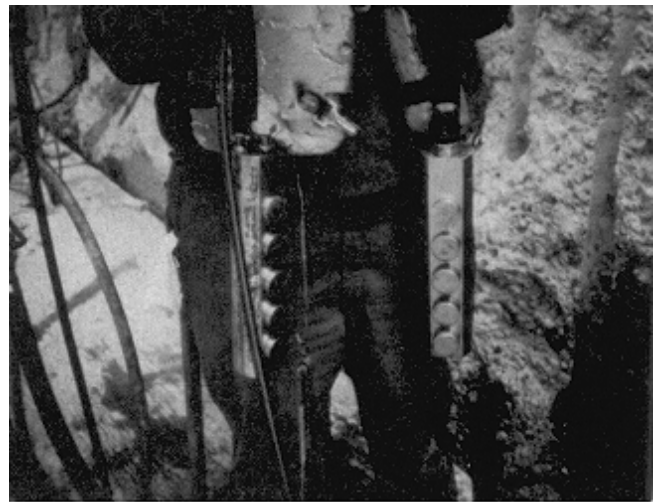
Figure 5-13. Piston-jack splitter

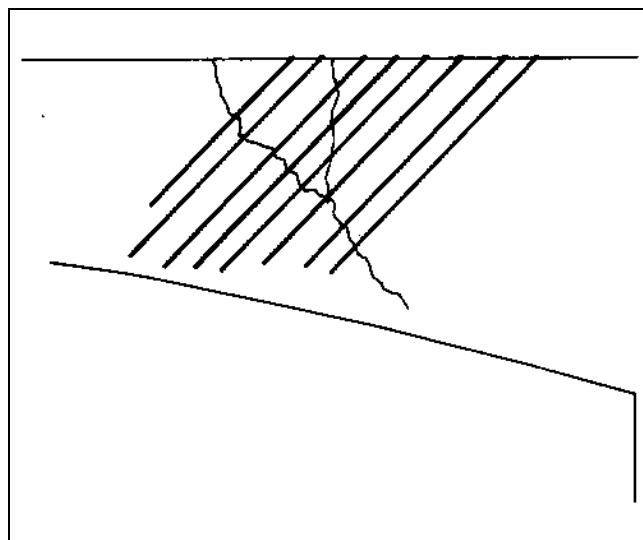
**Figure 6-1. Crack repair using conventional reinforcement with drillholes 90 deg to the crack plane**

(a) This technique consists of sealing the crack, drilling holes 19 mm (3/4 in.) in diam at 90 deg to the crack plane (Figure 6-1), cleaning the hole of dust, filling the hole and crack plane with an adhesive (typically epoxy) pumped under low pressure 344 to 552 KPa (50 to 80 psi), and placing a reinforcing bar into the drilled hole. Typically, No. 4 or 5 bars are used, extending at least 0.5 m (1.6 ft) on each side of the crack. The adhesive

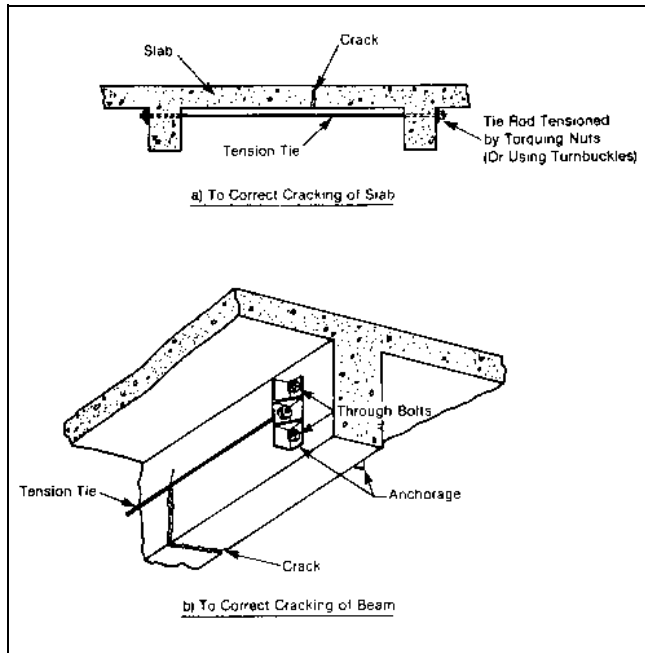
Figure 6-2. Crack repair with use of external prestressing strands or bars to apply a compressive force

(2) Prestressing steel. This technique uses prestressing strands or bars to apply a compressive force (Figure 6-2). Adequate anchorage must be provided for the prestressing steel, and care is needed so that the problem will not merely migrate to another part of the structure. The effects of the tensioning force (including eccentricity) on the stress within the structure should be carefully analyzed. For indeterminate structures posttensioned according to this procedure, the effects of secondary moments and induced reactions should be considered.

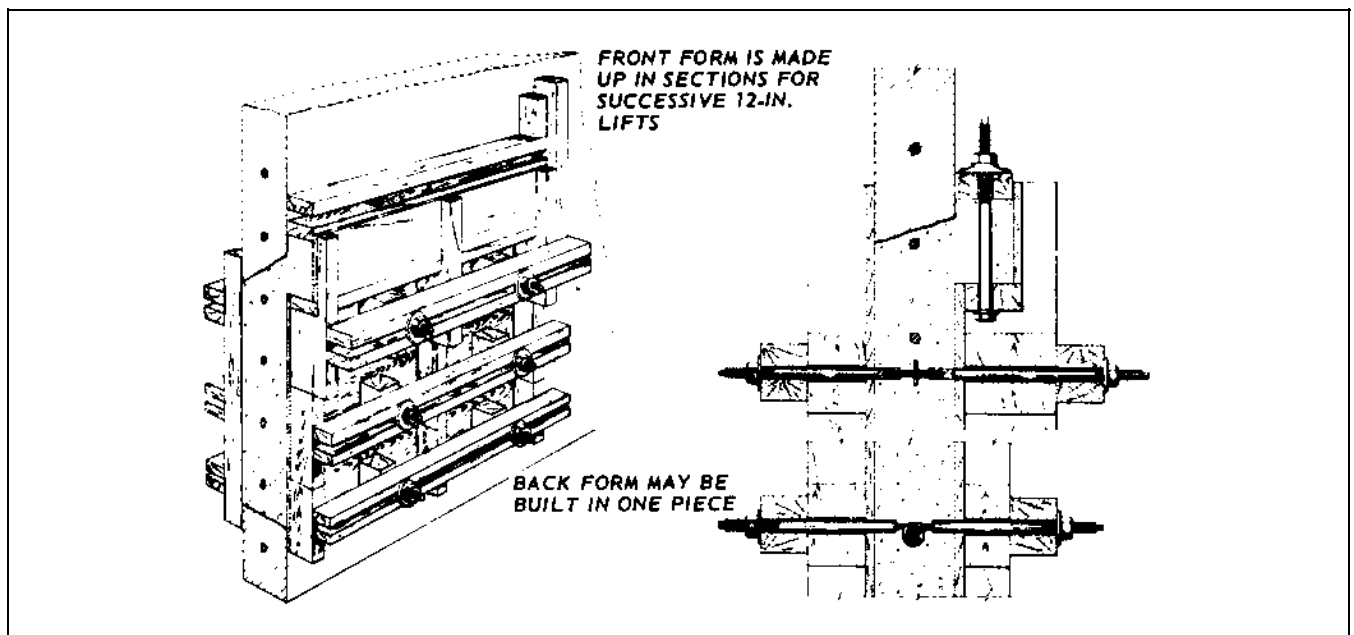
Figure 6-3. Detail of form for concrete replacement in walls after removal of all unsound concrete

(3) Forming will usually be required for massive repairs in vertical surfaces. The front form and the back form, where one is required, should be substantially constructed and mortar-tight. The back form may be assembled in one piece, but the front panel should be constructed as placing progresses so that the concrete can be conveniently placed in lifts. The contact surface should be dry at the time of patching. Small, thin repairs (less than 50 mm (2 in.) thick) should receive a bonding coat while thicker placements usually do not require a bonding coat (see paragraph 5-3a(2)(f)). The surface is first carefully coated with a thin layer of mortar, not exceeding 3 mm (1/8 in.) in thickness, containing sand passing the No. 16 sieve, and having the same w/c as the concrete to be used in the replacement. Hand-rubbing the mortar into the surface is effective. Epoxy resin

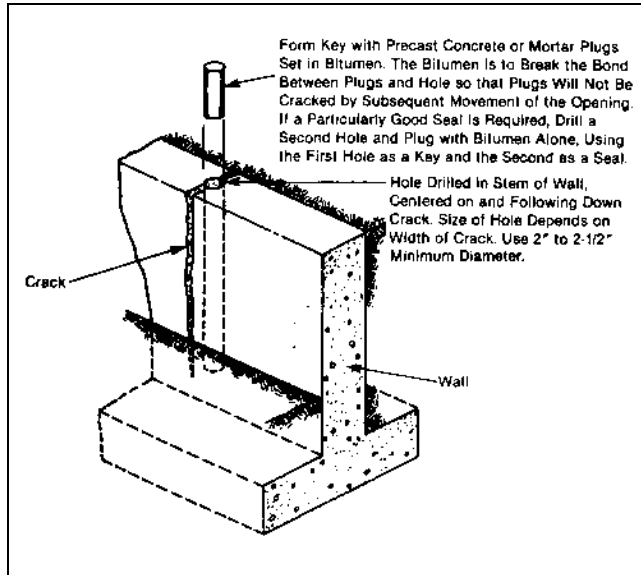
Figure 6-5. Repair of crack by drilling and plugging

a. *Description.* Drilling and plugging a crack consists of drilling down the length of the crack and grouting it to form a key (Figure 6-5).

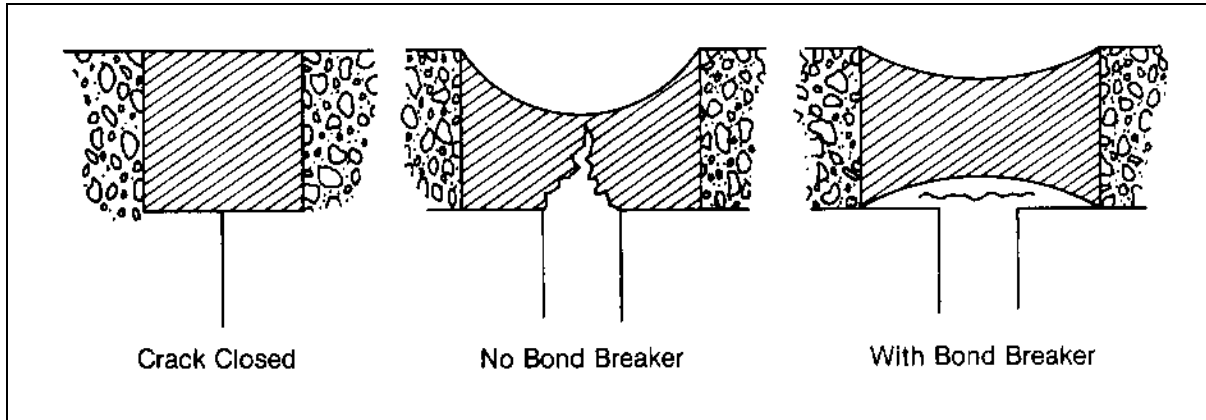
Figure 6-6. Effect of bond breaker involving a field-molded flexible sealant

(1) A bond breaker should be provided at the bottom of the slot to allow the sealant to change shape without a concentration of stress on the bottom (Figure 6-6). The bond breaker may be a polyethylene strip, pressure sensitive tape, or other material which will not bond to the sealant before or during cure.

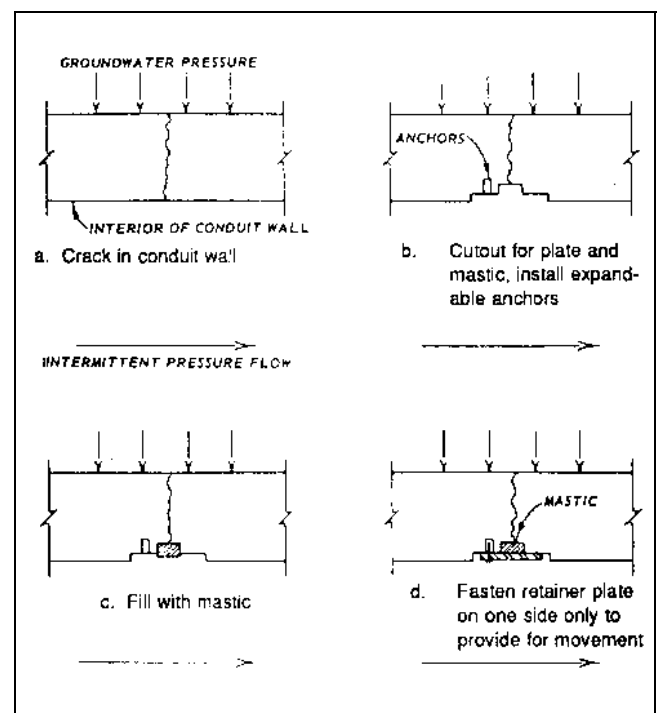
Figure 6-8. Repair of crack by use of a retainer plate to hold mastic in place against external pressure

necessary to cut the concrete surface adjacent to the crack and to place the retaining cap flush with the original flow lines (Figure 6-8).

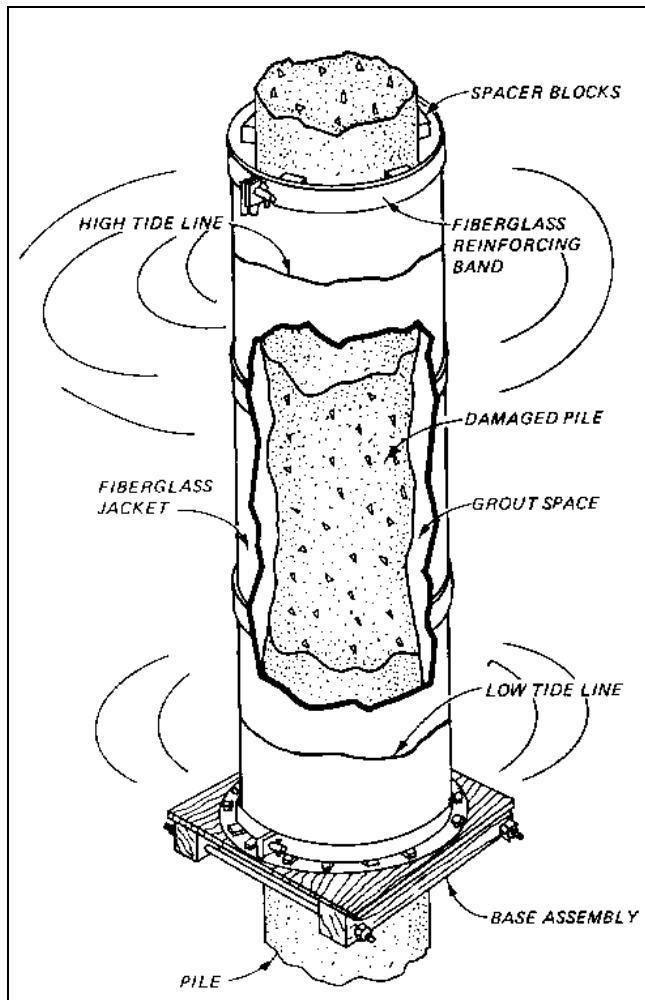
**Figure 6-9. Typical preformed fiberglass jacket being used in repair of a concrete pile**

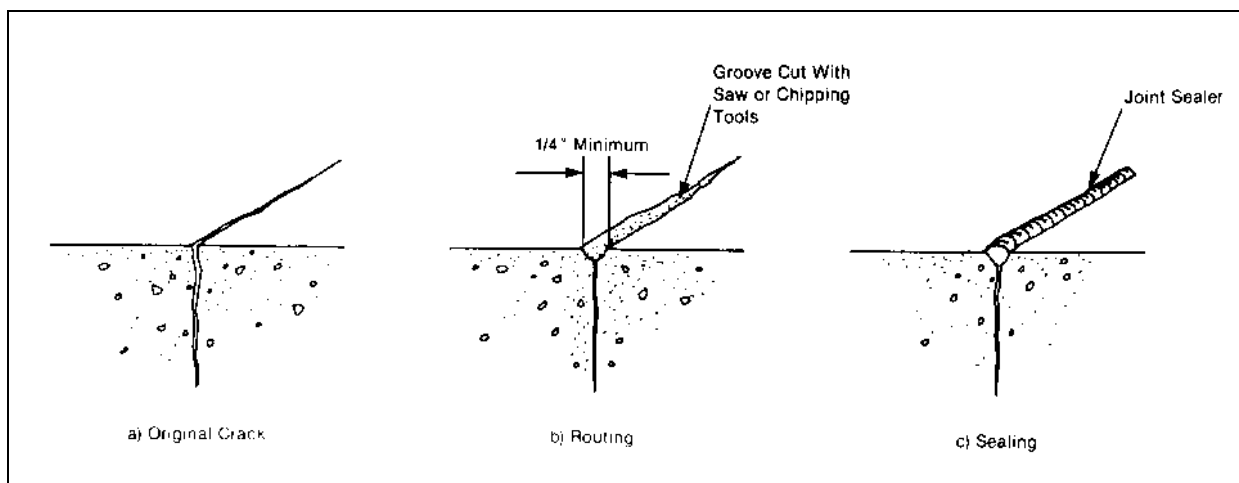
Figure 6-10. Repair of crack by routing and sealing

*a. Description.* This method involves enlarging the crack along its exposed face and filling and sealing it with a suitable material (Figure 6-10). The routing operation may be omitted but at some sacrifice in the permanence of the repair. This is the simplest and most common method for sealing dormant cracks.

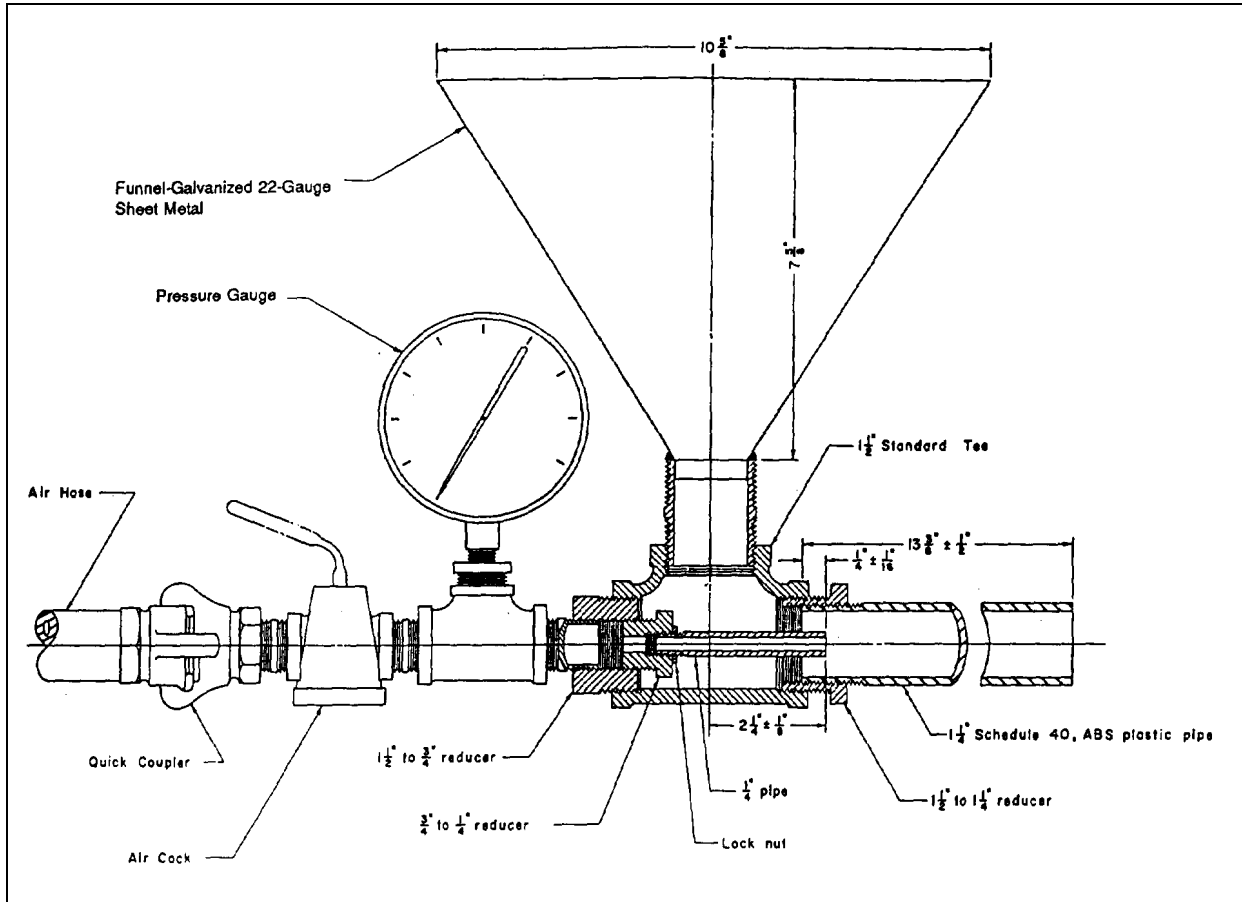
Figure 6-11. Mortar gun for concrete repair (U.S. Army Engineer Division, Missouri River 1974)

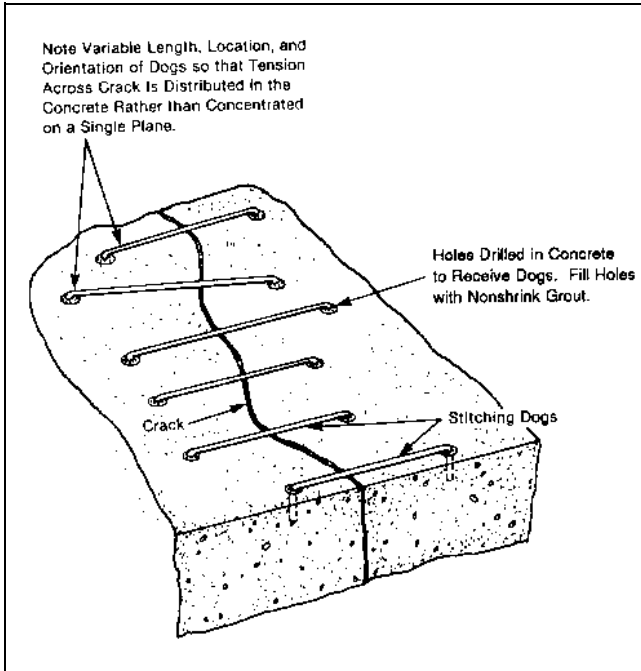
Figure 6-13. Repair of a crack by stitching

*b. Applications and limitations.* Stitching may be used when tensile strength must be reestablished across major cracks. Stitching a crack tends to stiffen the structure, and the stiffening may accentuate the overall structural restraint, causing the concrete to crack elsewhere. Therefore, it may be necessary to strengthen the adjacent

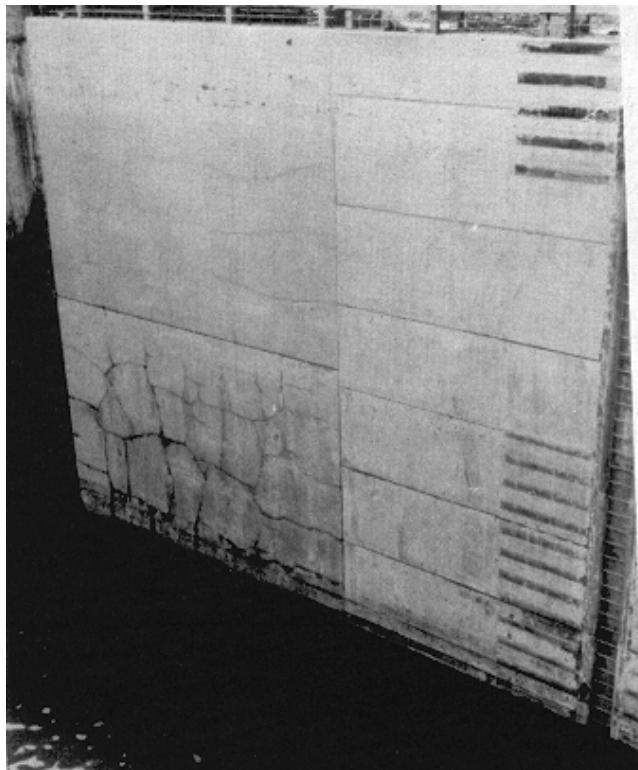
Figure 8-3. Concrete cracking in resurfaced monolith (left) compared to reconstructed monolith, Lock No. 1, Mississippi River

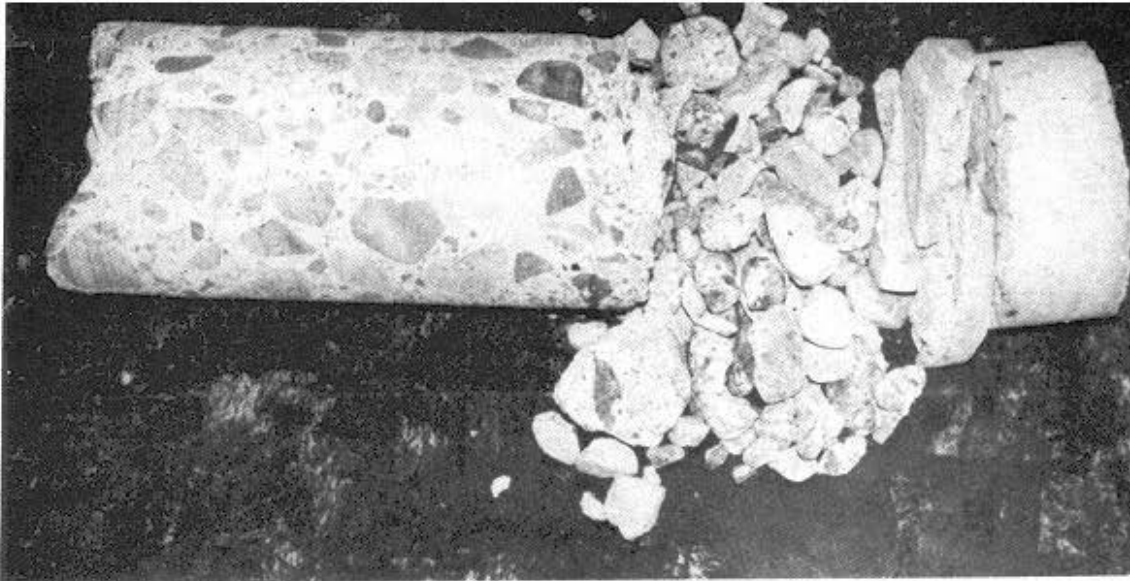
a. Concrete deterioration immediately behind shotcrete overlay

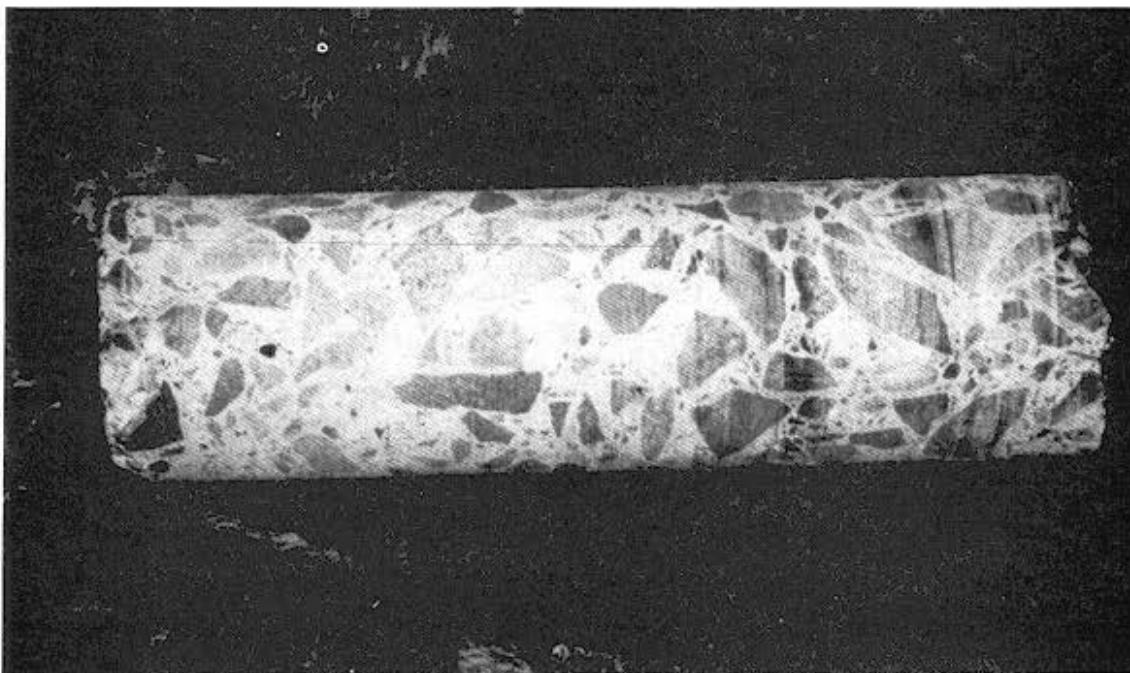
b. Concrete not refaced with shotcrete

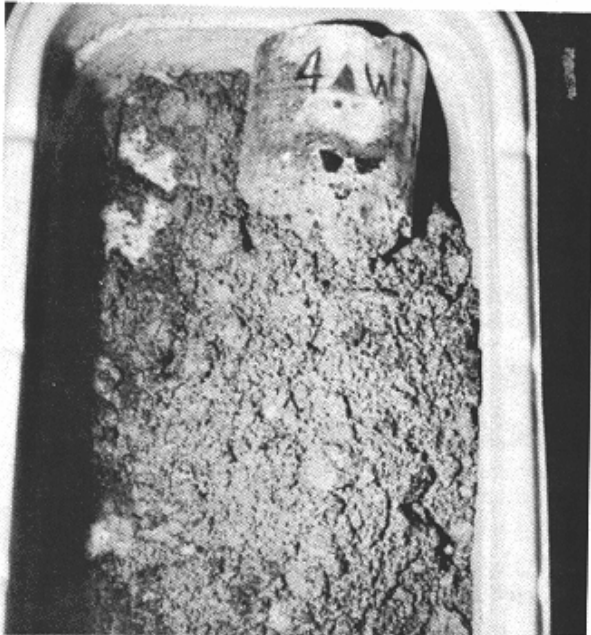
b. After freezing and thawing

Figure 8-8. Combination shotcrete and concrete core before and after 35 cycles of freezing and thawing in a saturated condition

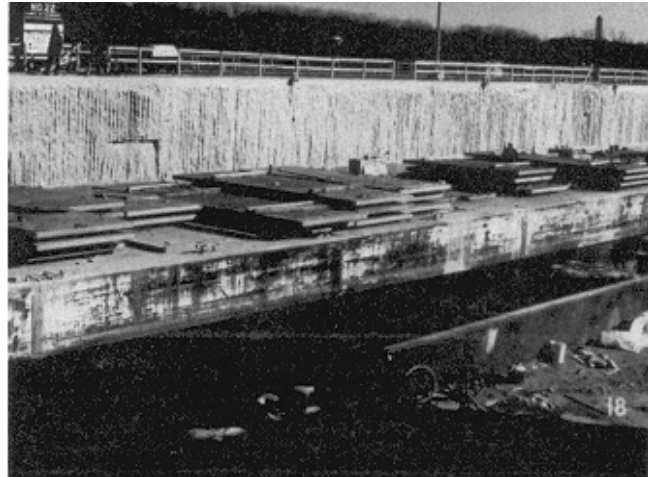
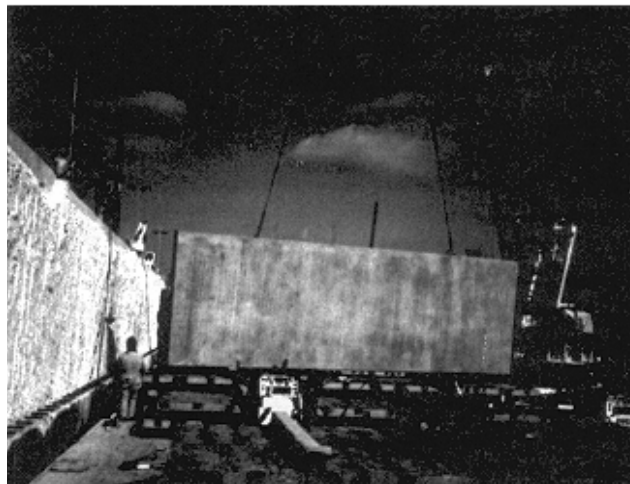
**Figure 8-14. Installation of precast concrete stay-in-place forms at Lock 22, Mississippi River**

(d) This application of the precast concrete stay-in-place forming system demonstrated the potential for eliminating the need to close and dewater a lock during rehabilitation. Consequently, concepts for installation of the system in an operational lock were developed as part of the REMR research program (ABAM 1989). A mobile cofferdam was selected as the preferred installation method and a final design completed for this concept. This study indicated that it is feasible to repair the walls in an operational lock with only minimal impact on costs.
