CECW-EG  Engineer Manual 1110-2-2002	Department of the Army U.S. Army Corps of Engineers Washington, DC 20314-1000	EM 1110-2-2002  30 June 1995
	Engineering and Design  EVALUATION AND REPAIR OF CONCRETE STRUCTURES	
	<b>Distribution Restriction Statement</b> Approved for public release; distribution is unlimited.

**Engineering and Design**  
**EVALUATION AND REPAIR OF CONCRETE STRUCTURES**

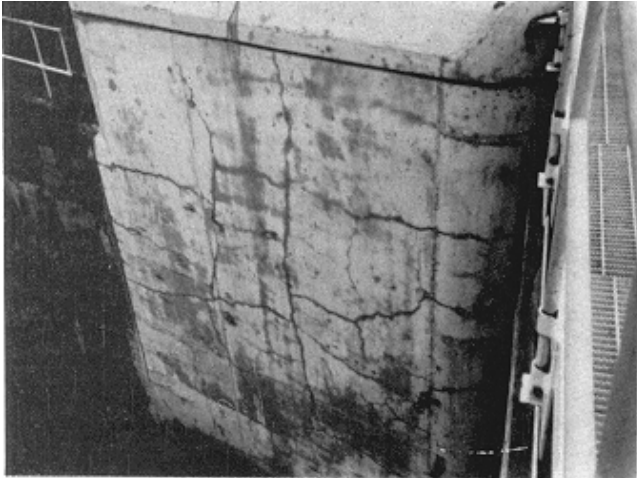
**Figure 8-16. Typical cracking in miter gate monoliths resurfaced with cast-in-place concrete, Troy Lock, Hudson River (Miles 1993)**

(i) The top of the precast panels was capped with 0.6 m (2 ft) of reinforced concrete, cast-in-place. A 152-mm (6-in.)-thick apron slab was also placed on top of the existing monolith wall to reduce water penetration and improve durability. Joints between panels and concrete cap and between cap and apron slab were sealed with joint sealant. Upon completion of the lock chamber resurfacing, an inspection of the precast panels revealed that 11 of 112 panels exhibited some fine cracks. Those cracks (four locations) with widths in excess of 0.15 mm (0.006 in.) were repaired by epoxy injection. In contrast, the miter gate monoliths previously resurfaced with cast-in-place concrete exhibited extensive cracking (Figure 8-16).

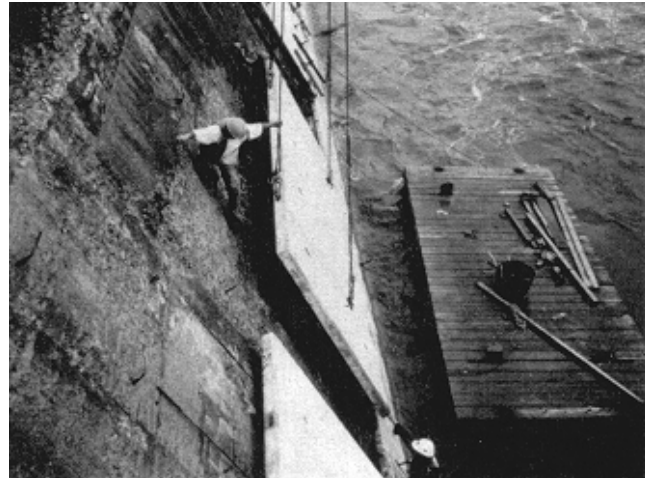
**Figure 8-17. Installing precast concrete panels used to overlay the back side of the river wall at Troy Lock, Hudson River (Miles 1993)**

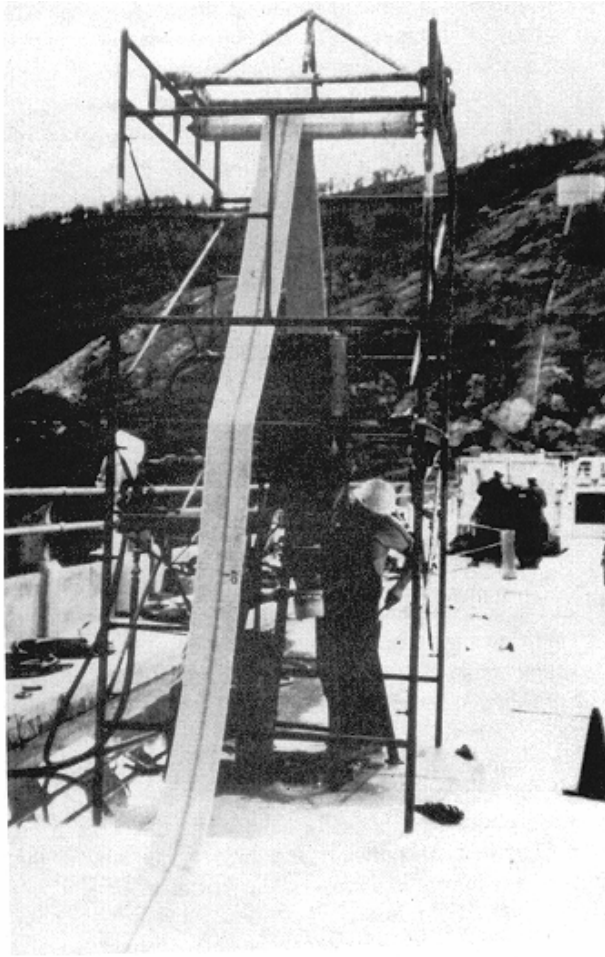
**Figure 8-24. Inversion apparatus for installing tube in drill hole, Pine Flat Dam**

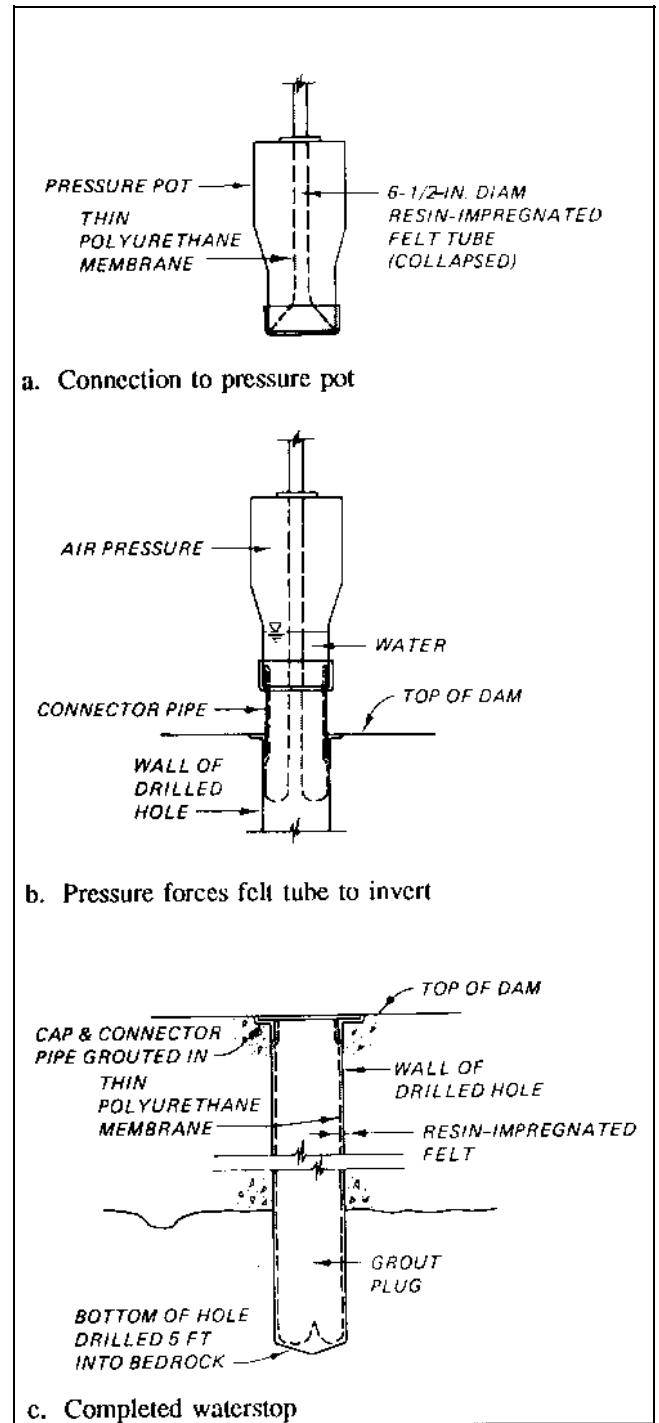
**Figure 8-25. Remedial waterstop installation, Pine Flat Dam**

(1) Interior joints. The repair procedure consists of drilling an array of small-diameter holes from various locations within the gallery or conduit to intercept the

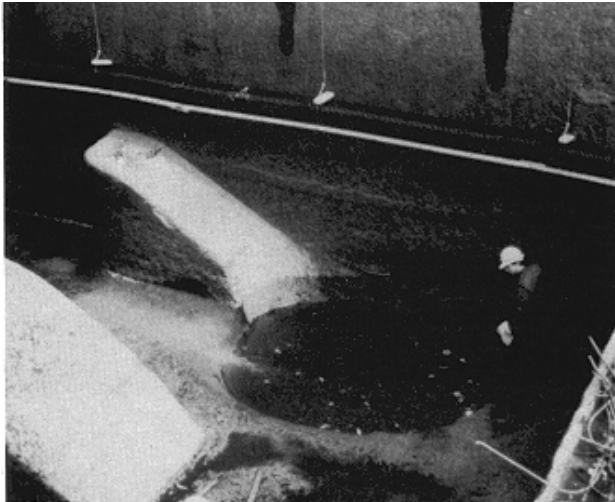
a. Scour holes behind baffles

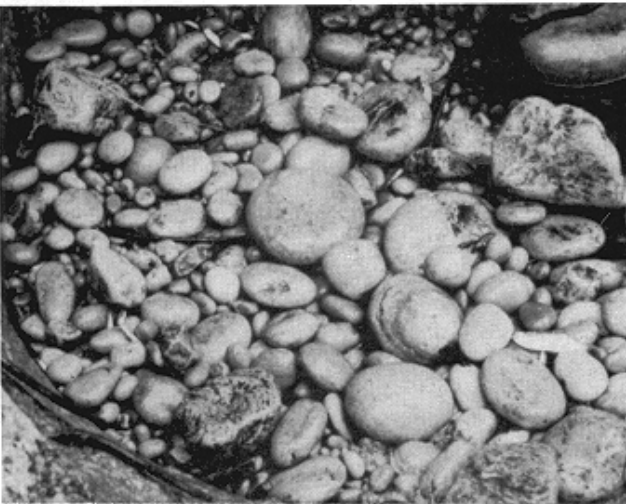
b. Debris in scour holes

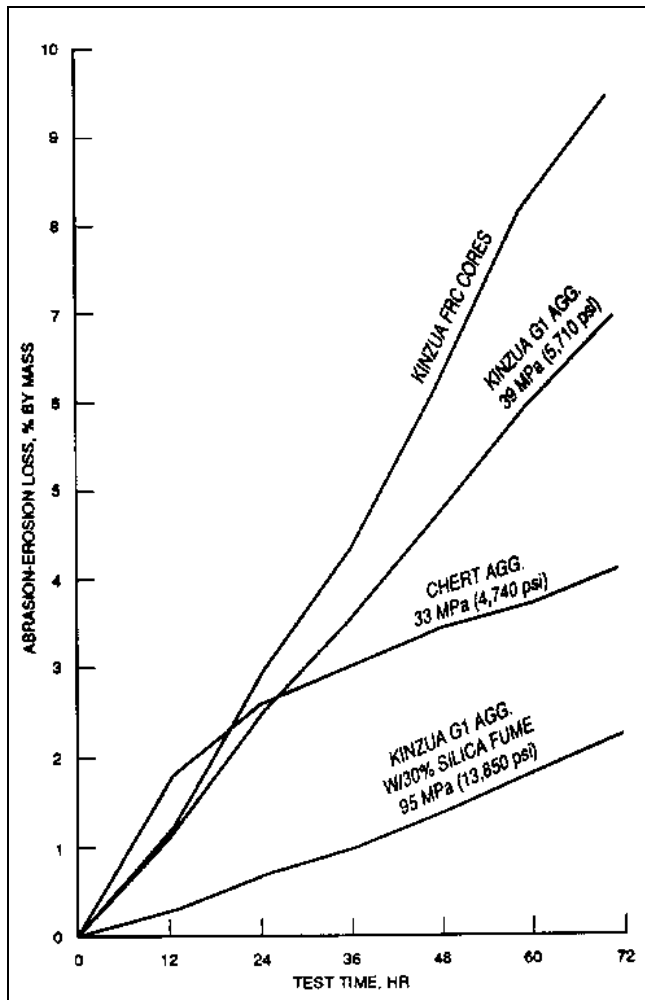
Figure 8-35. Results of selected abrasion-erosion tests, Kinzua Dam

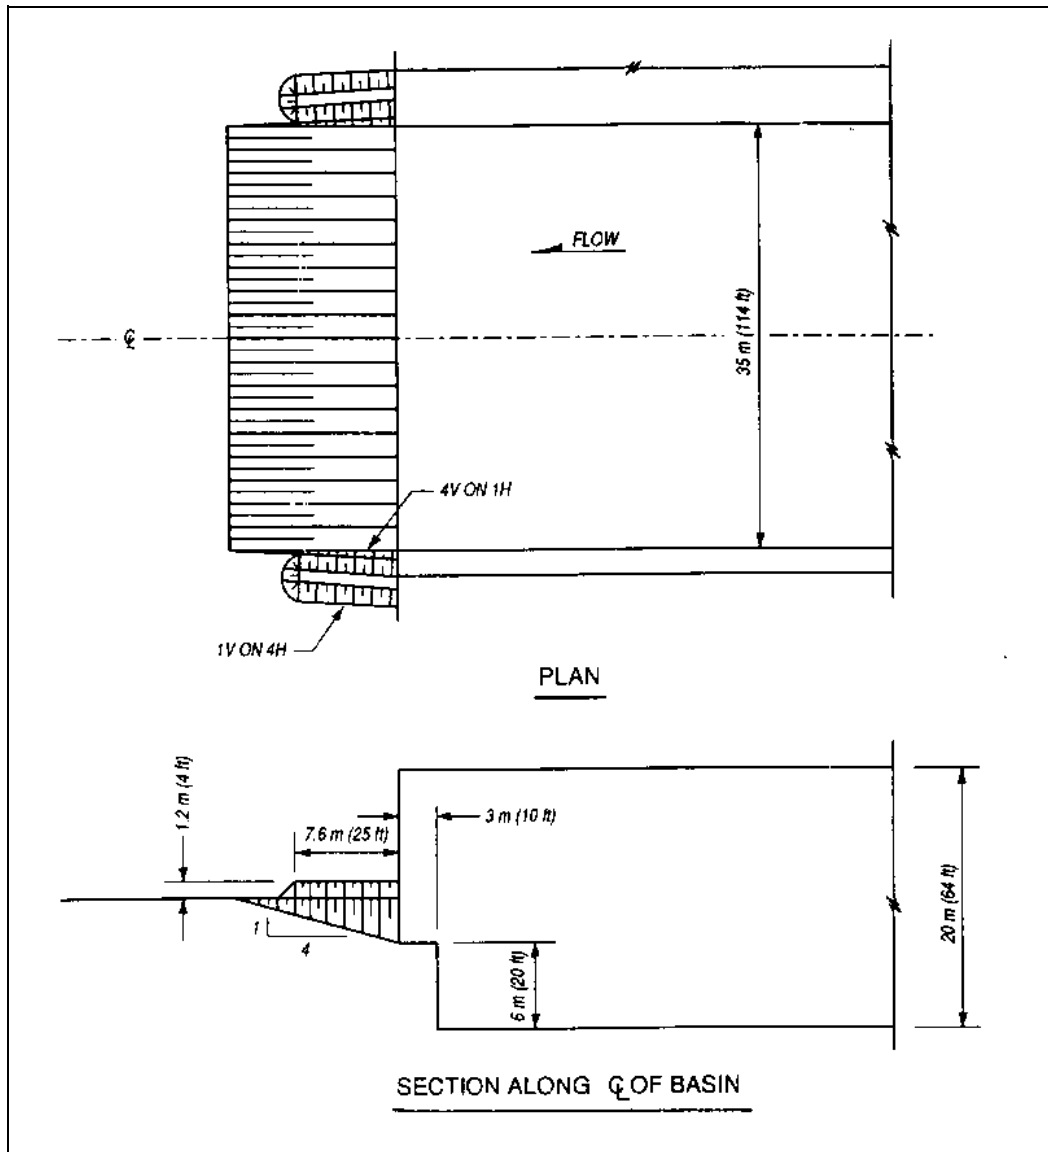
Figure 8-37. Stilling basin wall extension fills, Dworshak Dam

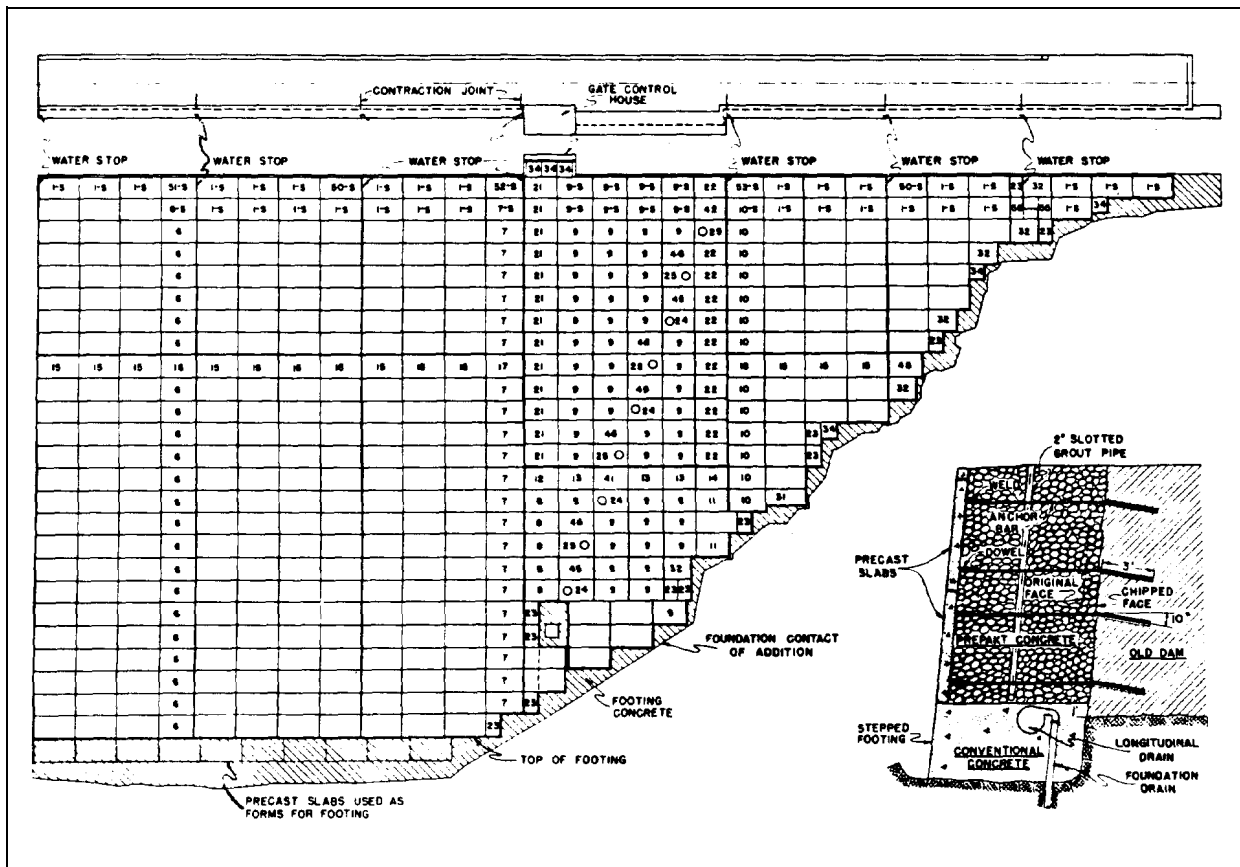
Figure 8-38. Footing and slab layout, south half of Barker Dam (from Davis, Jansen, and Neelands 1948)

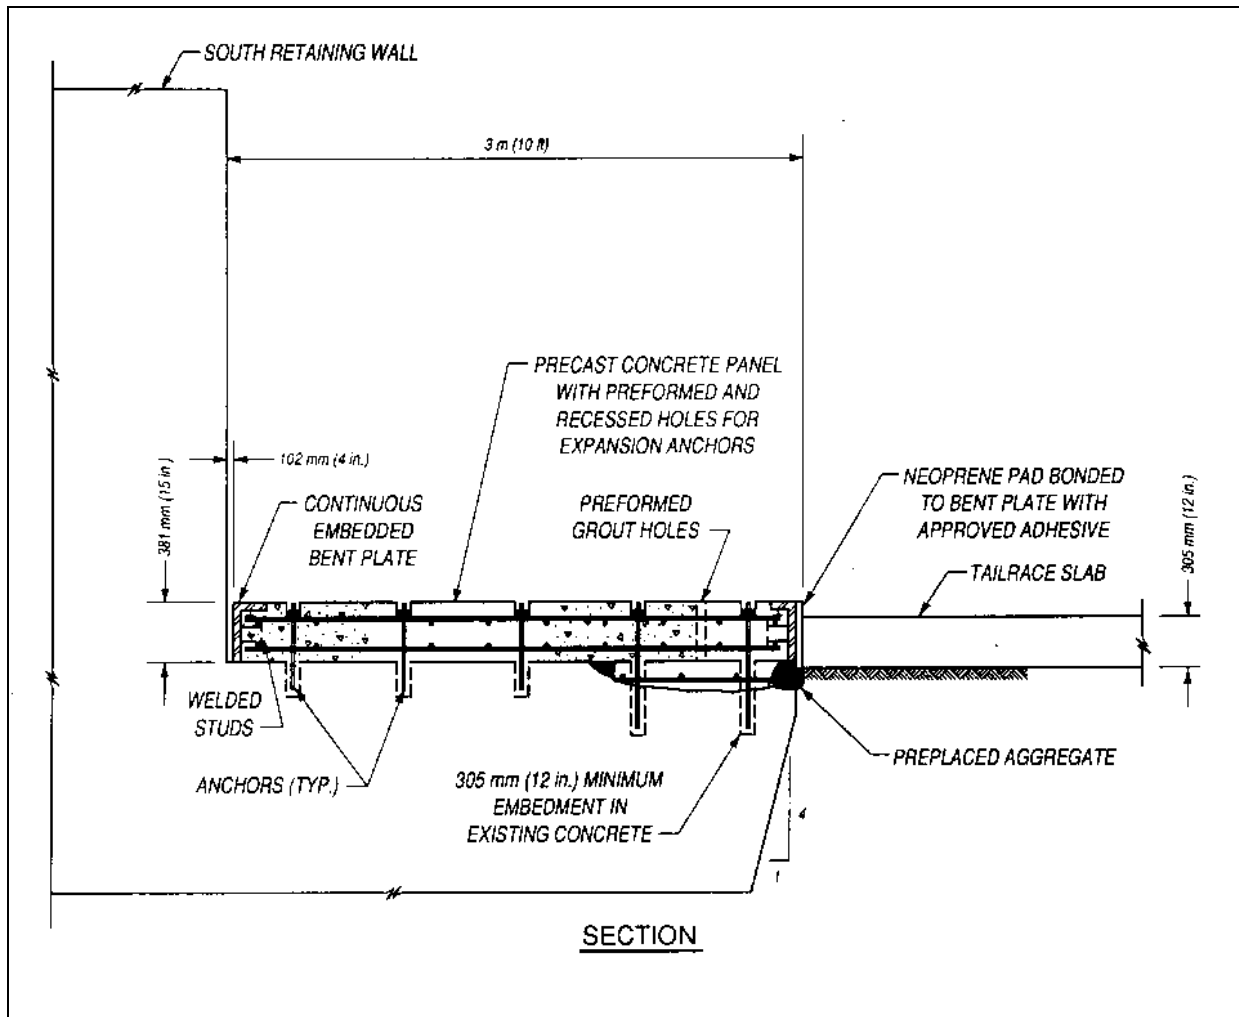
Figure 8-39. Underwater repair of concrete spalling, Gavins Point Dam

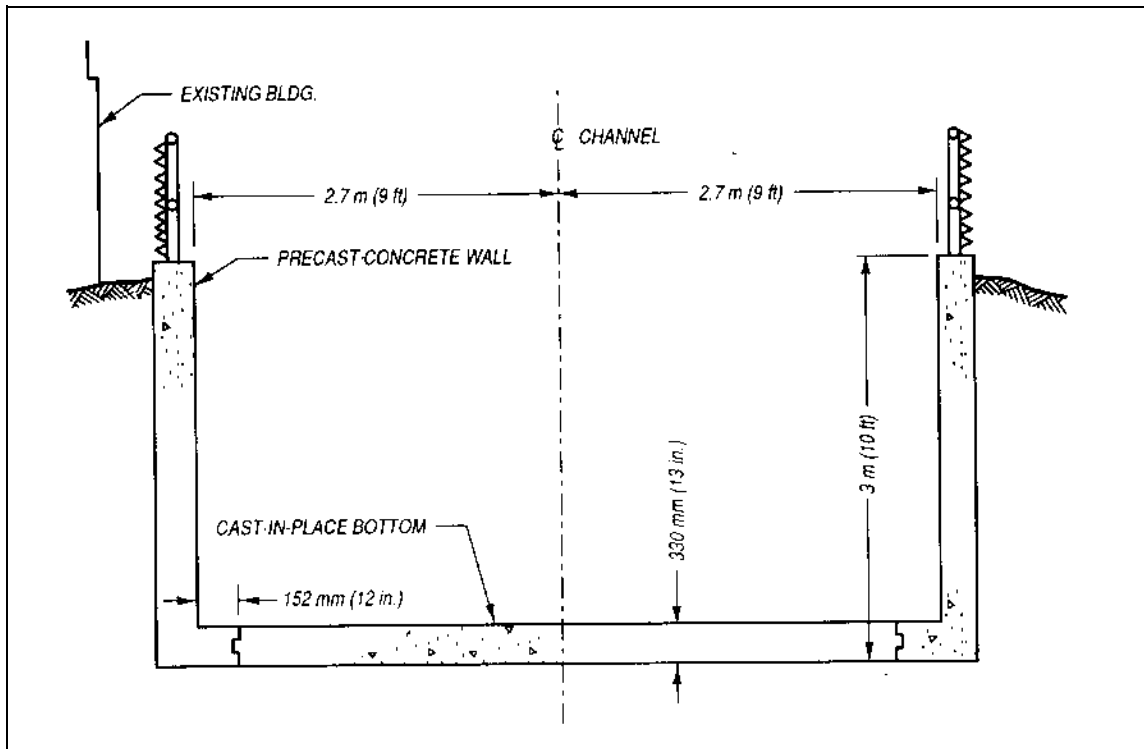
Figure 8-45. Typical channel repair section, Placer Creek (after Hacker 1986)

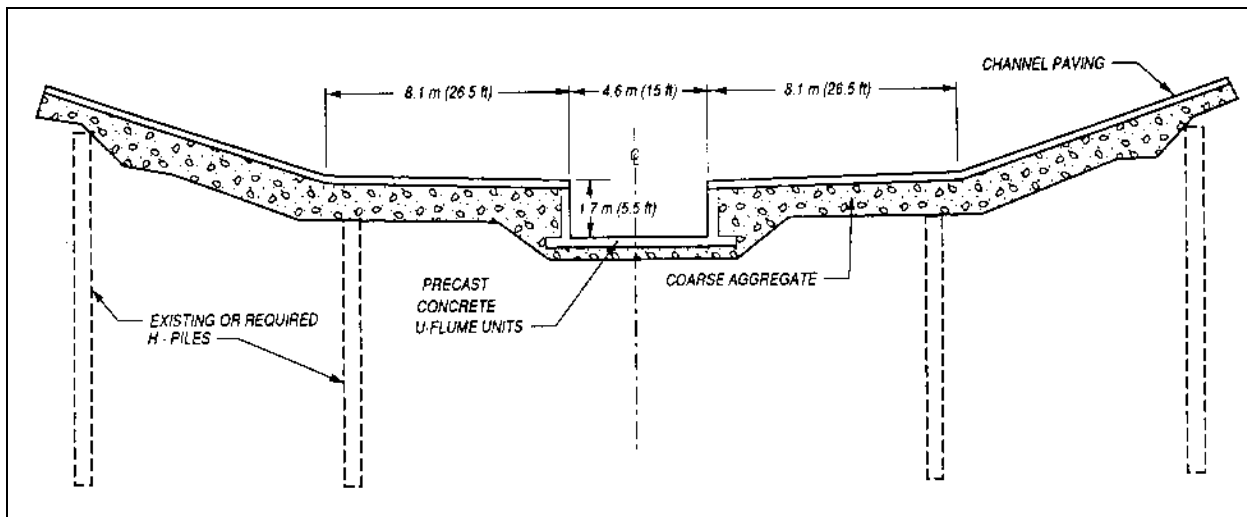
Figure 8-46. Cross section of precast low-flow channel, Blue River Channel (after Mitscher 1992)

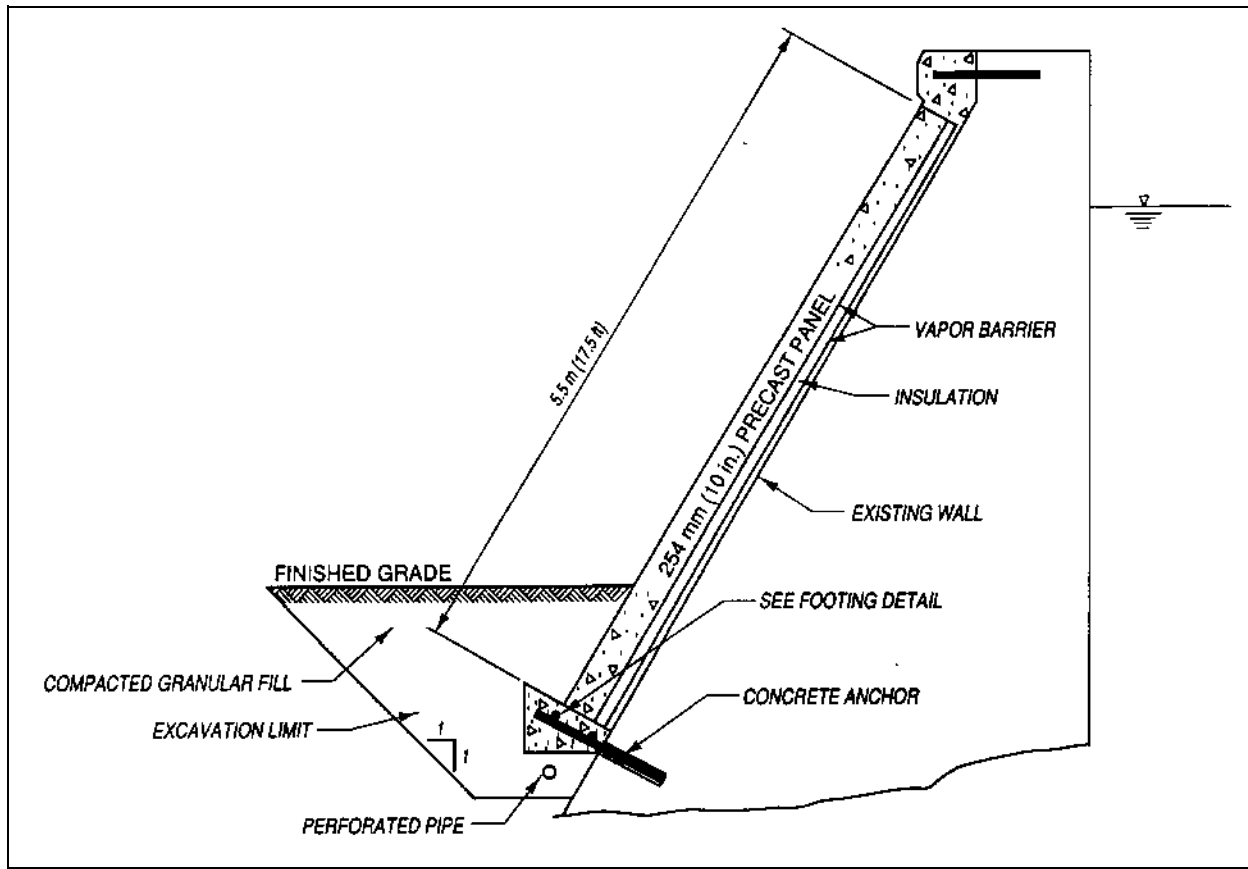
Figure 8-49. Typical repair section, Joliet Channel Wall

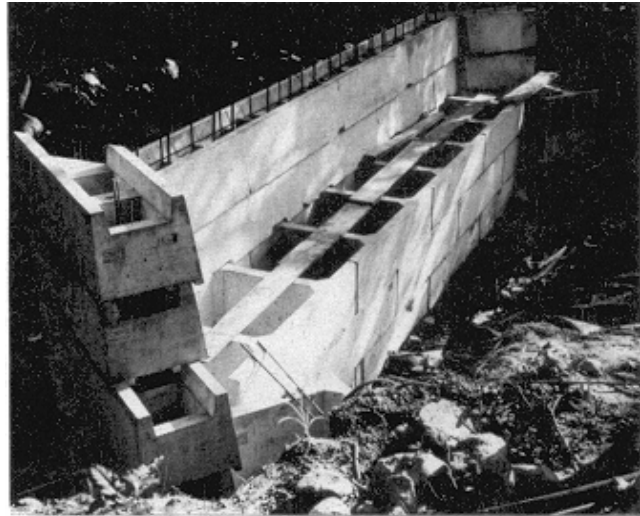
**Figure 8-51. Top view of precast abutment prior to backfilling, Ulsterville Bridge**

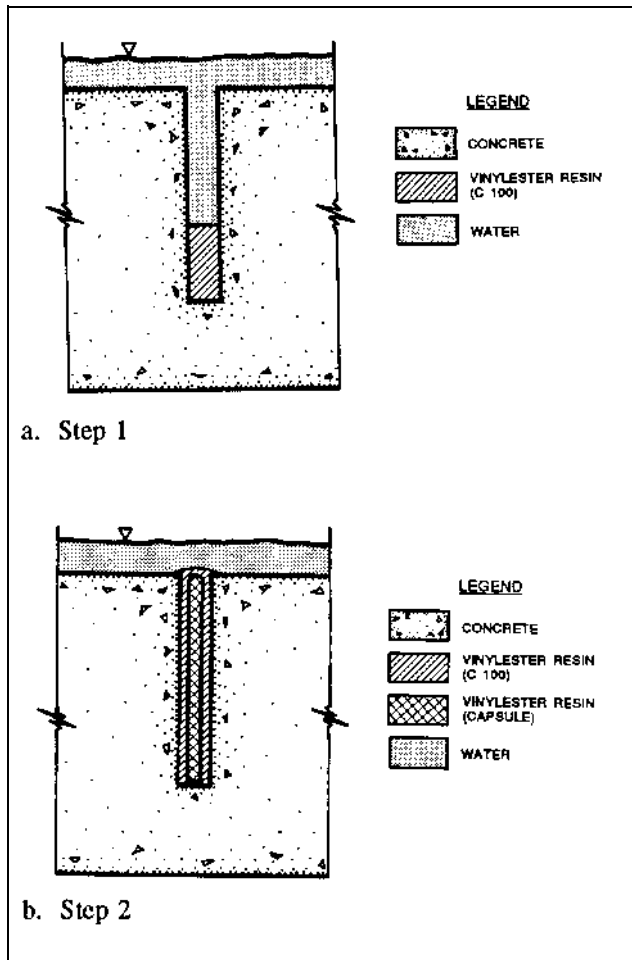
Figure 8-56. Two-step procedure for anchor installation under submerged conditions

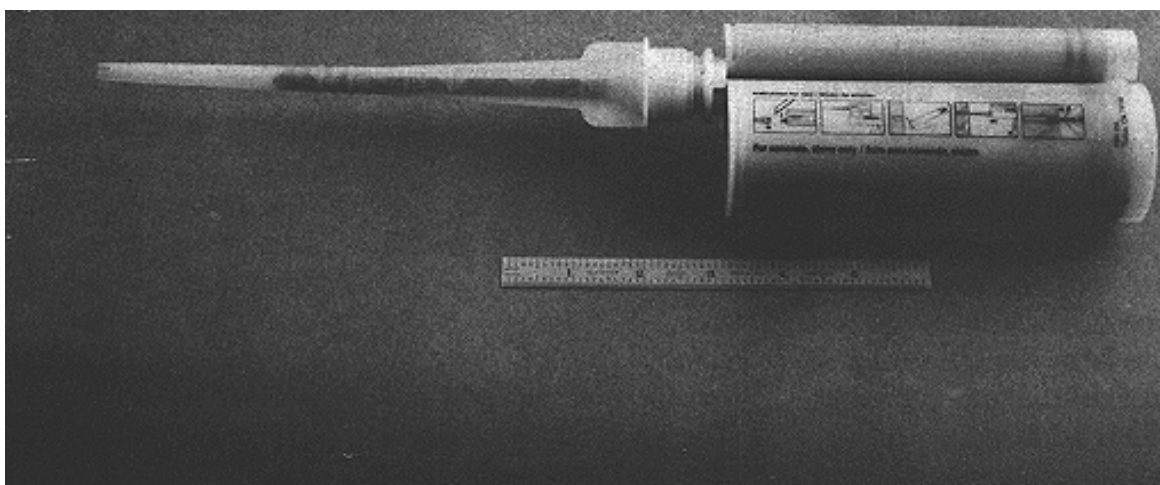
Figure 8-57. Paired disposable cartridges and static mixing tube

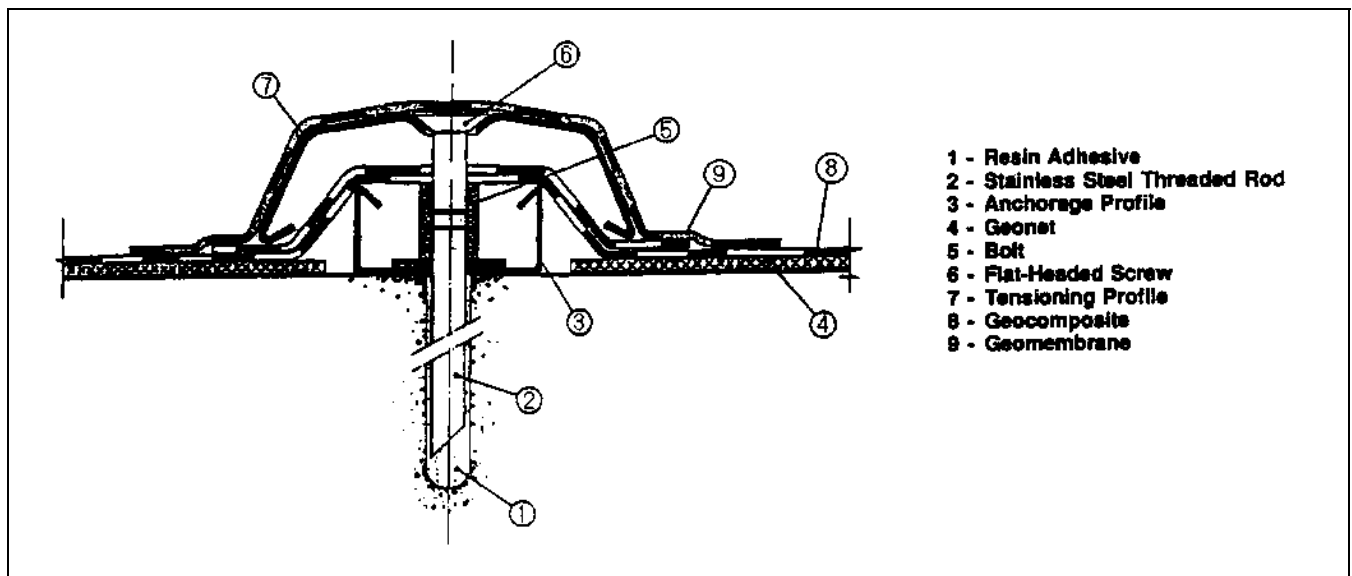
Figure 8-58. Detail of vertical anchorage and drainage profile

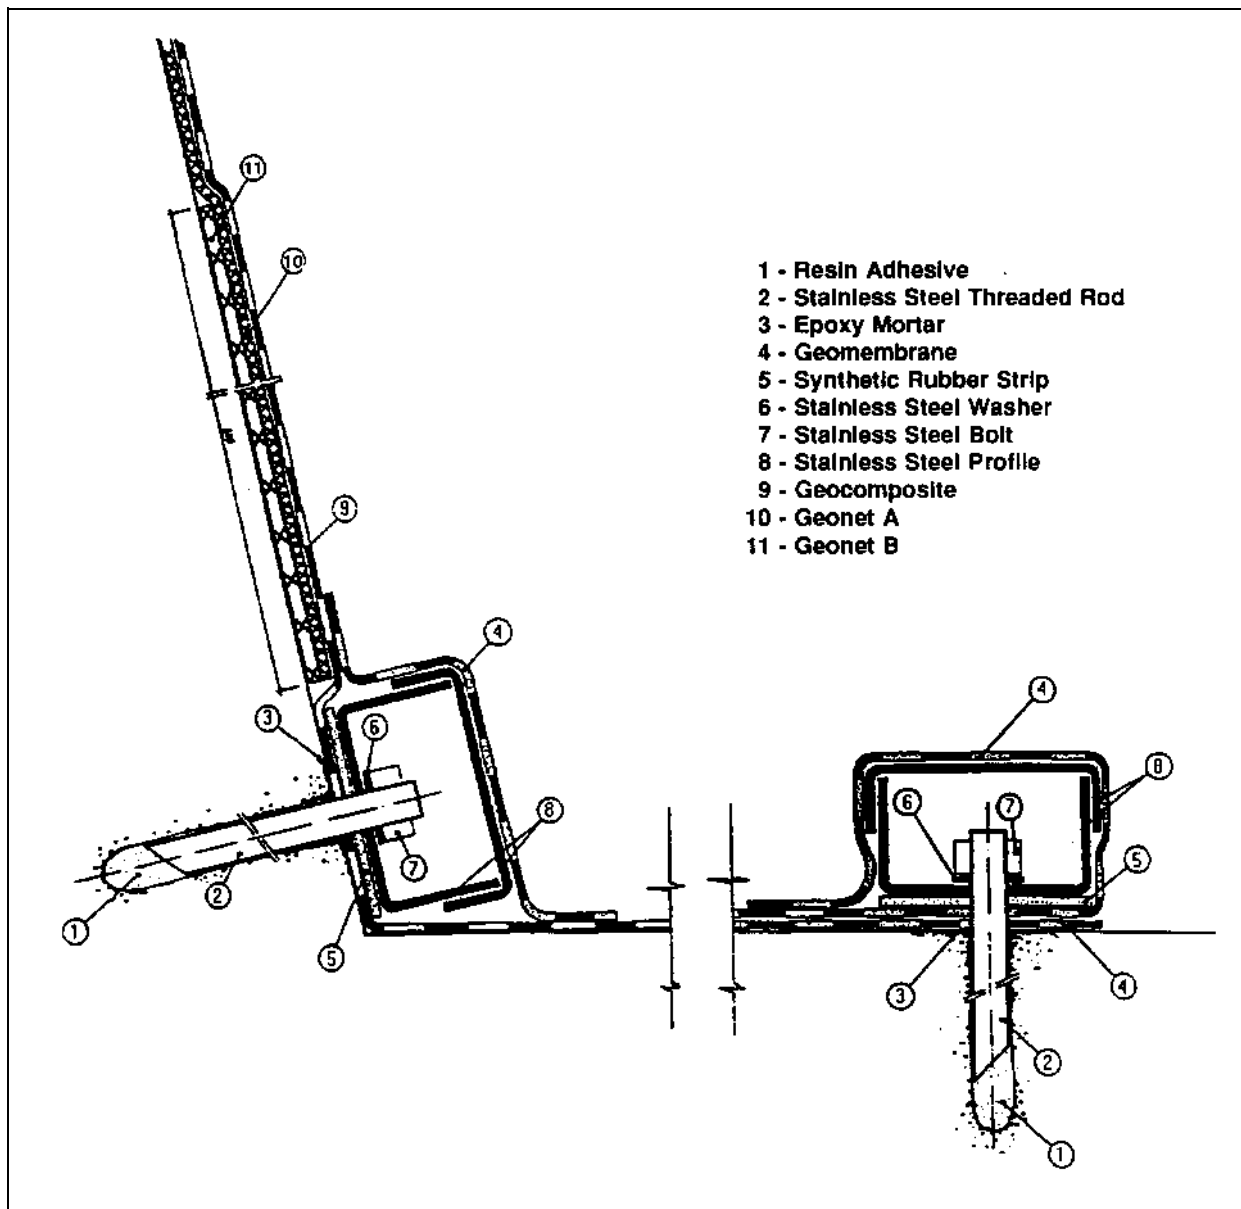
Figure 8-59. Detail of sealing profiles

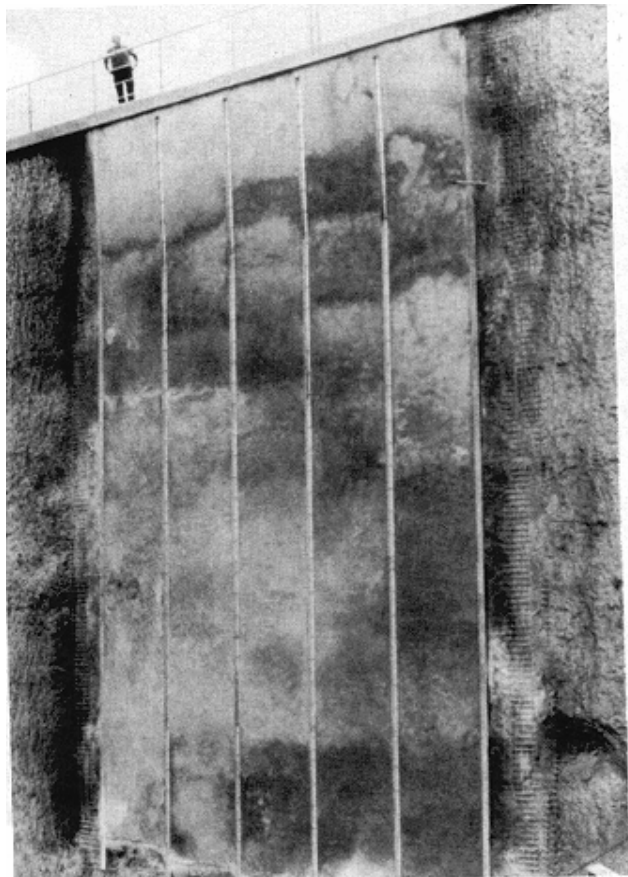
**Figure 8-61. Steel profiles embedded in shotcrete, Cignana Dam**

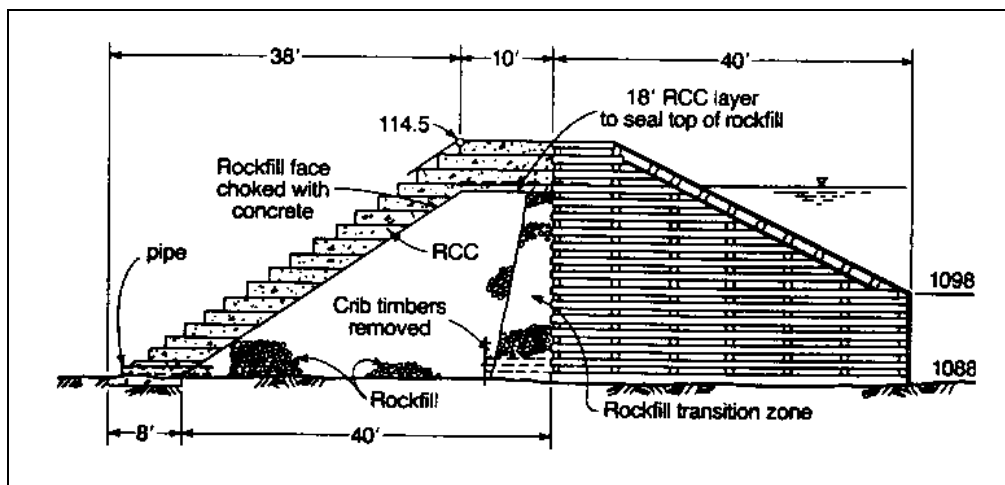
Figure 8-63. Section through modified dam, Ocoee Dam No. 2 (Hansen 1989)

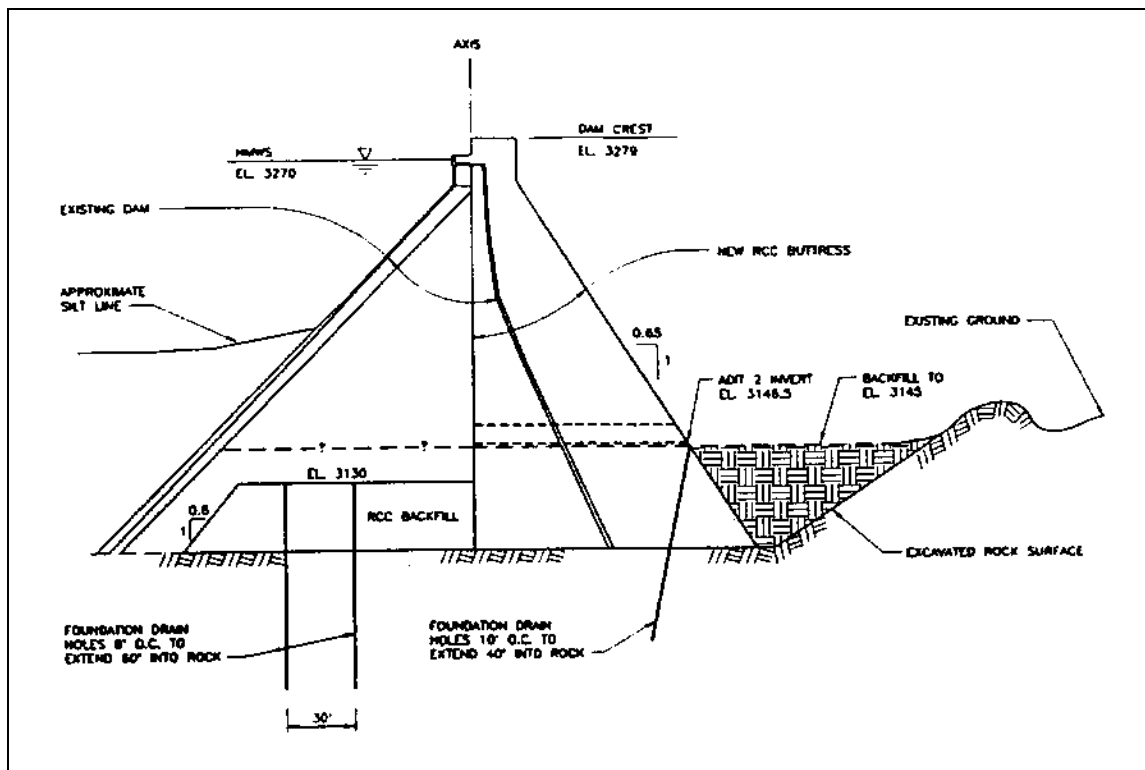
Figure 8-70. Littlerock Dam modification (Bischoff and Obermeyer 1993)
