**Berkeley Balcony
Investigation Materials**

On June 16, 2015, a fourth floor balcony at the Library Gardens apartment complex in Berkeley, California collapsed, killing six people and seriously injuring seven others.

Re: Unit 305 & 405 Balcony Destructive Testing Protocol
Project: Library Gardens, 2020 Kittridge St., Berkeley, CA

Pursuant to the California Contractor's State License Board's request, I have performed an initial onsite investigation, reviewed various documents noted below and prepared the Construction Summary Report. Additionally, I have performed onsite visual & destructive testing investigations at the subject project located at 2020 Kittredge St., Berkeley, CA as well as the remnants of the balconies at Units 405 & 305. Exhibit "C" attached to this report contains a specific comparison of the design of various balcony components versus the as-built conditions found in the field through visual observation, destructive testing & laboratory analysis. This Construction Summary Report is organized by the following sections.

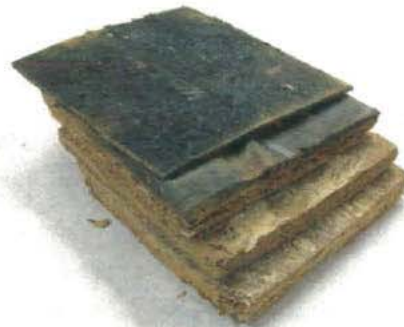
Unit 305 Test Sample Photo 6235 – 7 October 2015

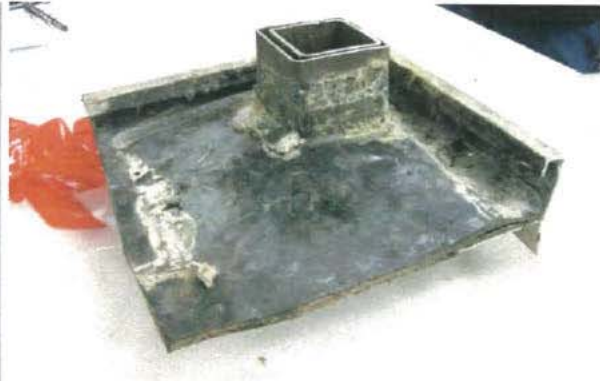
Unit 405 Test Sample Photo 6249 – 7 October 2015
